### **OPTIONAL DETERMINATION OF NON-SIGNIFICANCE (DNS) NOTICE MATERIALS**

File No. 09-122918-LO  
Project Name/Address: Ellison Slope Reconstruction and Enhancement  
853 97<sup>th</sup> Ave SE  
Planner: Kevin LeClair  
Phone Number: 425-452-2928

# CRITICAL AREAS REPORT

## Steep Slope Reconstruction & Enhancement

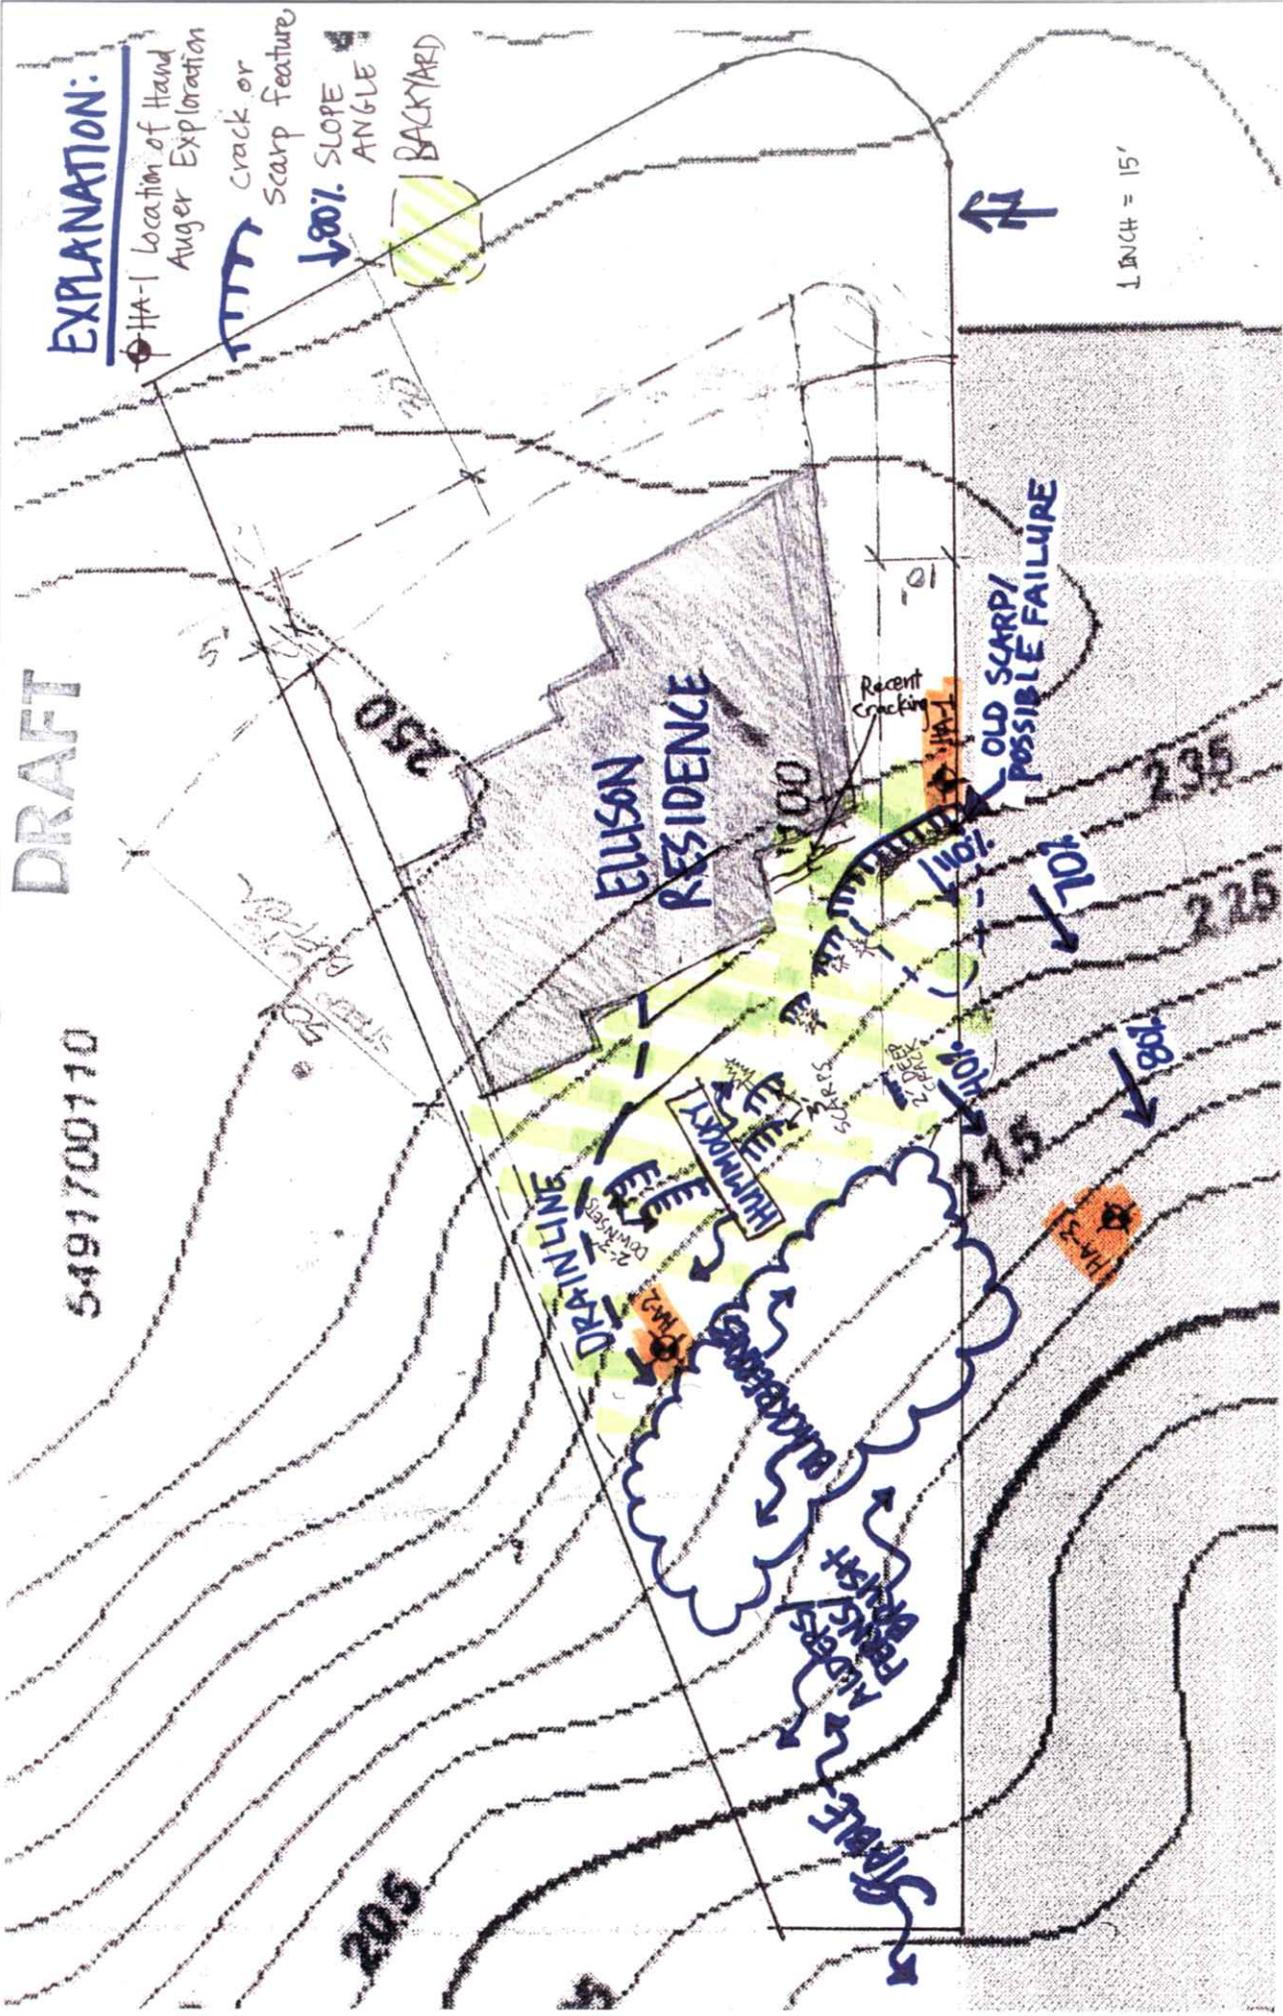
I traversed along the backyard and slope area west of the yard on the property to evaluate slope conditions. I observed evidence of cracking, slumping, and slope movement within the yard area. I observed a very steep scarp feature immediately south of the house near the top of the slope, which appears to be an old failure. I also observed several arcuate cracks indicative of downsetting or soil creep along the slope. Exposed soils were observed in each of the crack features and scarp feature. No evidence of groundwater seepage was observed along the slope. Sketches of these features are shown on the plan attached.

OLD SCARP/ POSSIBLE FAILURE

Recent Cracking

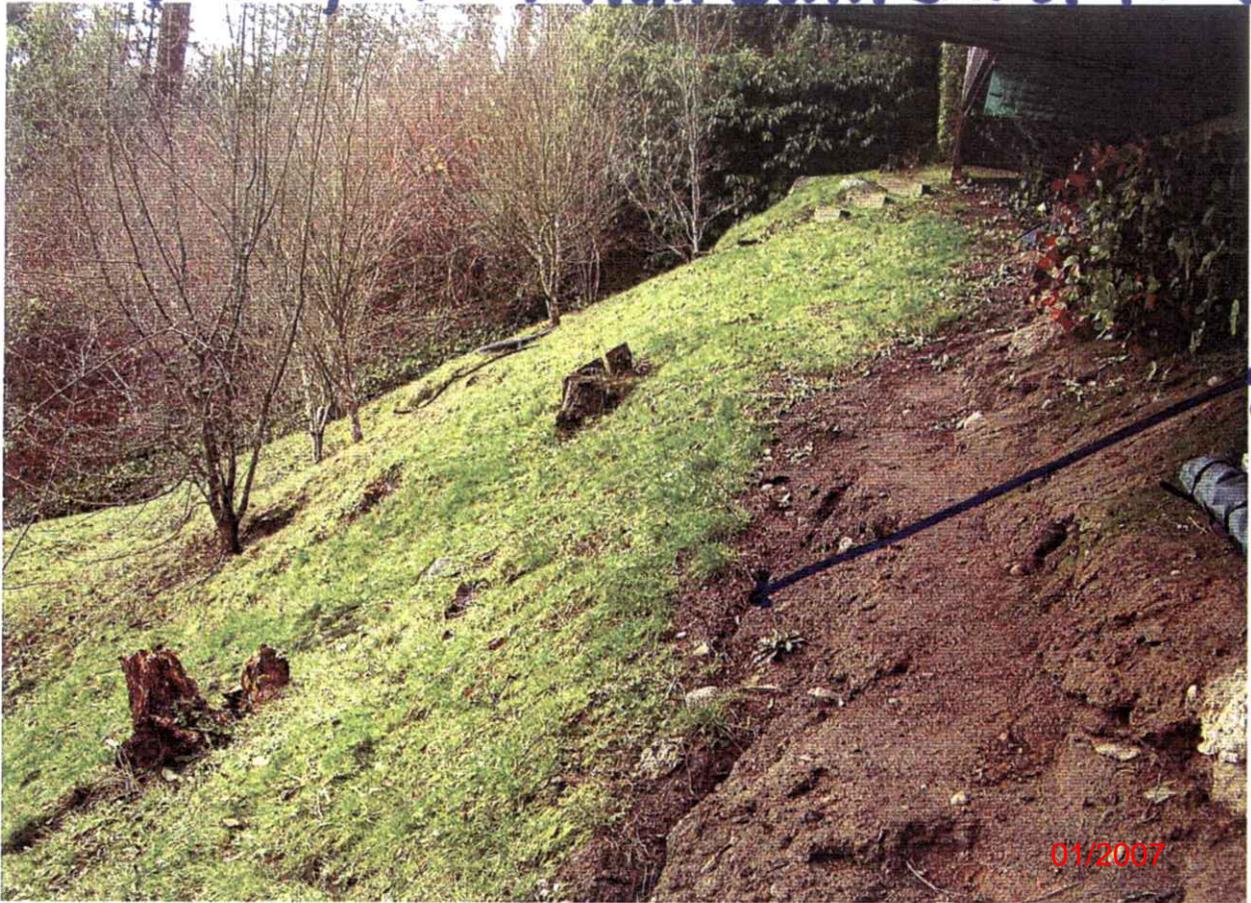
Looking North from South end of house

Recent  
Cracks

Downsets

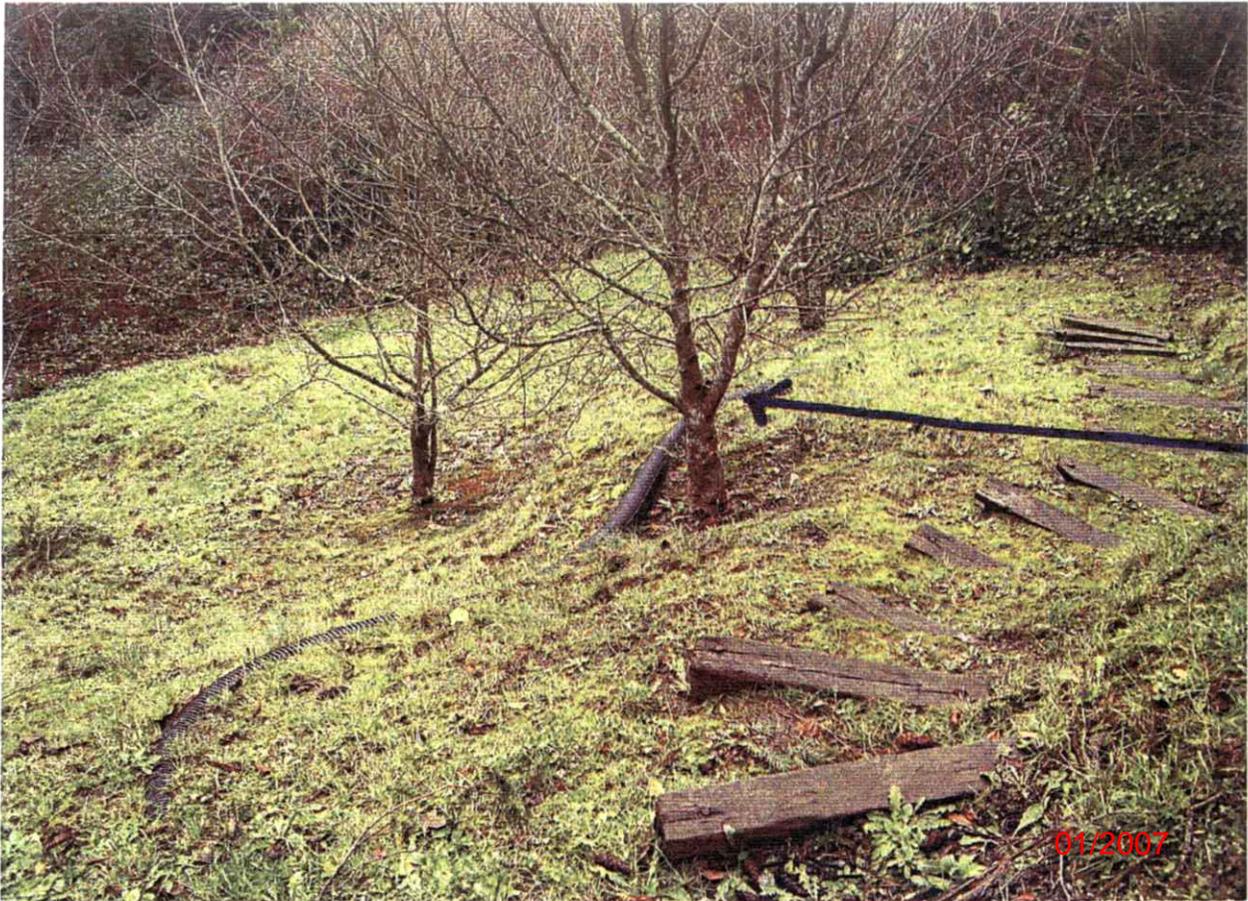
Drainpipe

Drainage

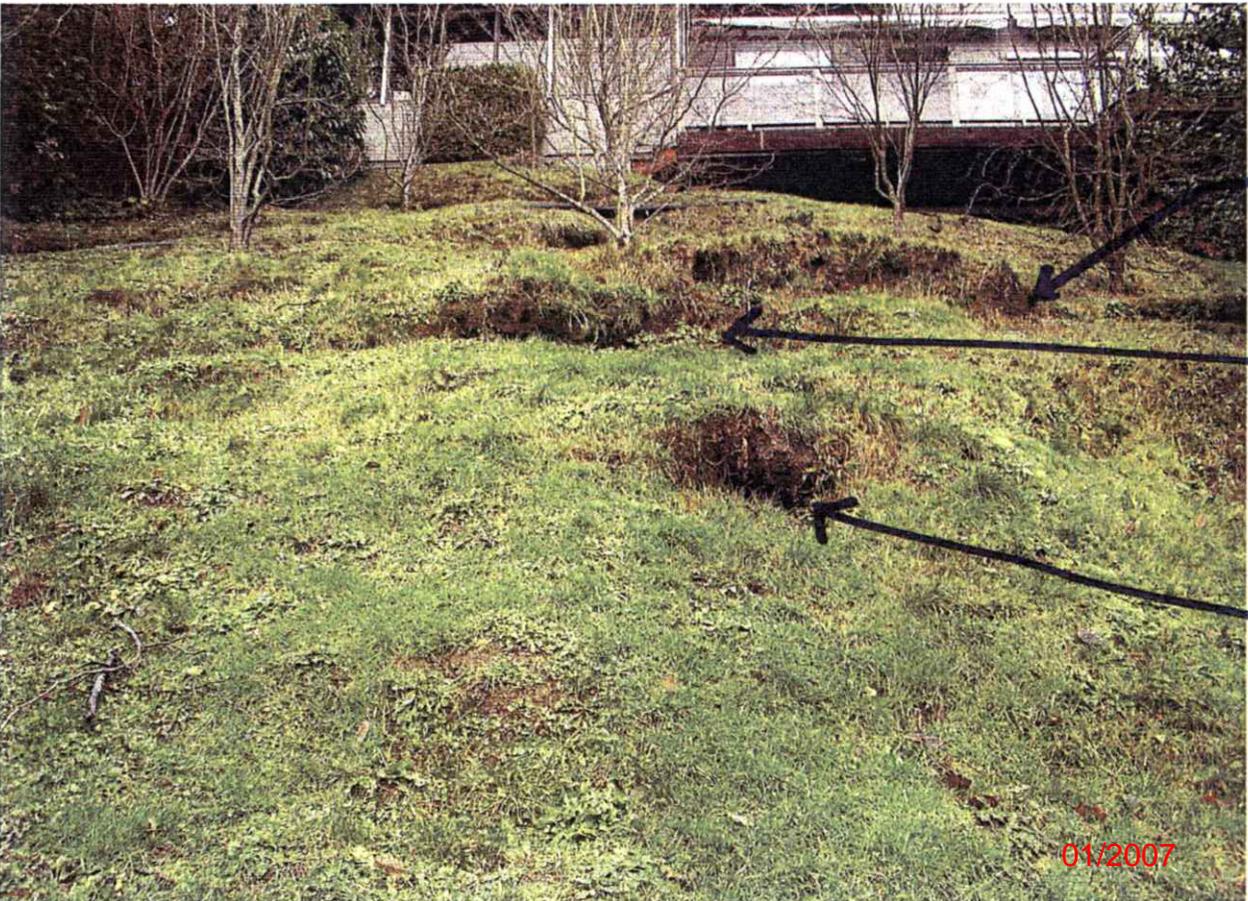
Cracking/Slumping

Looking East from bottom of yard

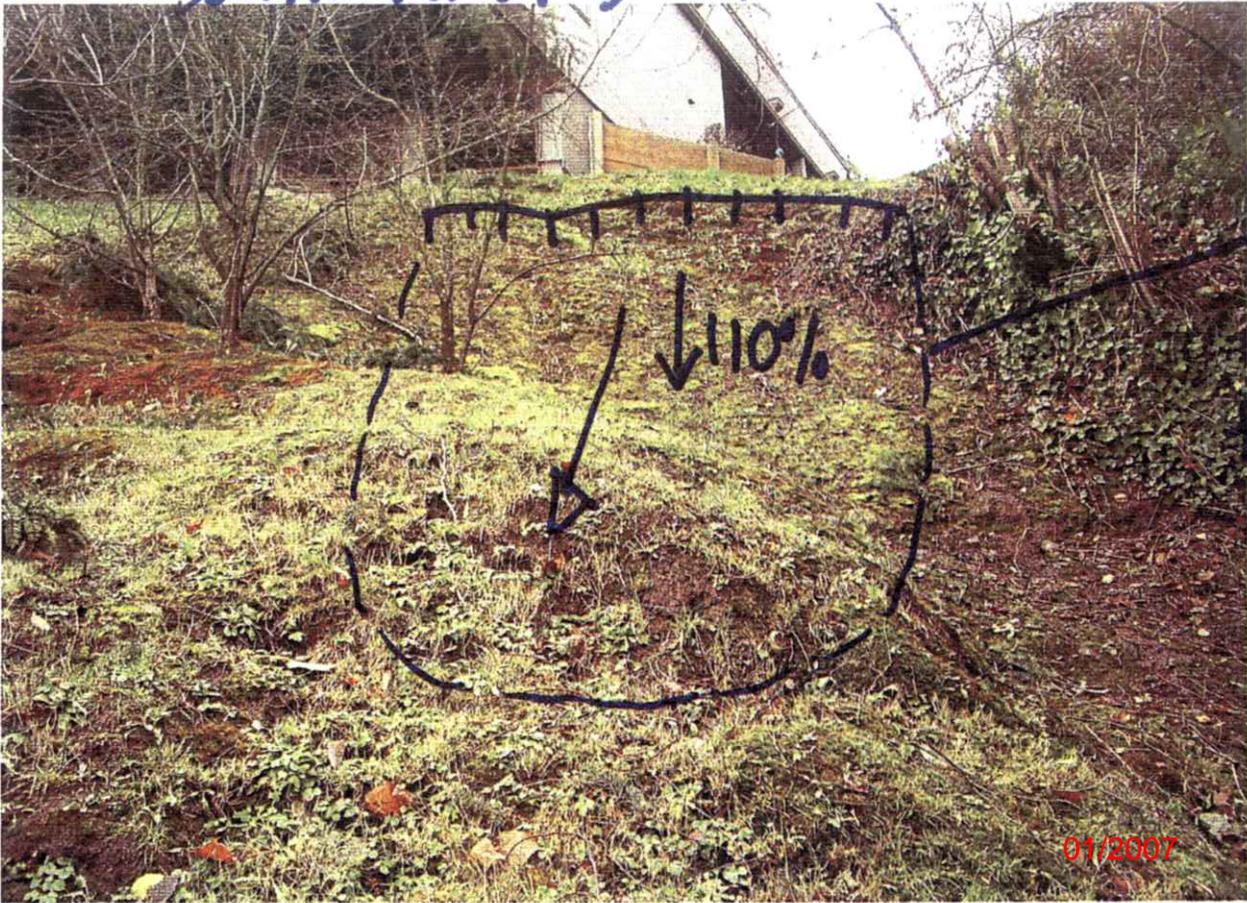
Very  
Steep  
old  
Failure  
(?)

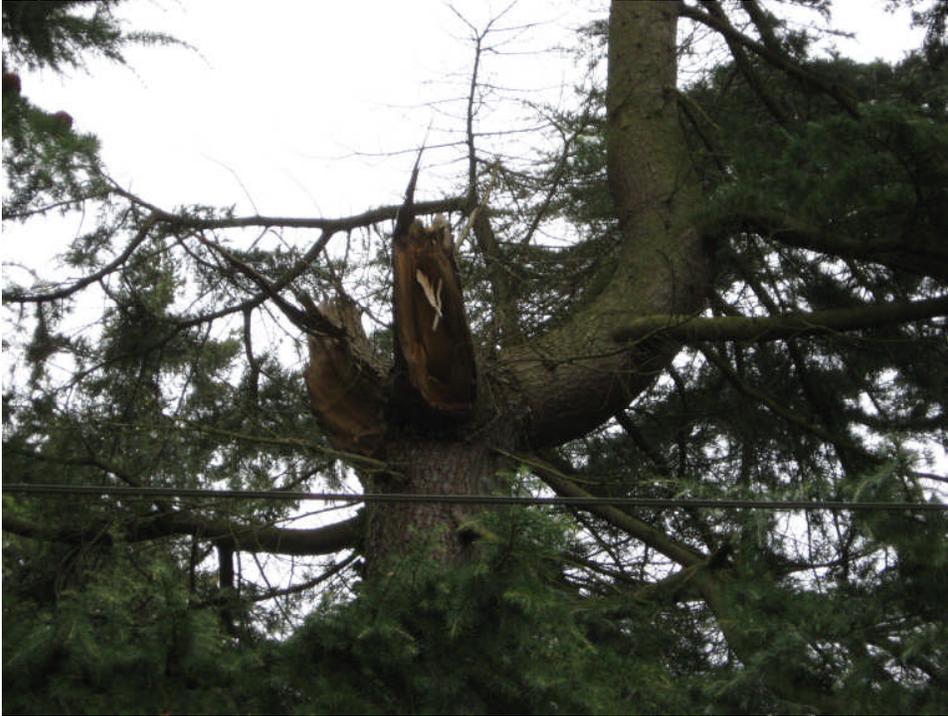
Top failure of tree #111

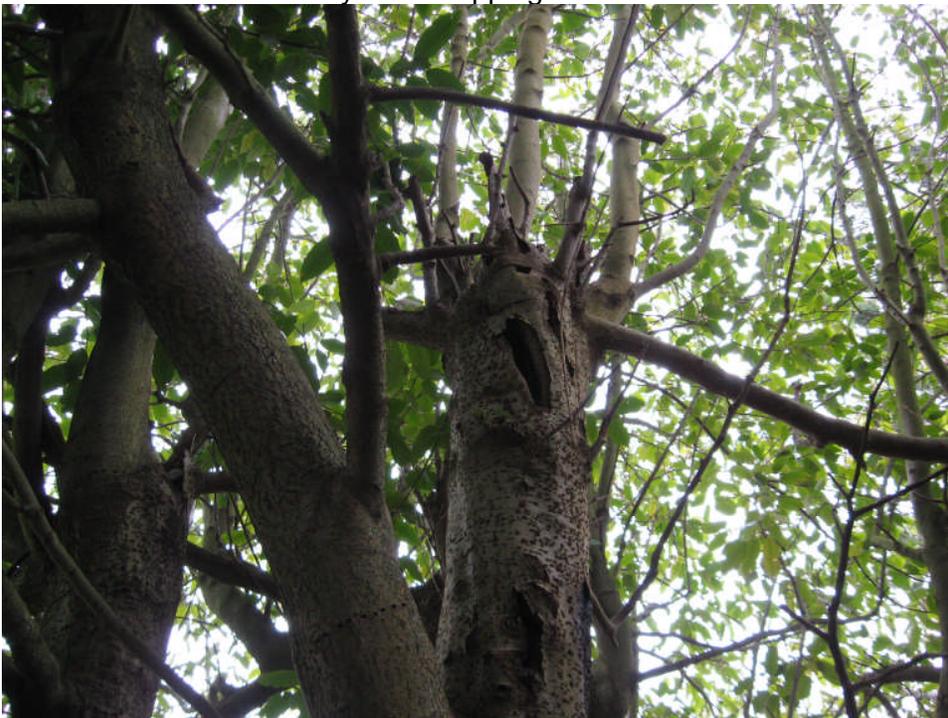
Tree #113 Extensive decay below topping cut

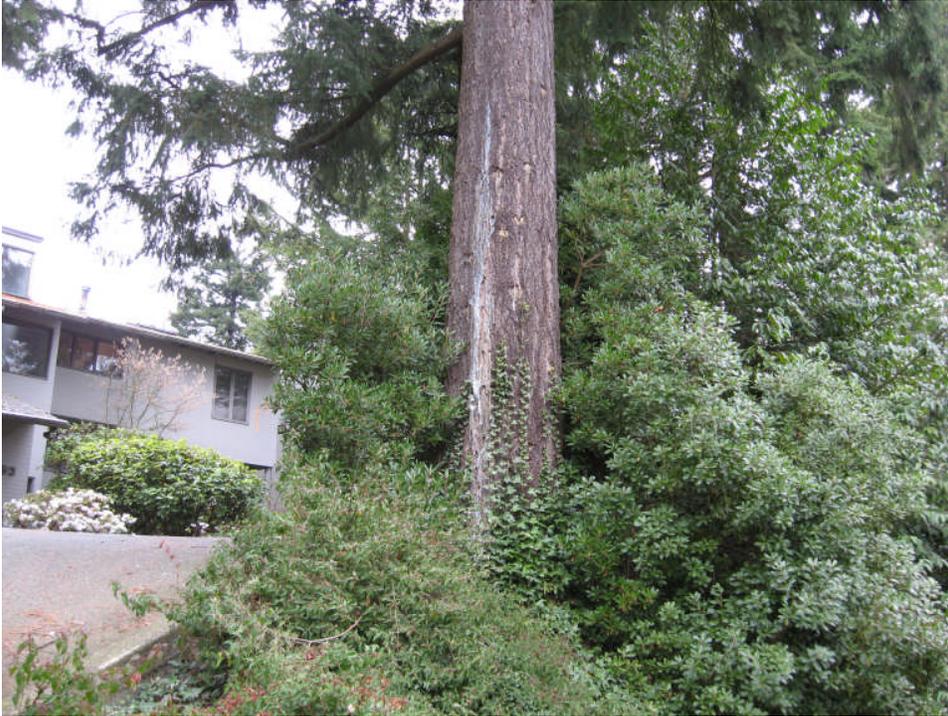
Tree #105 Cambial rupture on lower trunk – not concerning at this time
