# Petrescu Retaining Wall

Project No. KE130063A

Subject: Slope Restoration and Ecology Block Wall Recommendations  
16710 SE 34<sup>th</sup> Street  
Bellevue, Washington

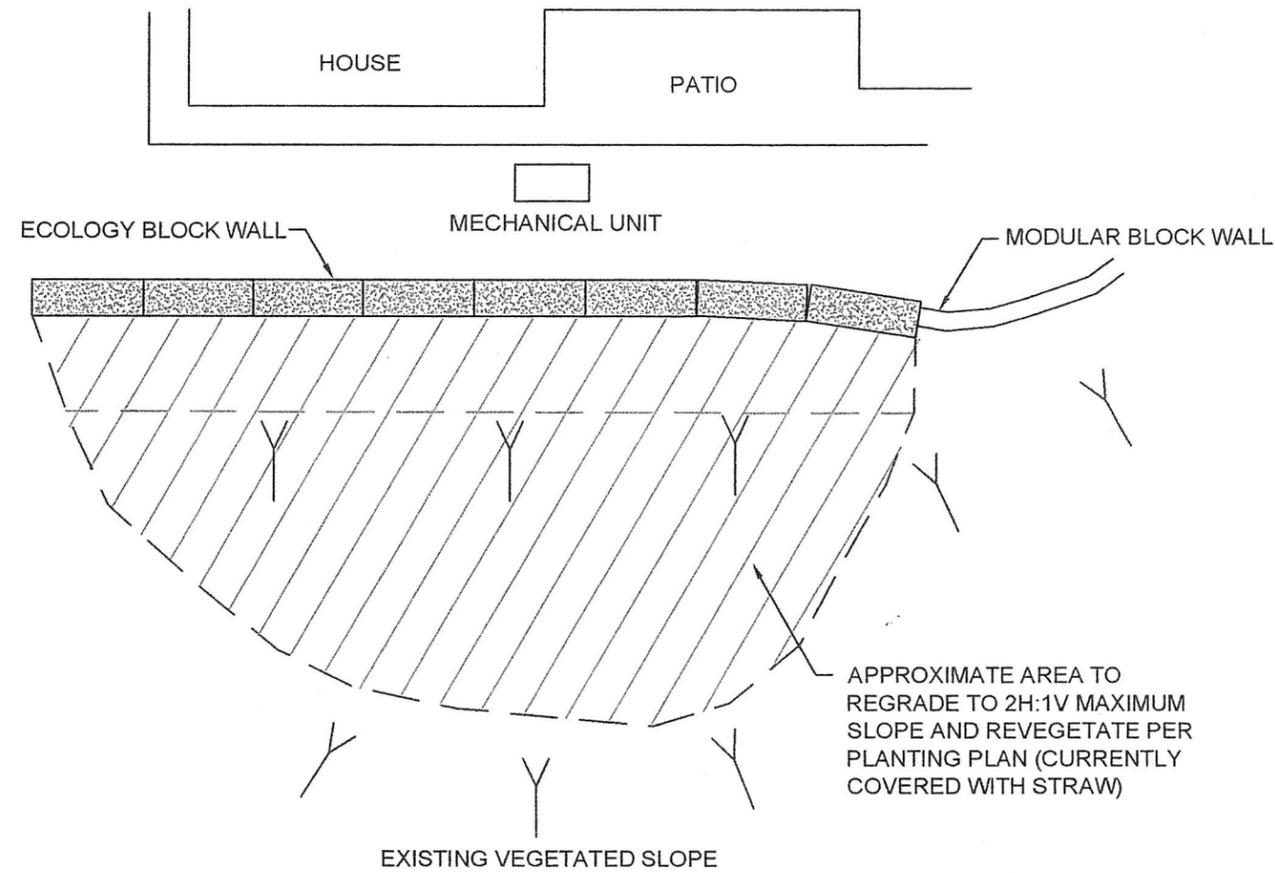
**SITE PLAN**

The “affected” area immediately below the ecology block wall includes a roughly 4- to 6-foot-wide level bench leading to an approximate 1.5H:1V (Horizontal:Vertical) slope. The affected area extends roughly 20 feet downslope and consists of exposed, loose soil currently covered with straw. We observed shallow surface cracks along the transition between the level and steep portions of the affected area. Several, discarded random modular blocks were observed along the lower portion of the affected area. The steep slope below the affected area was well vegetated, with both trees and native underbrush.

Based on our observations, we recommend that drainage elements be incorporated into the existing ecology block wall, along with a moderate amount of remedial grading followed by revegetation of the slope with erosion-resistant plantings. Figure 1 shows the existing residence and the area of the recommended mitigation measures. Based on our limited site and document review, we have the following comments:

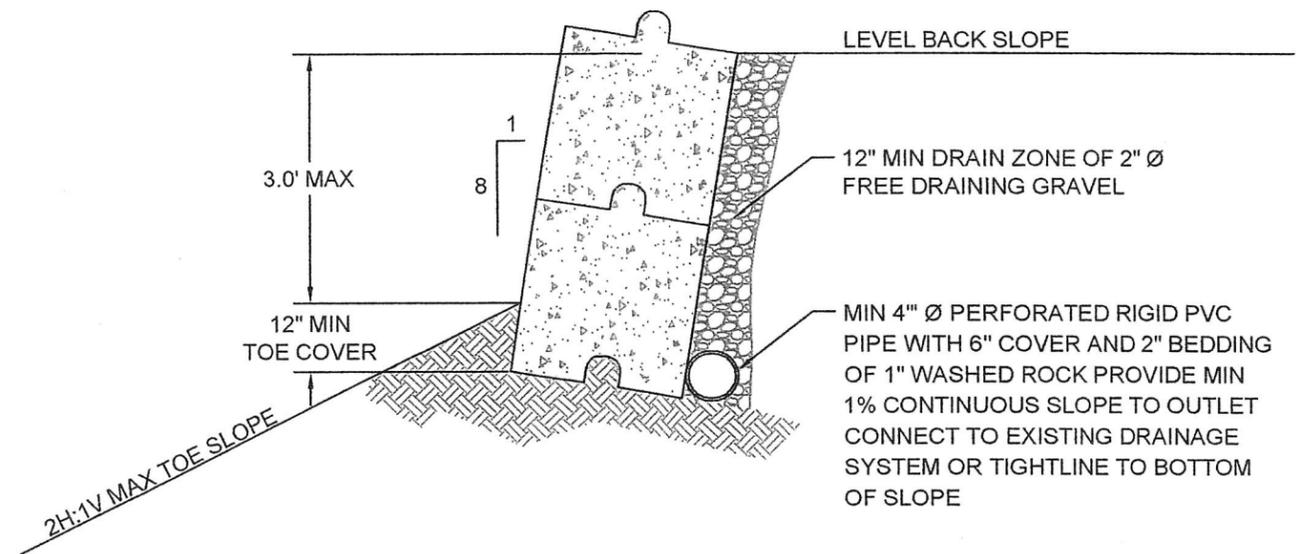
**ECOLOGY BLOCK WALL DETAIL**

The subject wall consists of two rows of stacked concrete ecology blocks (2'x2'x6') trending parallel to and approximately 9 to 10 feet from the east side of the residence. The area between the residence and the wall includes a sidewalk/patio area and a grassy backyard. The exposed height of the 48-foot-long wall is roughly 2 to 2½ feet. We probed the area near to the wall toe and encountered firm and non-yielding soil at the wall base. We observed the in-place portion of the existing modular block wall continuing northward along a similar alignment as the ecology block wall.

- Figure 1 includes a recommended detail for the existing ecology block wall. A minimum 1-foot-wide blanket of 2-inch-diameter drain rock should be placed along the back face of the ecology block wall. A 4-inch-diameter, perforated drainpipe should be placed at the base of the drainage zone and routed by gravity to a suitable discharge. If not tied to the existing house drainage system, the wall drainage should be tightlined to the bottom of the existing slope east of the wall.
- We recommend that the affected portion of the slope below the ecology block wall be regraded to a maximum slope of 2H:1V, with the resulting ground surface compacted to a firm condition. Excess soil should be removed from the slope area. The distances shown on Figure 1 from the wall and recommended mitigation area to the residence should be considered approximate.

NOTE: OBSERVATION OF DRAINAGE INSTALLATION BY GEOTECHNICAL ENGINEER OR THEIR REPRESENTATIVE IS REQUIRED.
