Tse Patio
File Number: 11-130705-LO

Memorandum

PROJECT: RESIDENTIAL RETAINING WALL,
13617 SE 54TH STYREET, BELLEVUE, WA

SUBJECT: CRITICAL AREA REVIEW, GEOTECHNICAL
REVIEW OF WALL CONSTRUCTION

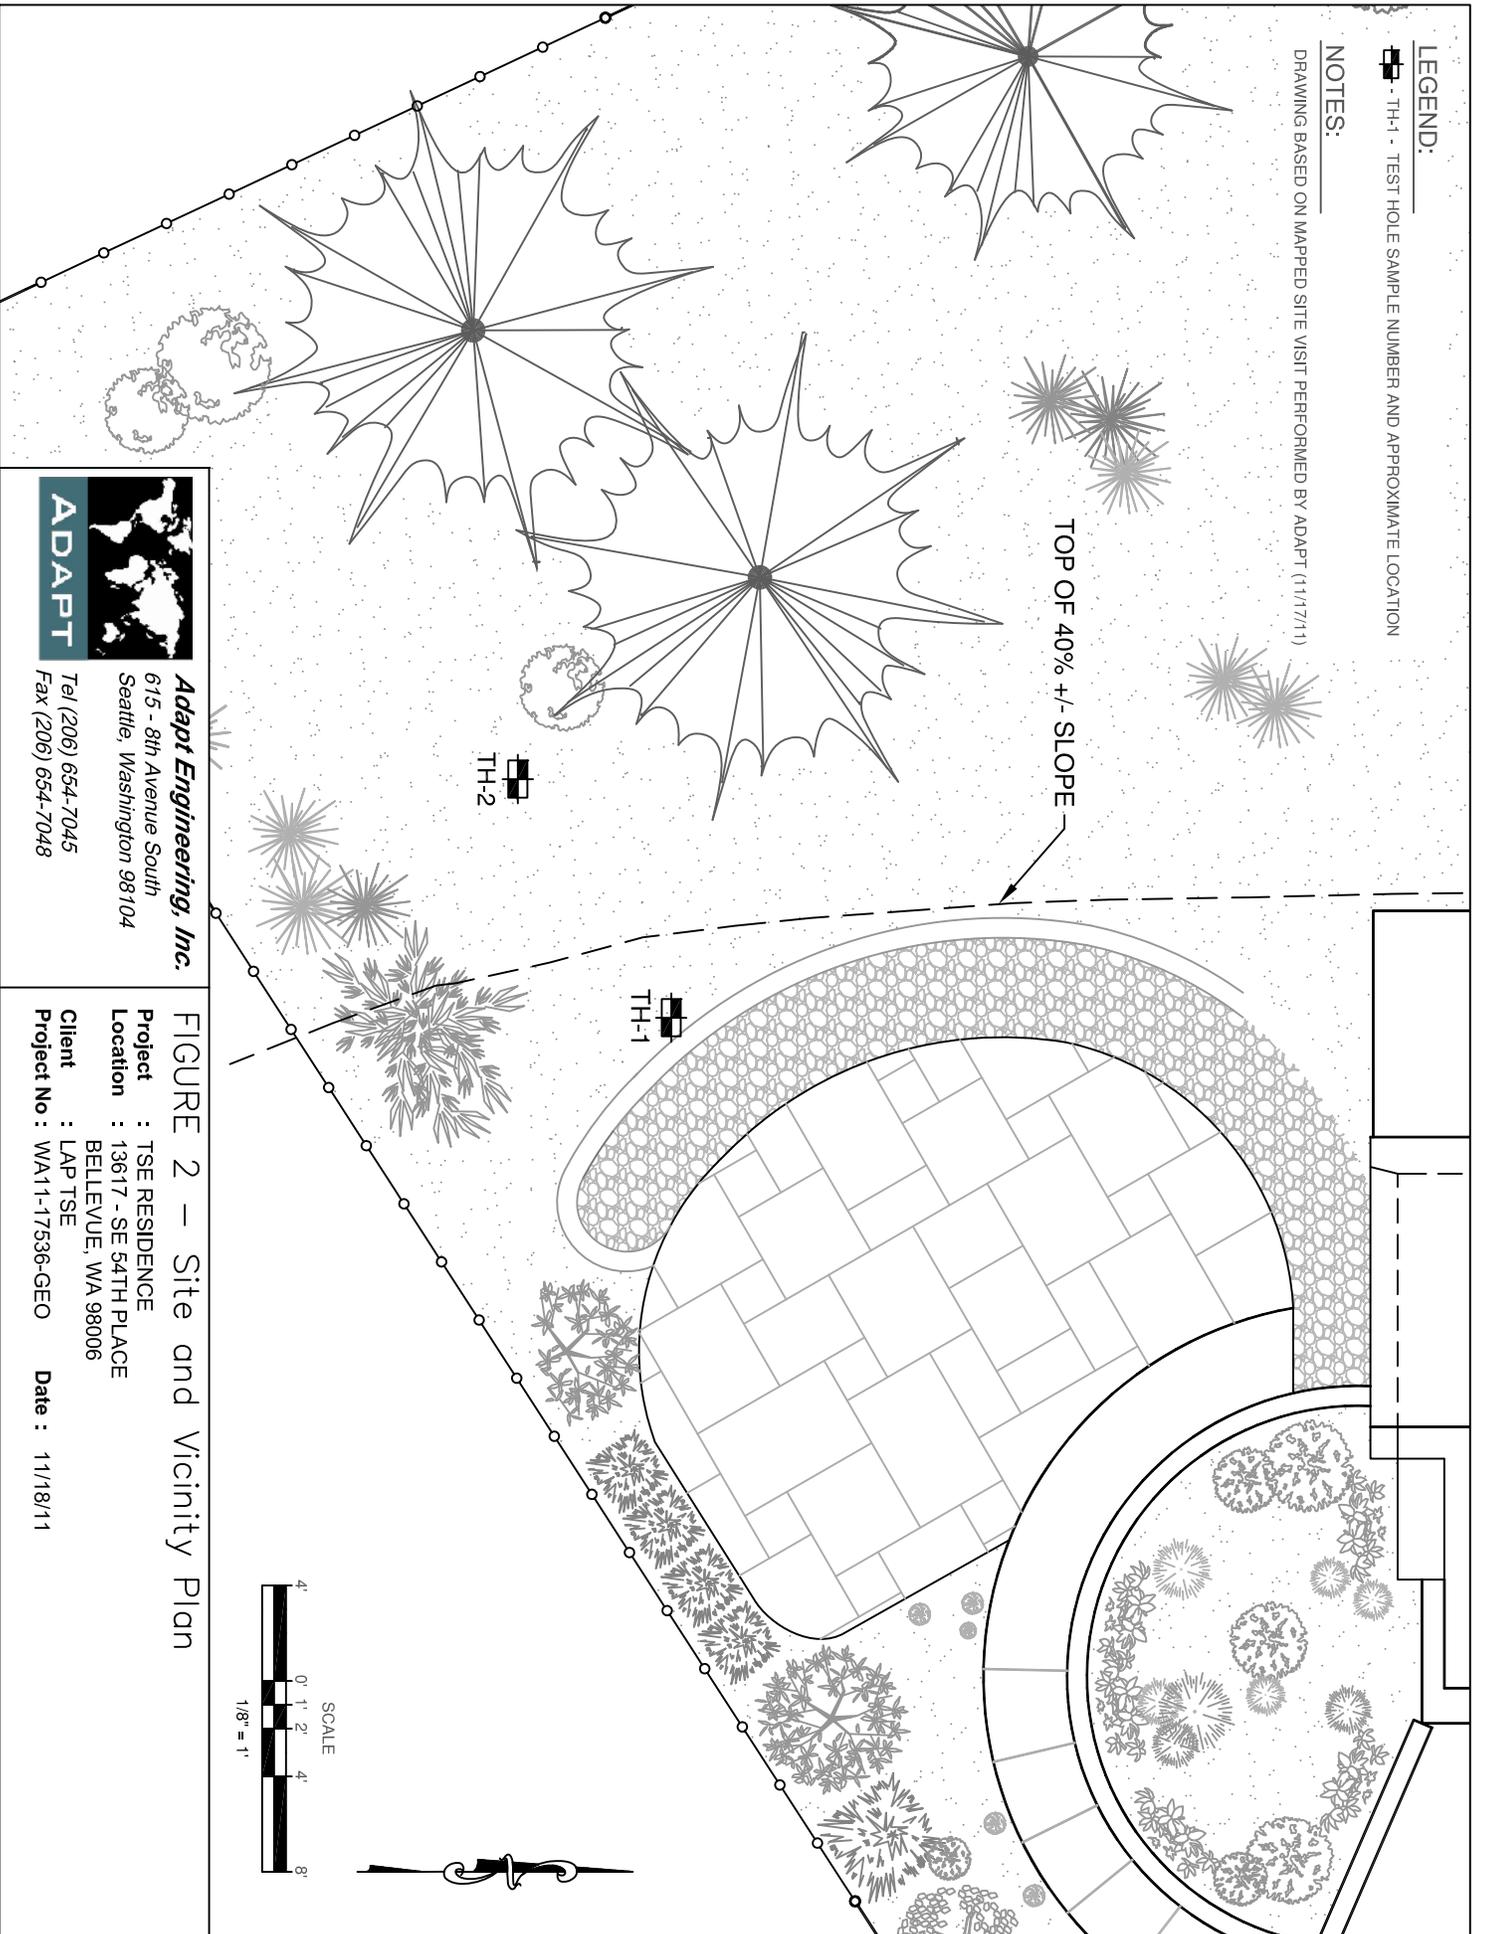
FIGURE 2 – Site and Vicinity Plan

TH-1 - TEST HOLE SAMPLE NUMBER AND APPROXIMATE LOCATION

DRAWING BASED ON MAPPED SITE VISIT PERFORMED BY ADAPT (11/17/11)
