APPENDIX A
TECHNICAL MEMORANDUM

Ecological Inventory and
Characterization of Existing and
Historical Conditions within the
Bel-Red Land Use Area

December 16, 2005

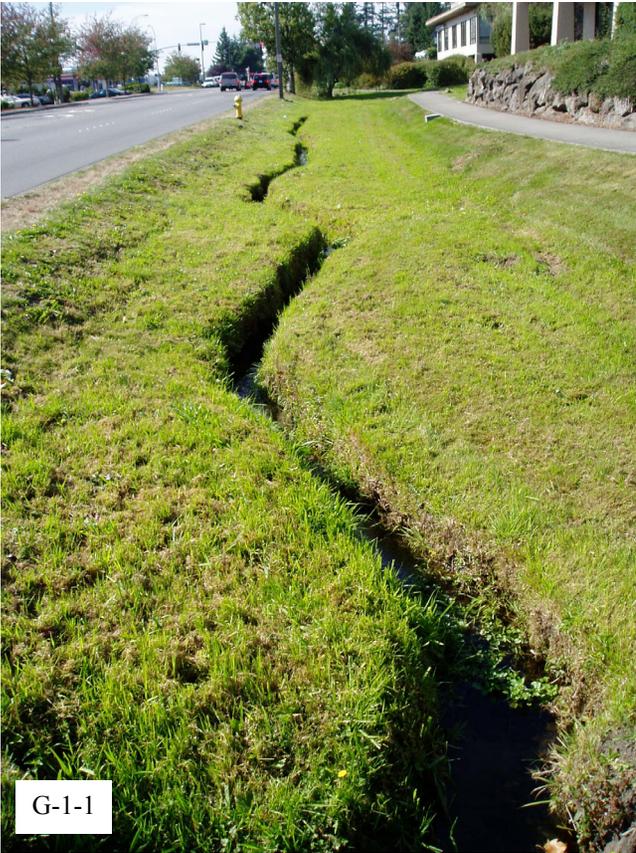
Creek	Site	Picture ID	Notes
West Tributary Creek	W-1	W-1-1	Looking upstream from 120 th Avenue NE culvert to eroded stream channel
West Tributary Creek	W-2	W-2-1	View of wetland area from right bank side of parking lot
Goff Creek	G-1	G-1-1	Looking upstream at grass-lined, ditched creek
Goff Creek	G-2	G-2-1	Looking upstream at armored creek through Harley Davidson's property
Goff Creek	G-3	G-3-1	Looking downstream at armored creek behind parking lots
Goff Creek	G-4	G-4-1	View upstream of natural channel through maintained, native vegetation
Goff Creek	G-5	G-5-1	View upstream of channel behind office park
Tributary to Kelsey Creek	K-1	K-1-1	View of first concentrated flow in tributary, looking downstream from culvert in commercial area
Tributary to Kelsey Creek	K-2	K-2-1	Looking upstream at vegetation bordering the ditched/armored creek
Tributary to Kelsey Creek	K-3	K-3-2	Looking upstream from Bellevue-Redmond Road culvert

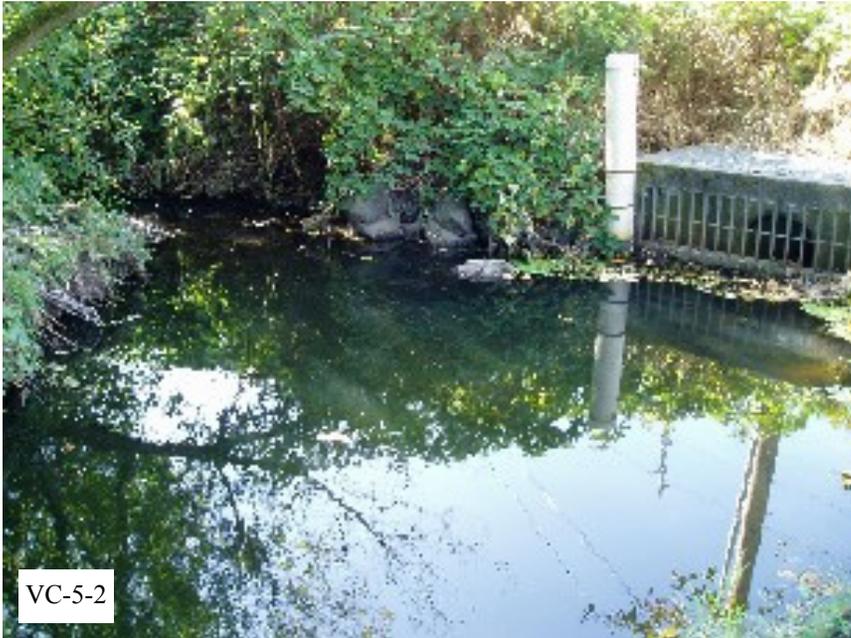
Valley Creek Main Channel	VC-5	VC-5-1	View of mainstem Valley Creek channel, just upstream of NE 20 th Street
Valley Creek Main Channel	VC-5	VC-5-2	View of mainstem Valley Creek channel, just downstream of NE 20 th Street, taken from right bank side of culvert
Valley Creek Main Channel	VC-5	VC-5-3	View of mainstem Valley Creek channel, just downstream of NE 20 th Street, taken from left bank side of culvert
Valley Creek Main Channel	VC-6	VC-6-1	Looking downstream, located in restored reach, just upstream of the Chinese restaurant – Noble Court
Valley Creek Main Channel	VC-7	VC-7-1	Looking upstream at armored reach of Valley Creek through the Chinese restaurant property
Valley Creek Tributary	VC-3	VC-3-2	View downstream, from left bank, at boulder armored channel
Valley Creek Tributary	VC-3b	VC-3b-6	View of flow/flood control structure at culvert
Valley Creek Tributary	VC-3b	VC-3b-4	Looking downstream at flow control structure and culvert from left bank

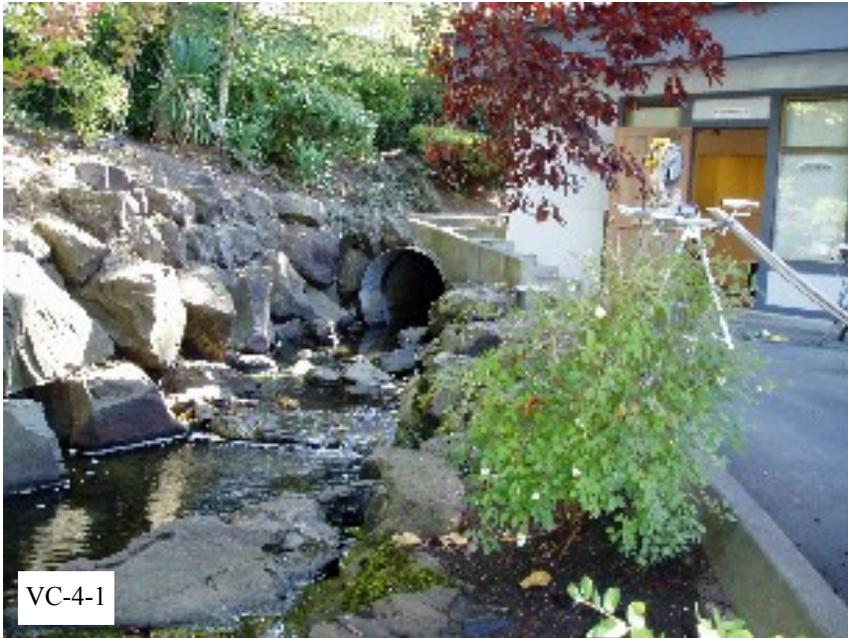
Valley Creek Tributary	VC-3b	VC-3b-2	View upstream from right bank, upstream of culvert under commercial area and NE 20 th Street
Valley Creek Tributary	VC-4	VC-4-1	View upstream of 36" creek culvert inlet to reach
