Belvedere Lot 6
5139 145th PI SE
Bellevue, WA 98006

**CRITICAL AREAS REPORT
AND
CONCEPTUAL MITIGATION PLAN

BELVEDERE LOT 6 – 145TH PLACE SE**

Wetland Resources, Inc. Project #16102

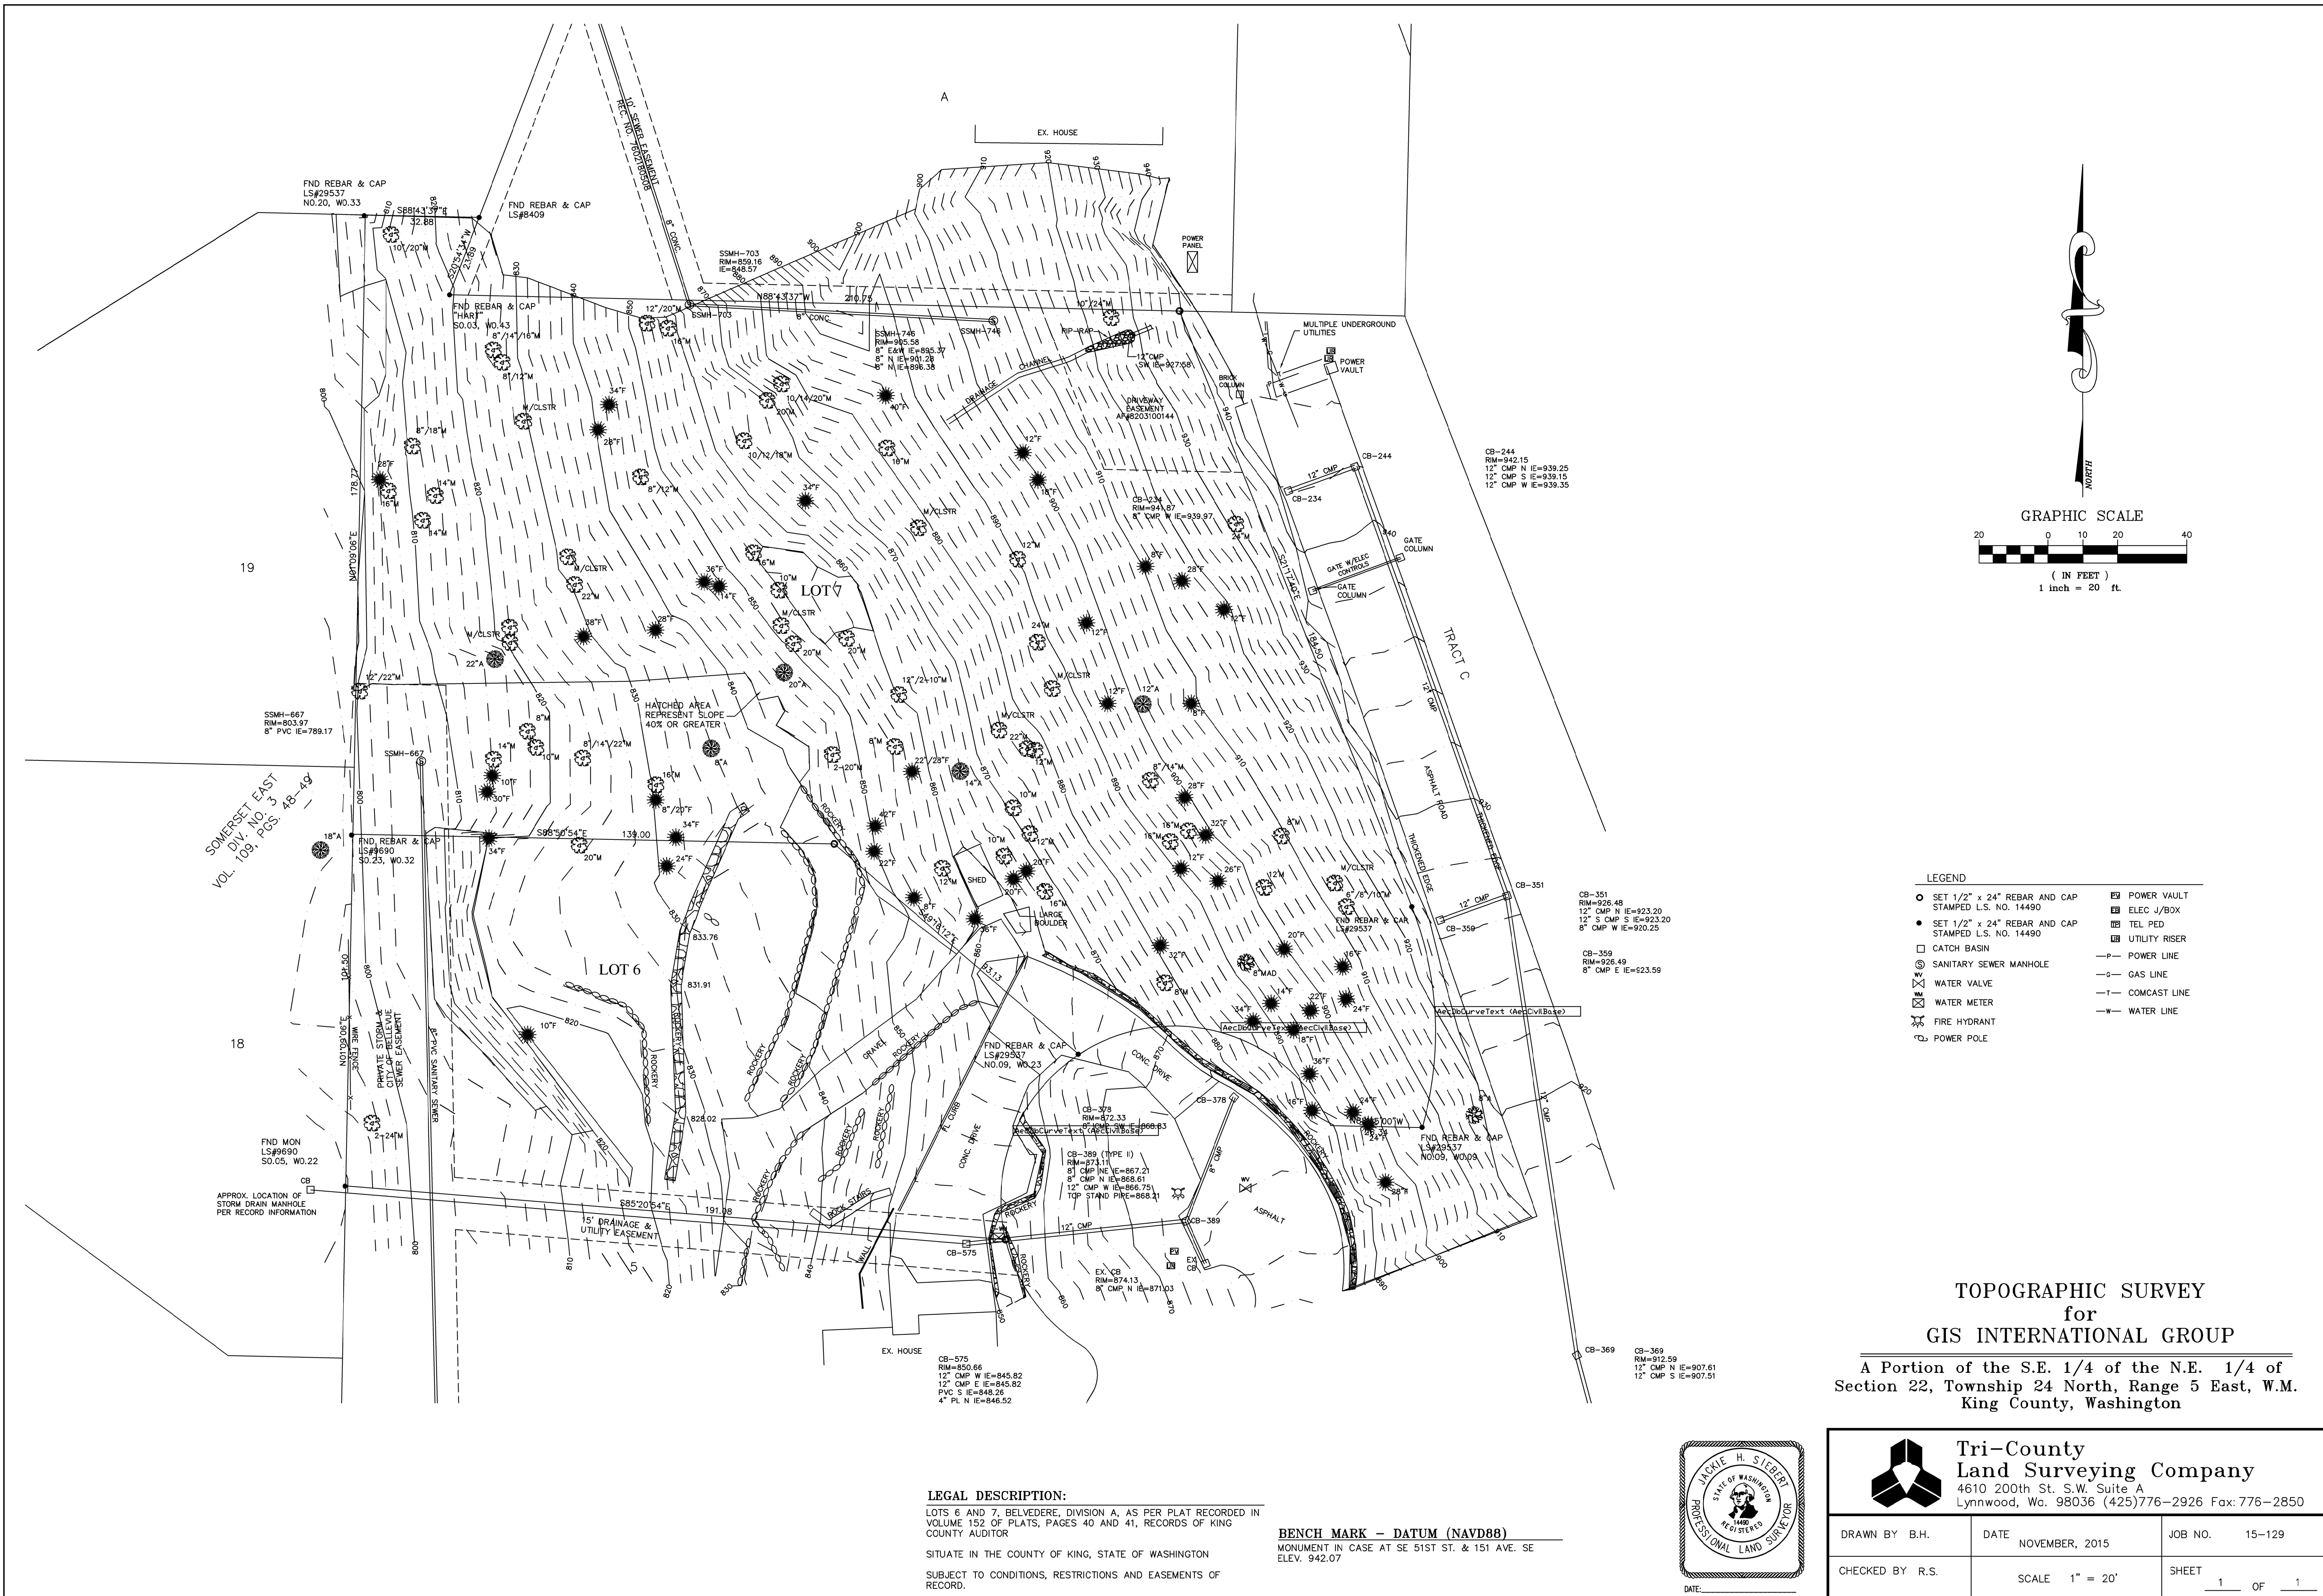
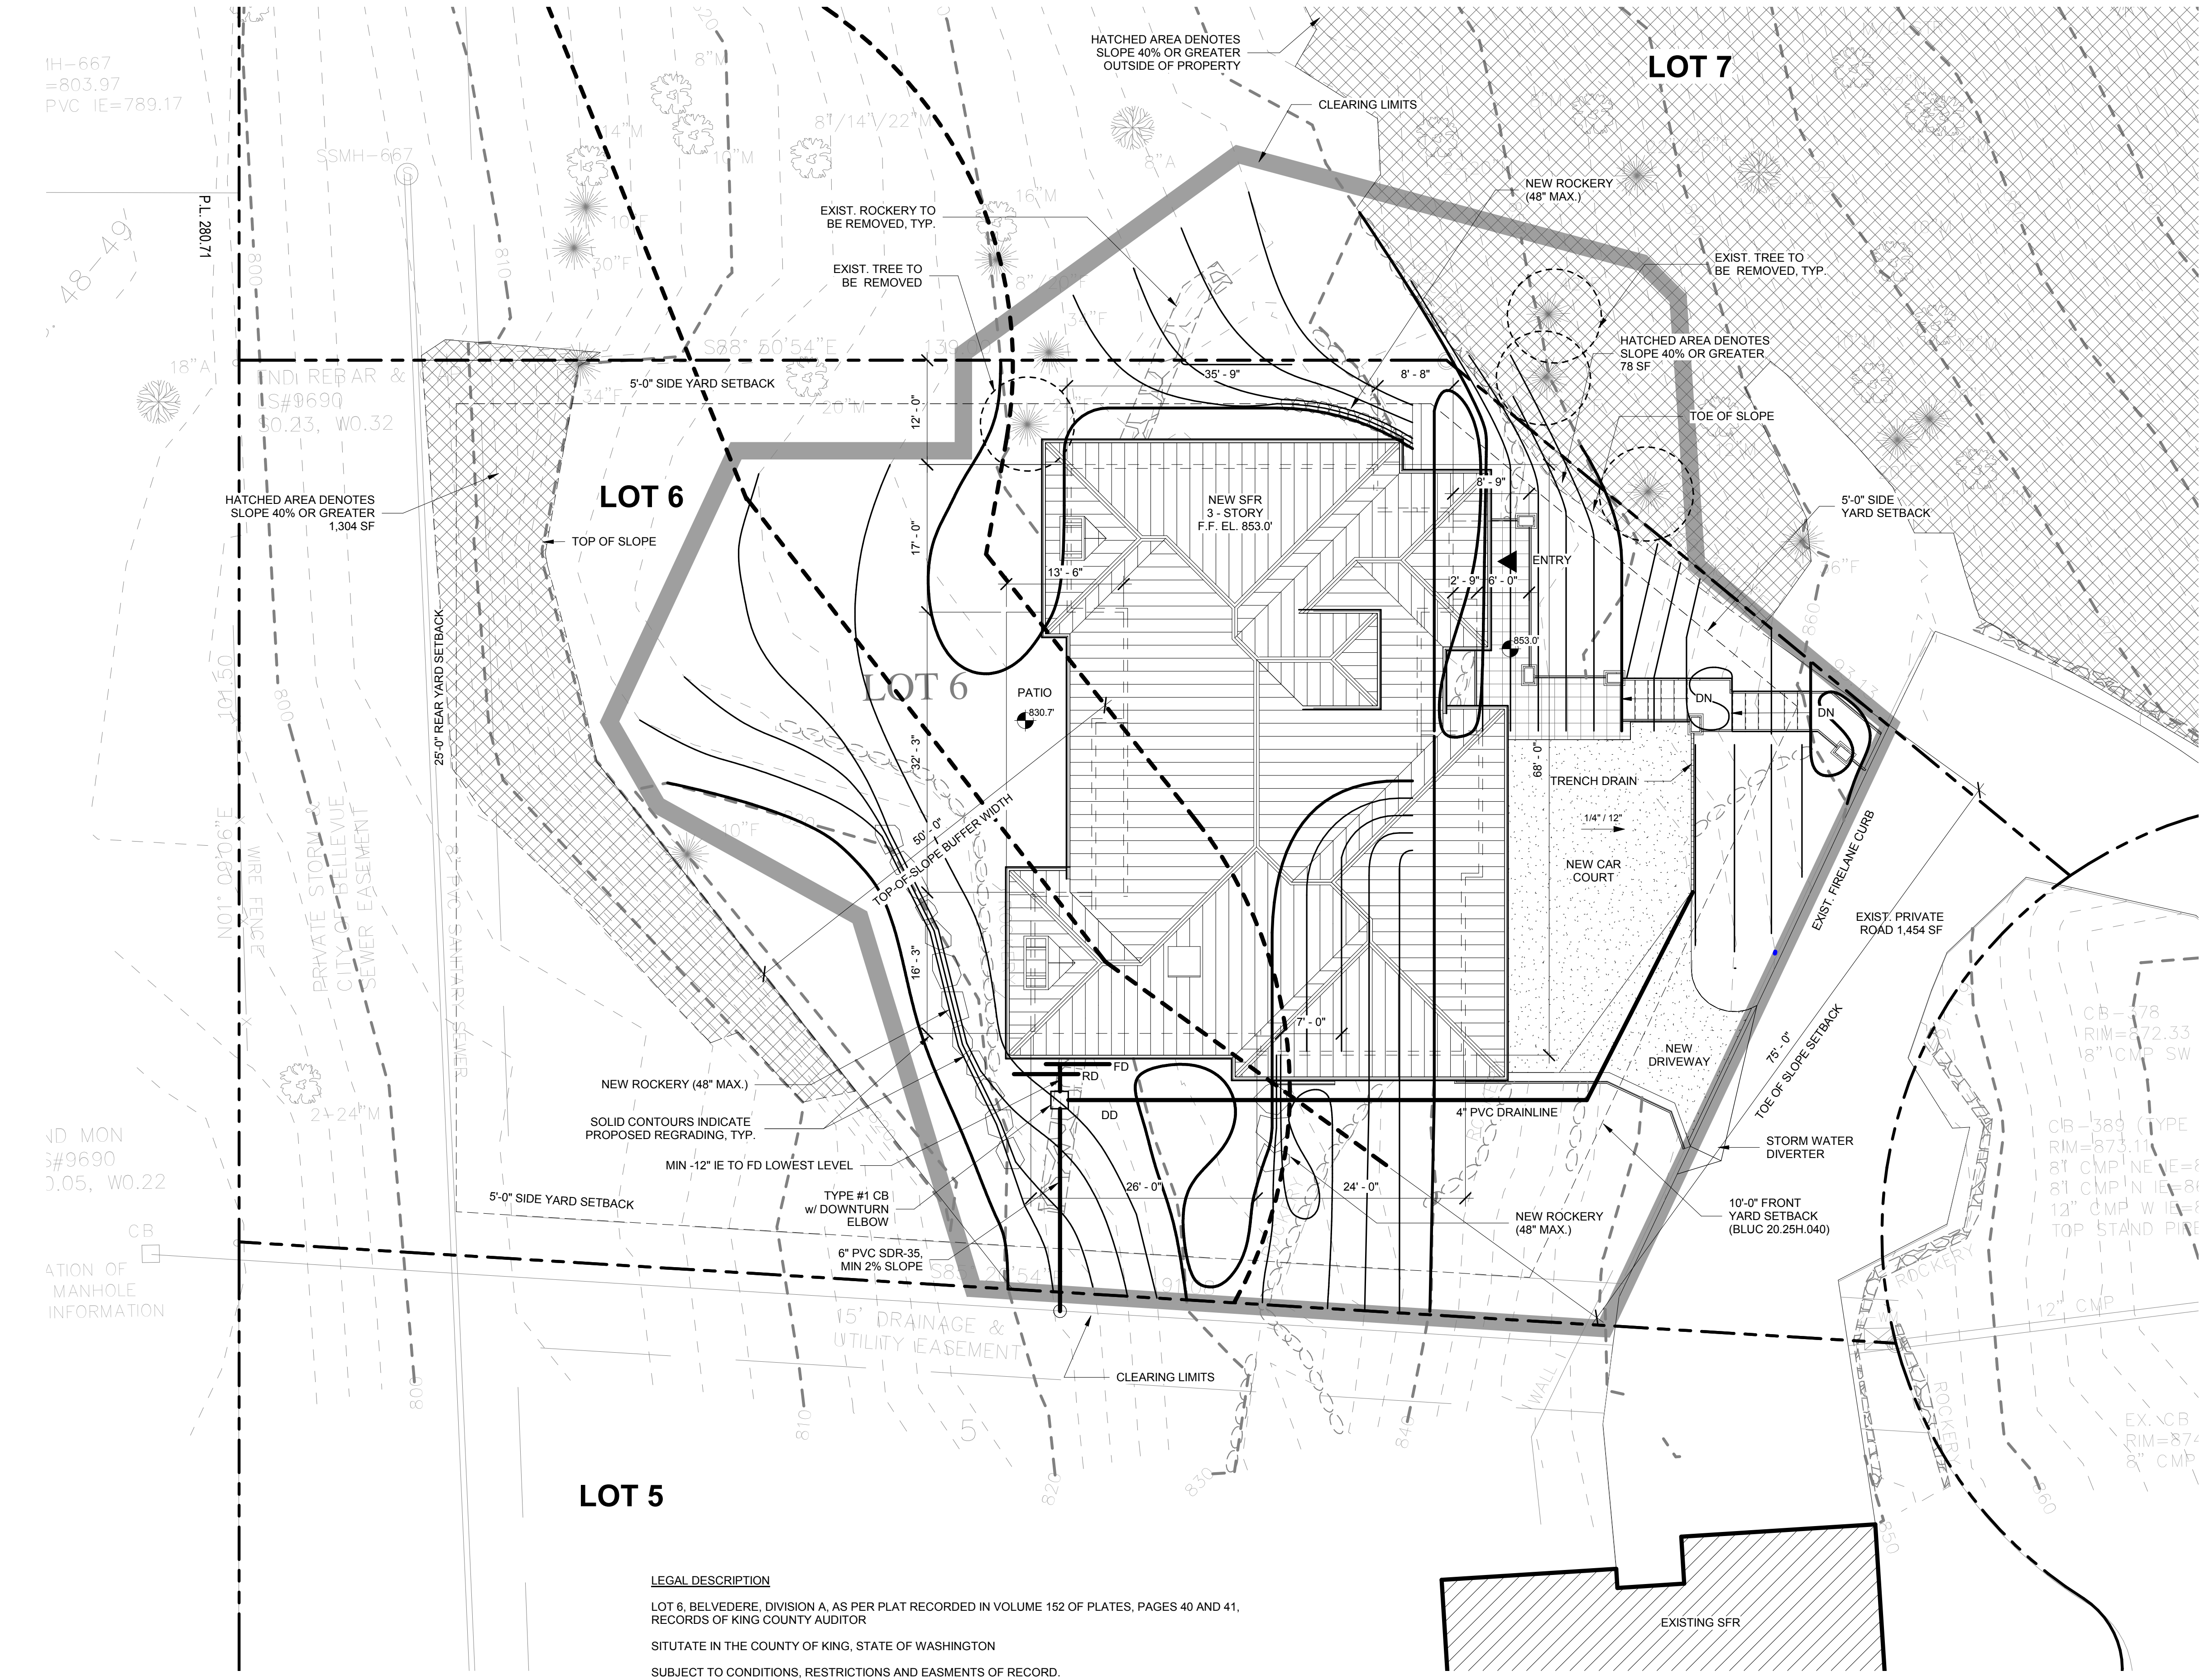
1 Site Plan
1" = 10'-0"

Site Plan

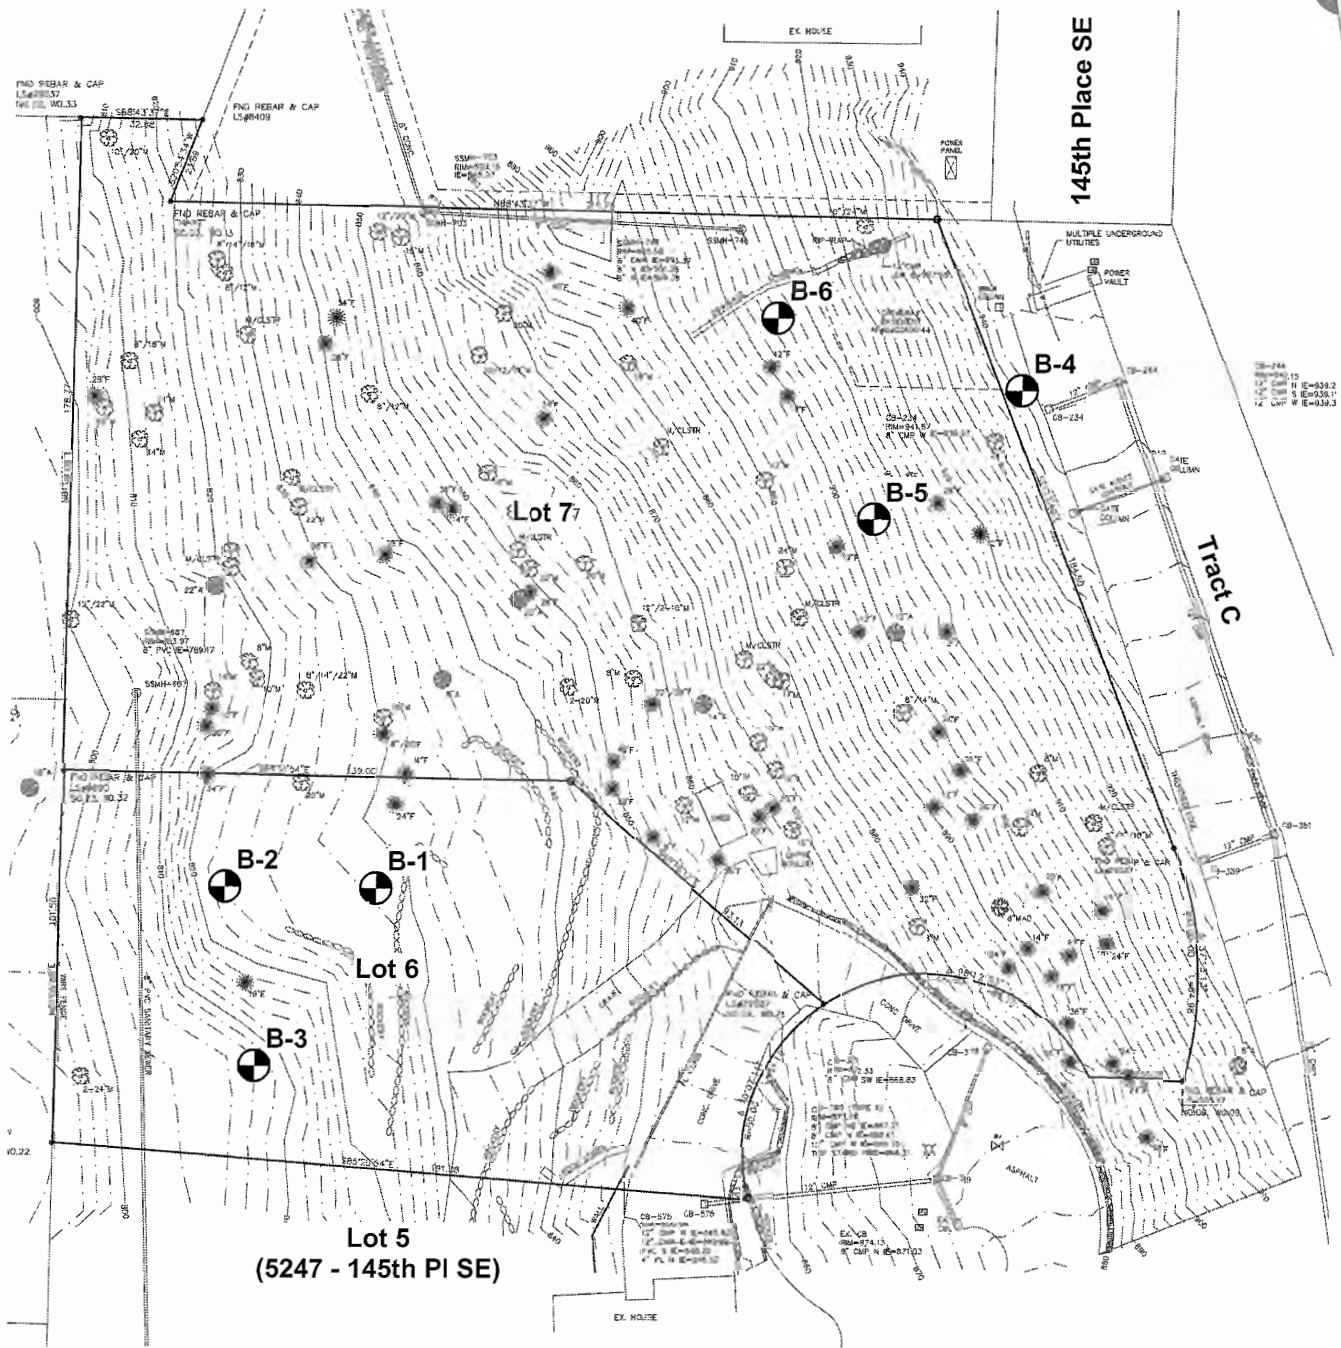
● Test Boring Location

The subsurface conditions were explored by drilling six borings at the approximate locations shown on the Site Exploration Plan, Plate 2. Our exploration program was based on the proposed construction, anticipated subsurface conditions and those encountered during exploration, and the scope of work outlined in our proposal.

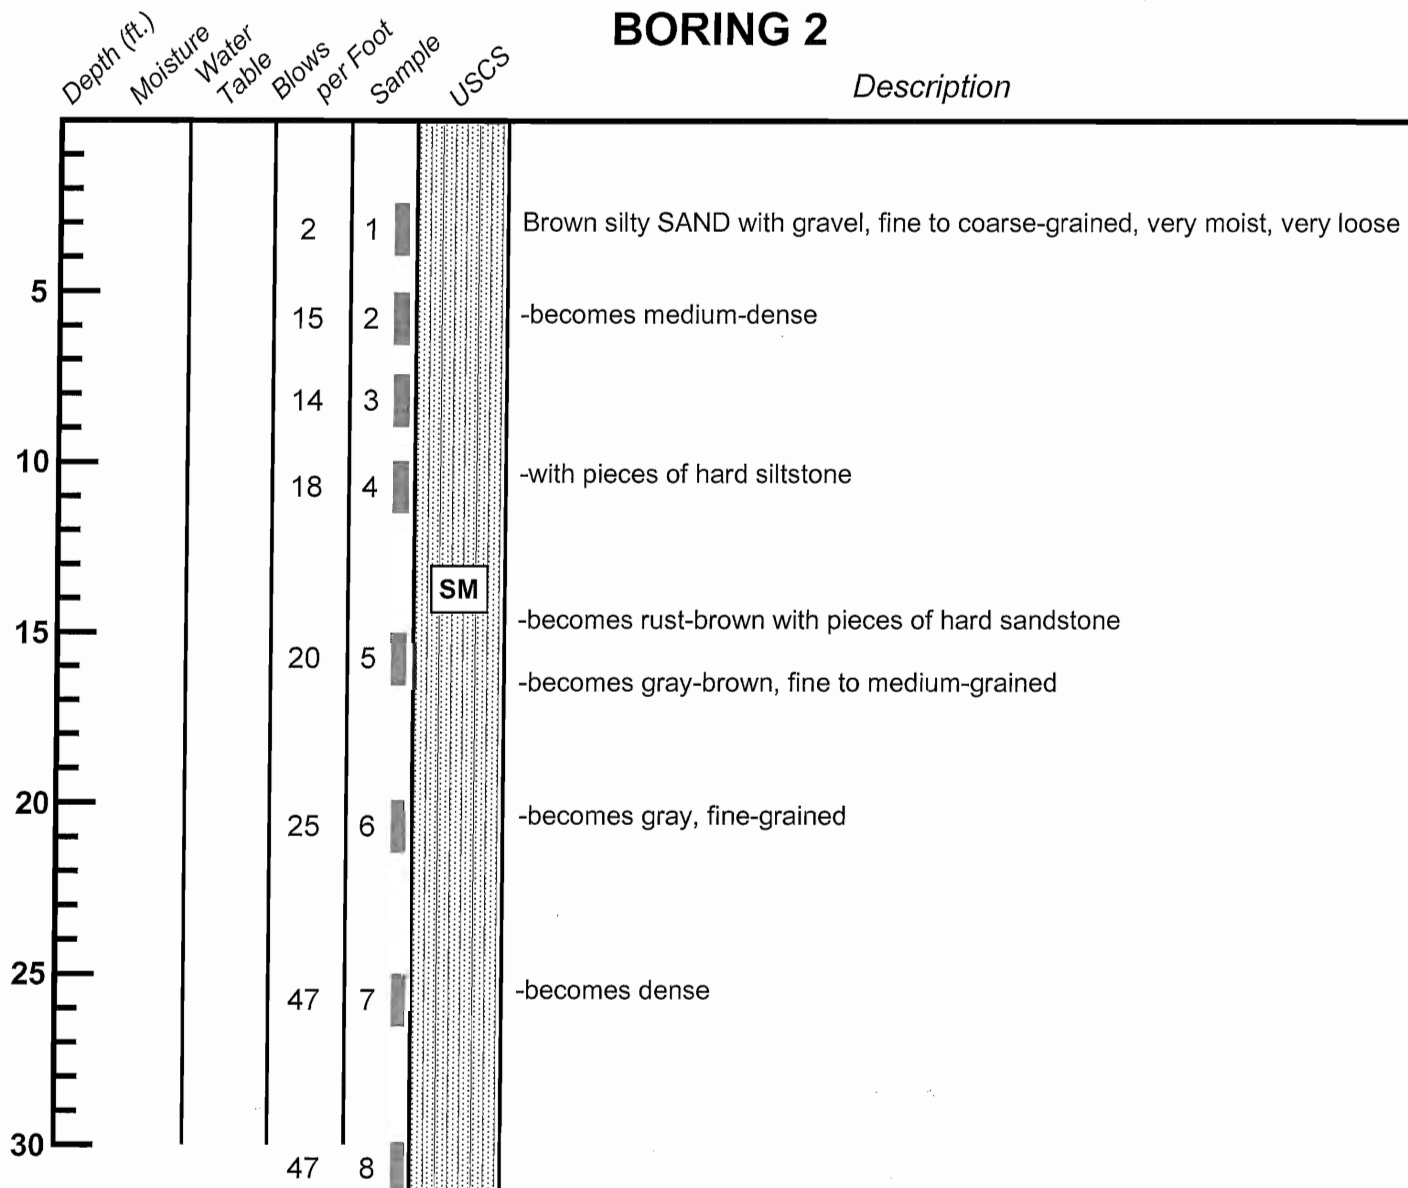
BORING 2

- * Test boring was terminated at 31.5 feet on November 16, 2015.
- * No groundwater was encountered during drilling.

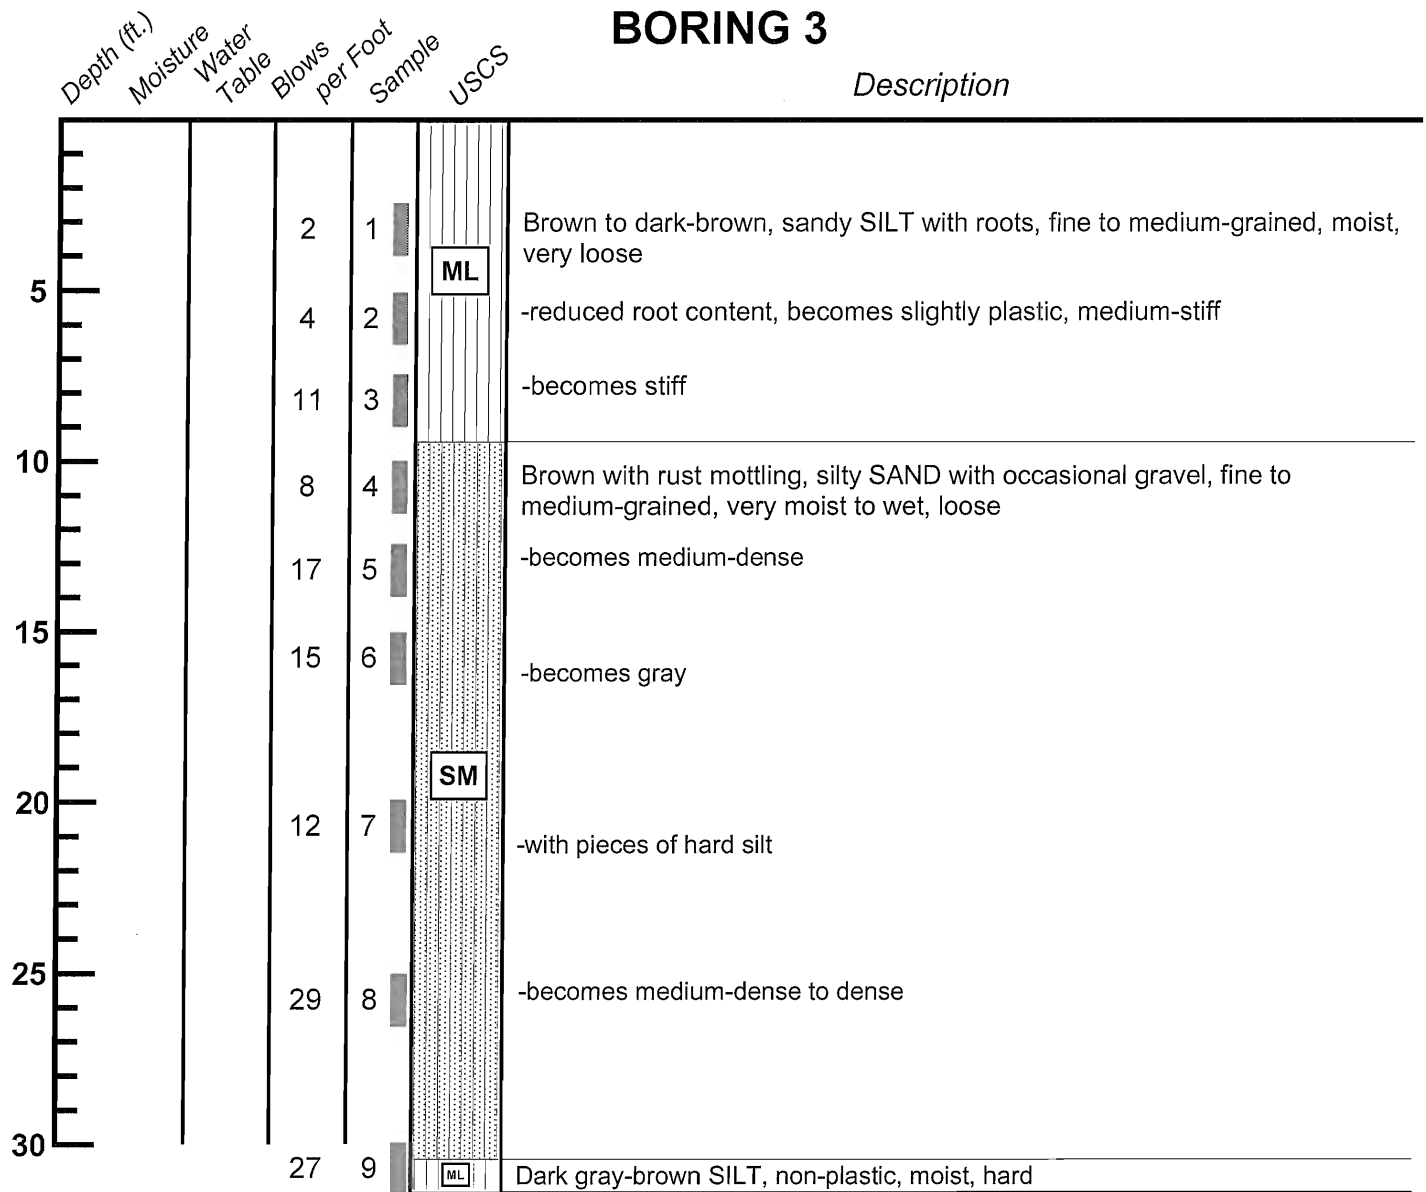
BORING 3

- * Test boring was terminated at 31.5 feet on November 16, 2015.
- * No groundwater was encountered during drilling.

Perched groundwater seepage was observed at a depth of 7 and 8.5 feet in Borings 1 and 3 located on Lot 6. The borings were conducted relatively early in the winter, and were left open for only a short time period. Therefore, the seepage levels on the logs represent the location of transient water seepage and may not indicate the static groundwater level. Groundwater levels encountered during drilling can be deceptive, because seepage into the boring can be blocked or slowed by the auger itself.

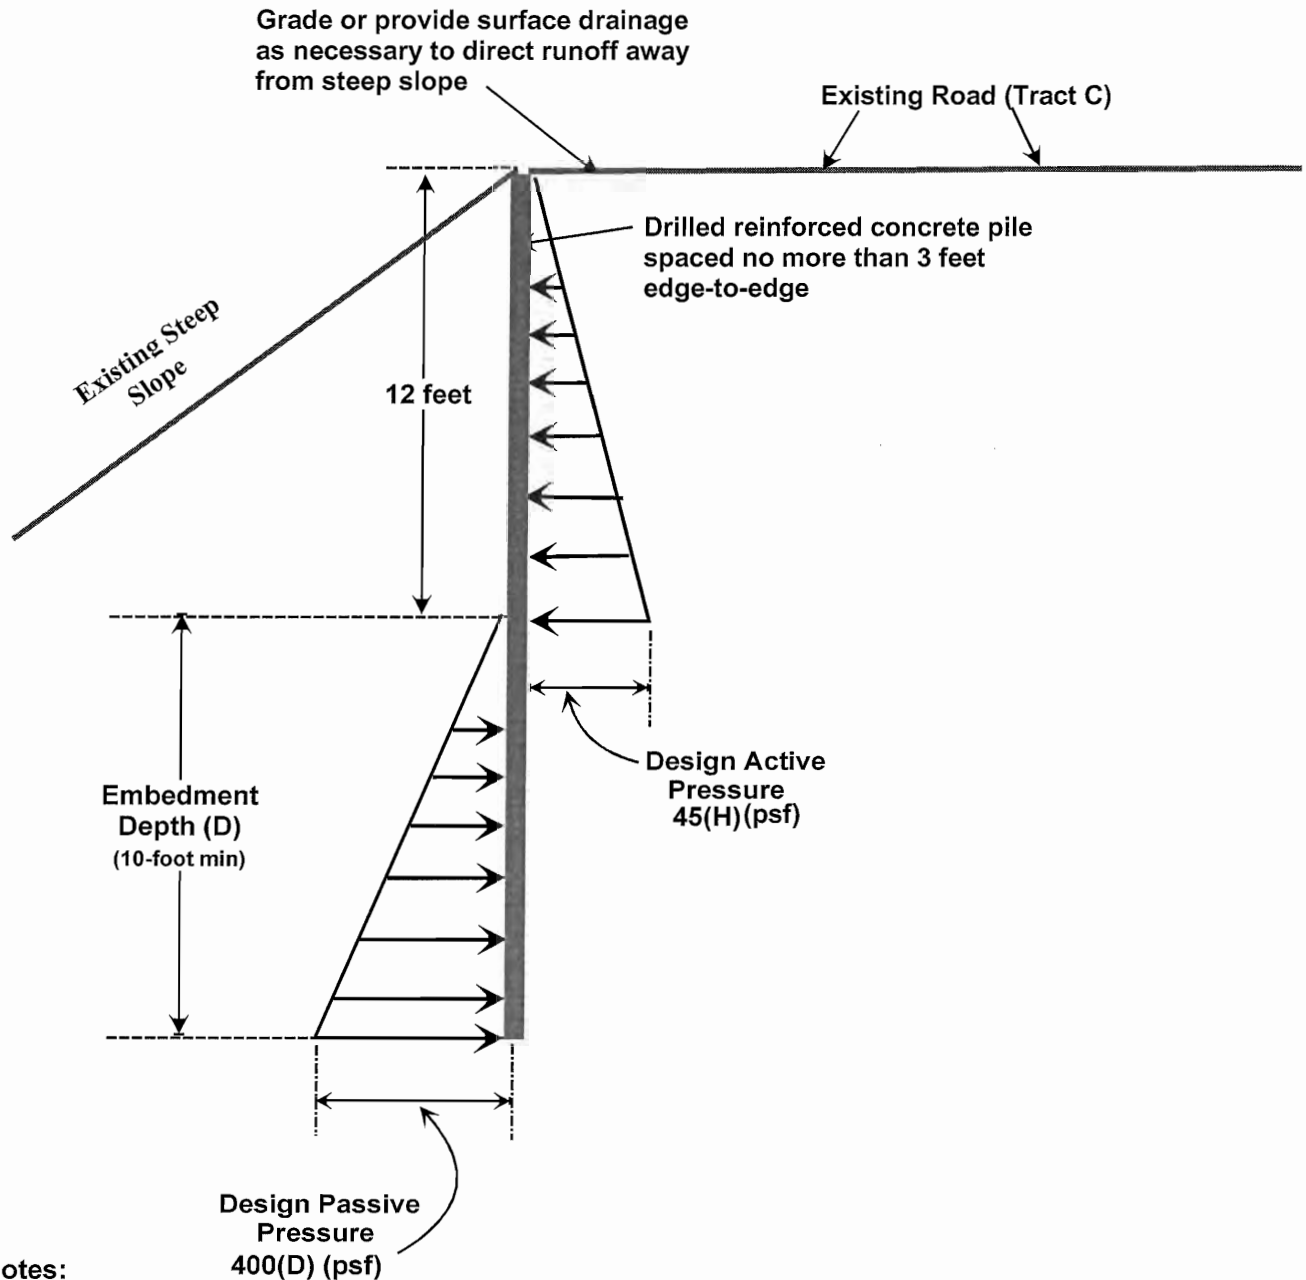
- (1) The report should be referenced for specifics regarding design and installation.
- (2) Active pressures act over the pile spacing.
- (3) Passive pressures act on two times the pile diameter.
- (4) It is assumed that no hydrostatic pressures act on the back of the wall.

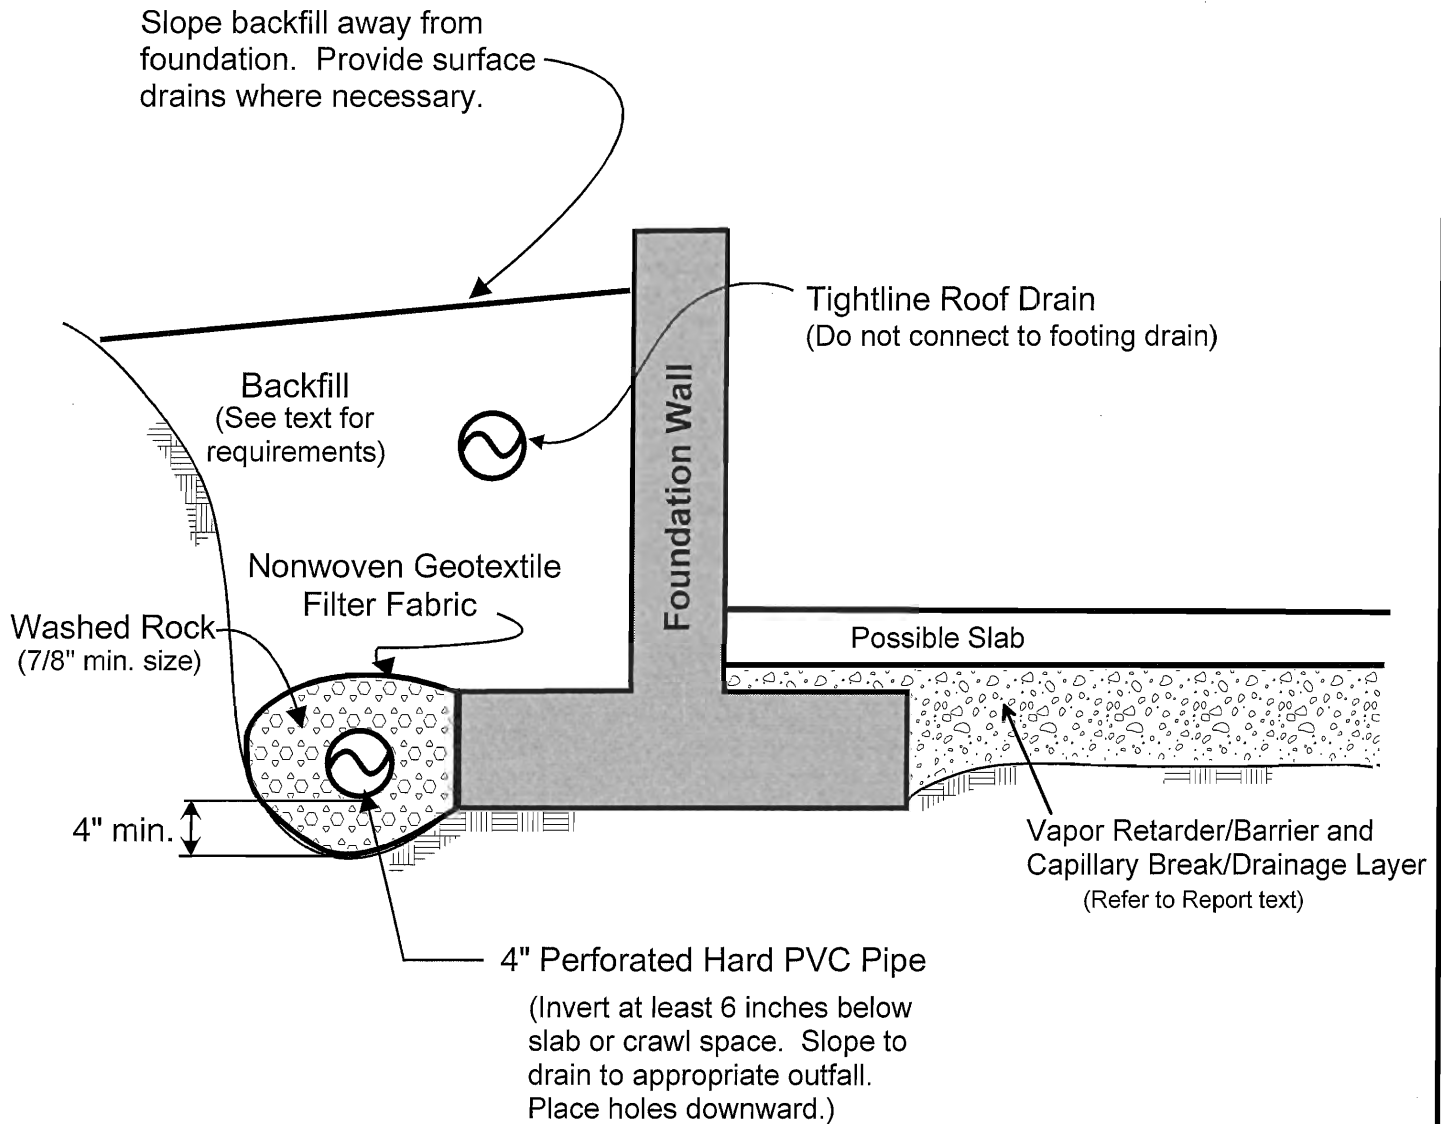
- (1) In crawl spaces, provide an outlet drain to prevent buildup of water that bypasses the perimeter footing drains.
- (2) Refer to report text for additional drainage, waterproofing, and slab considerations.

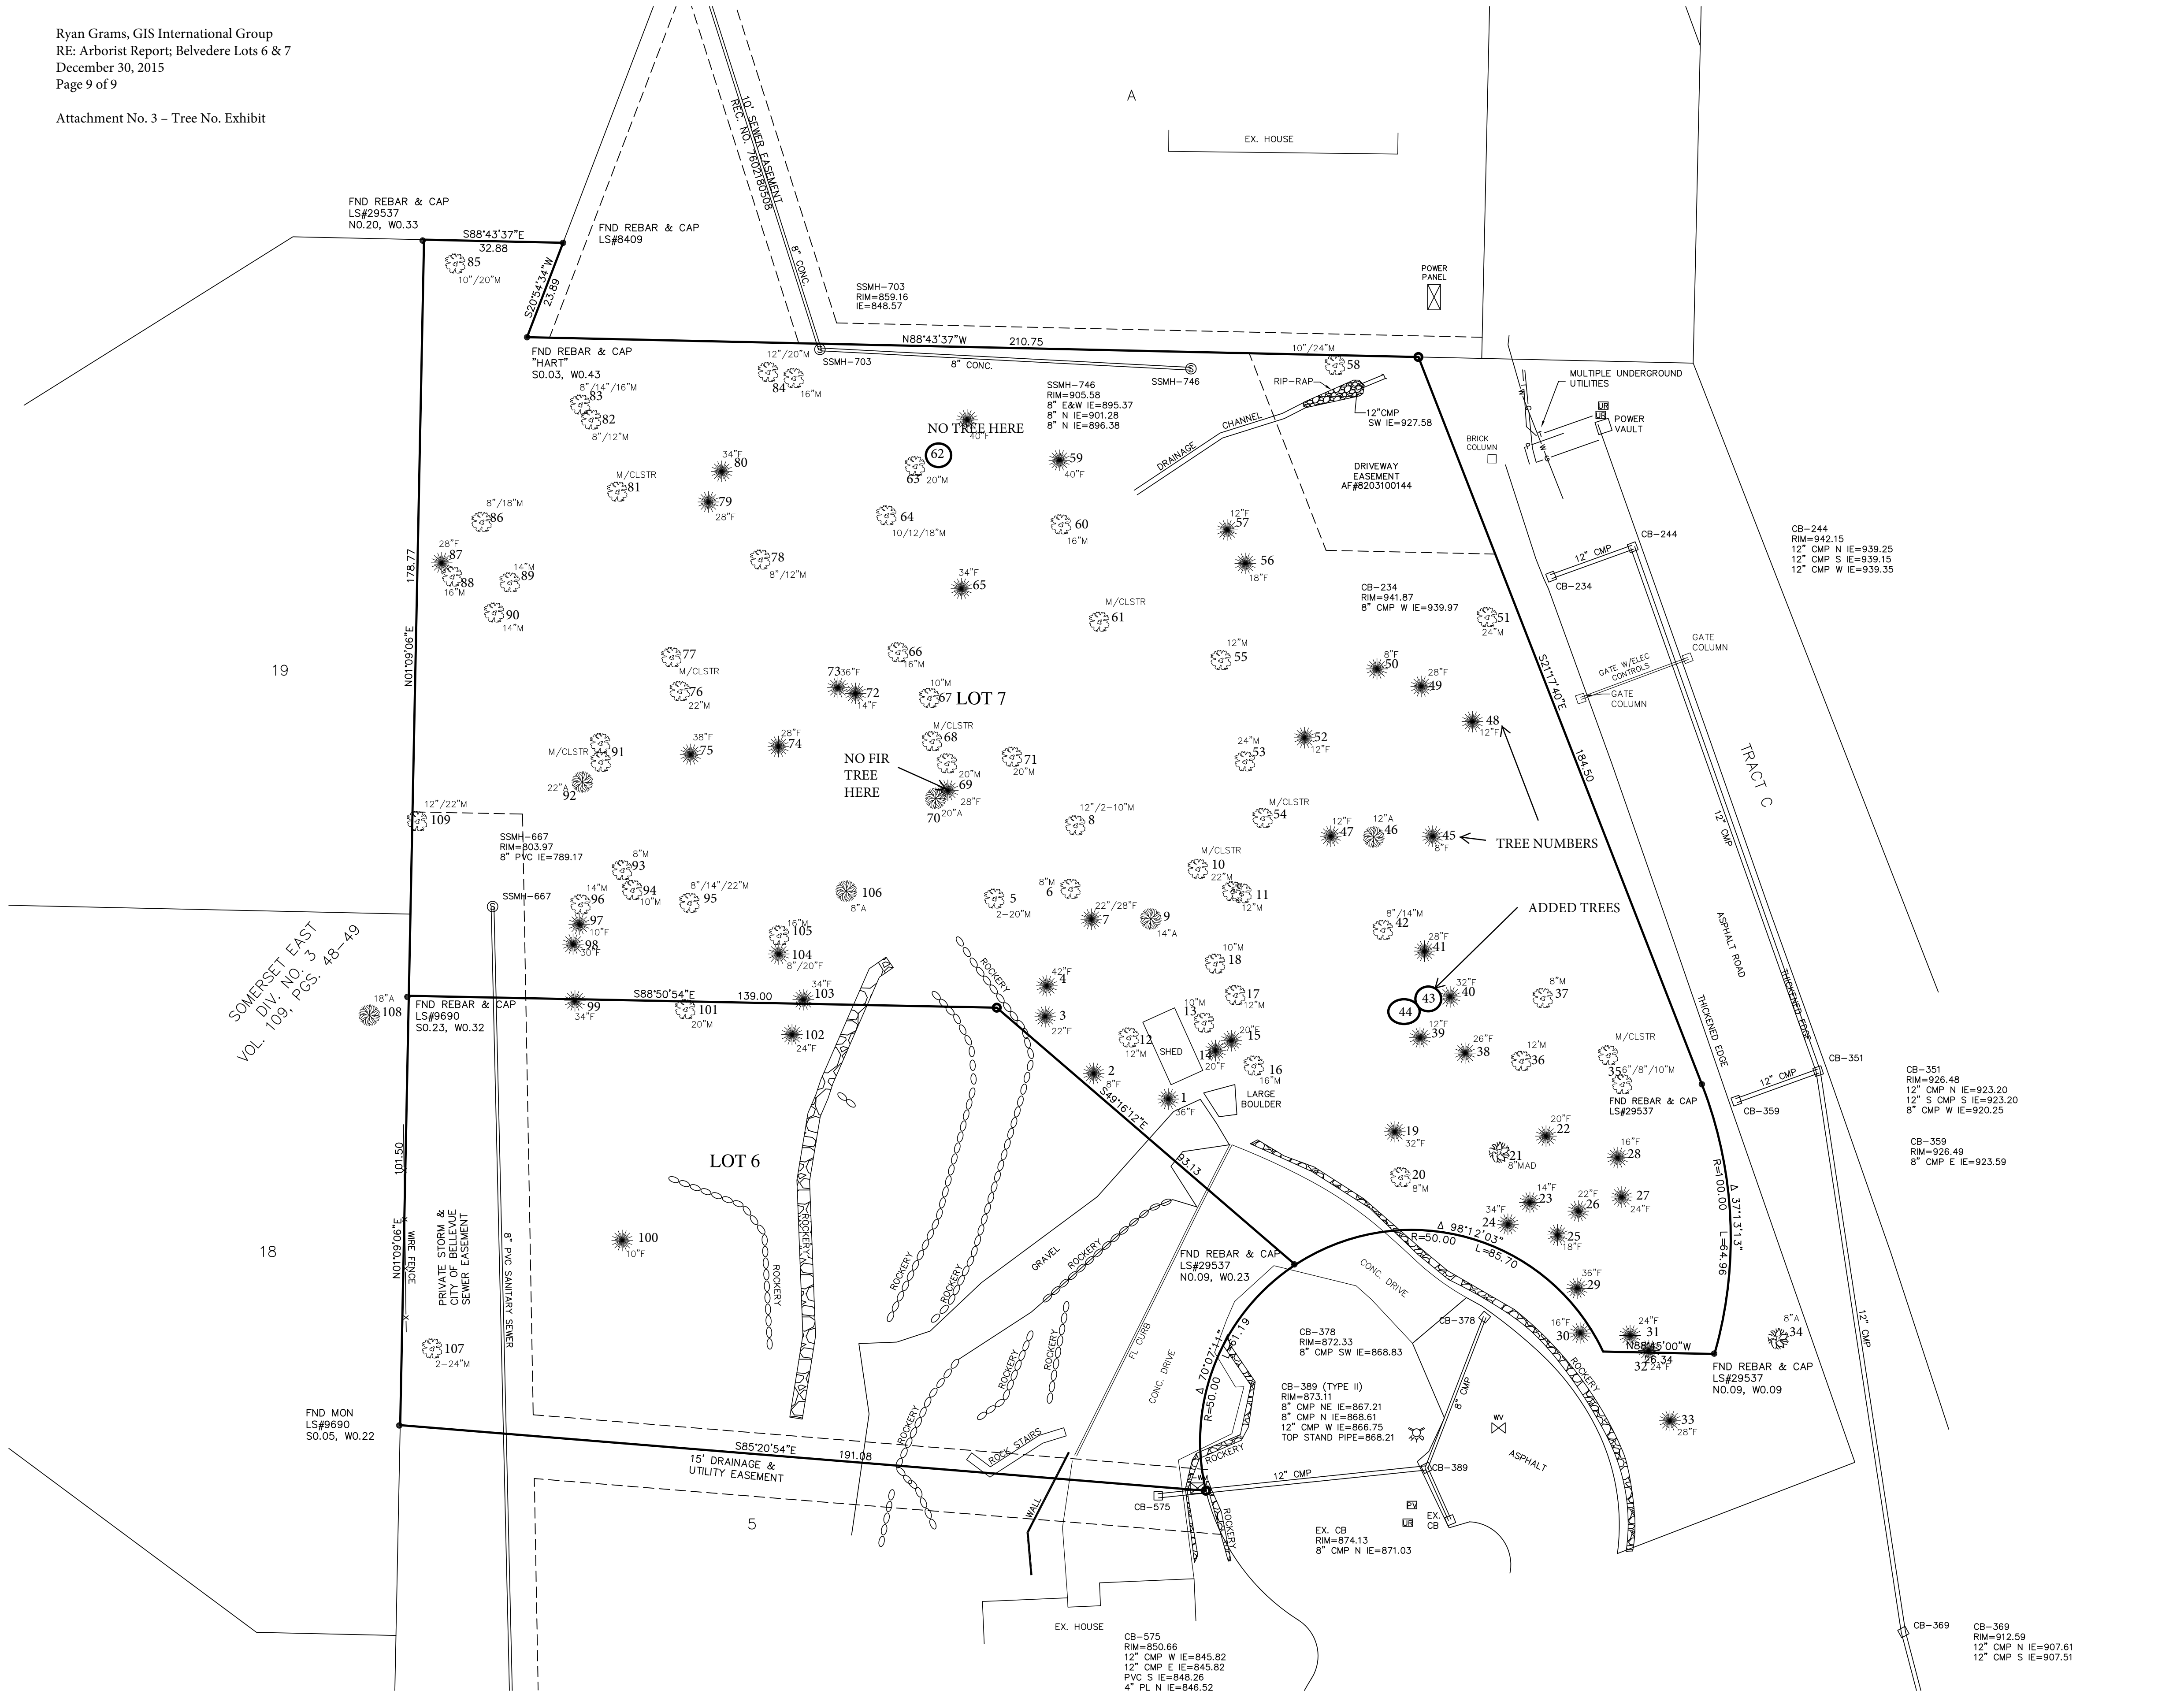
TOPOGRAPHIC SURVEY
for
GIS INTERNATIONAL GROUP

A Portion of the S.E. 1/4 of the N.E. 1/4 of
Section 22, Township 24 North, Range 5 East, W.M.
King County, Washington

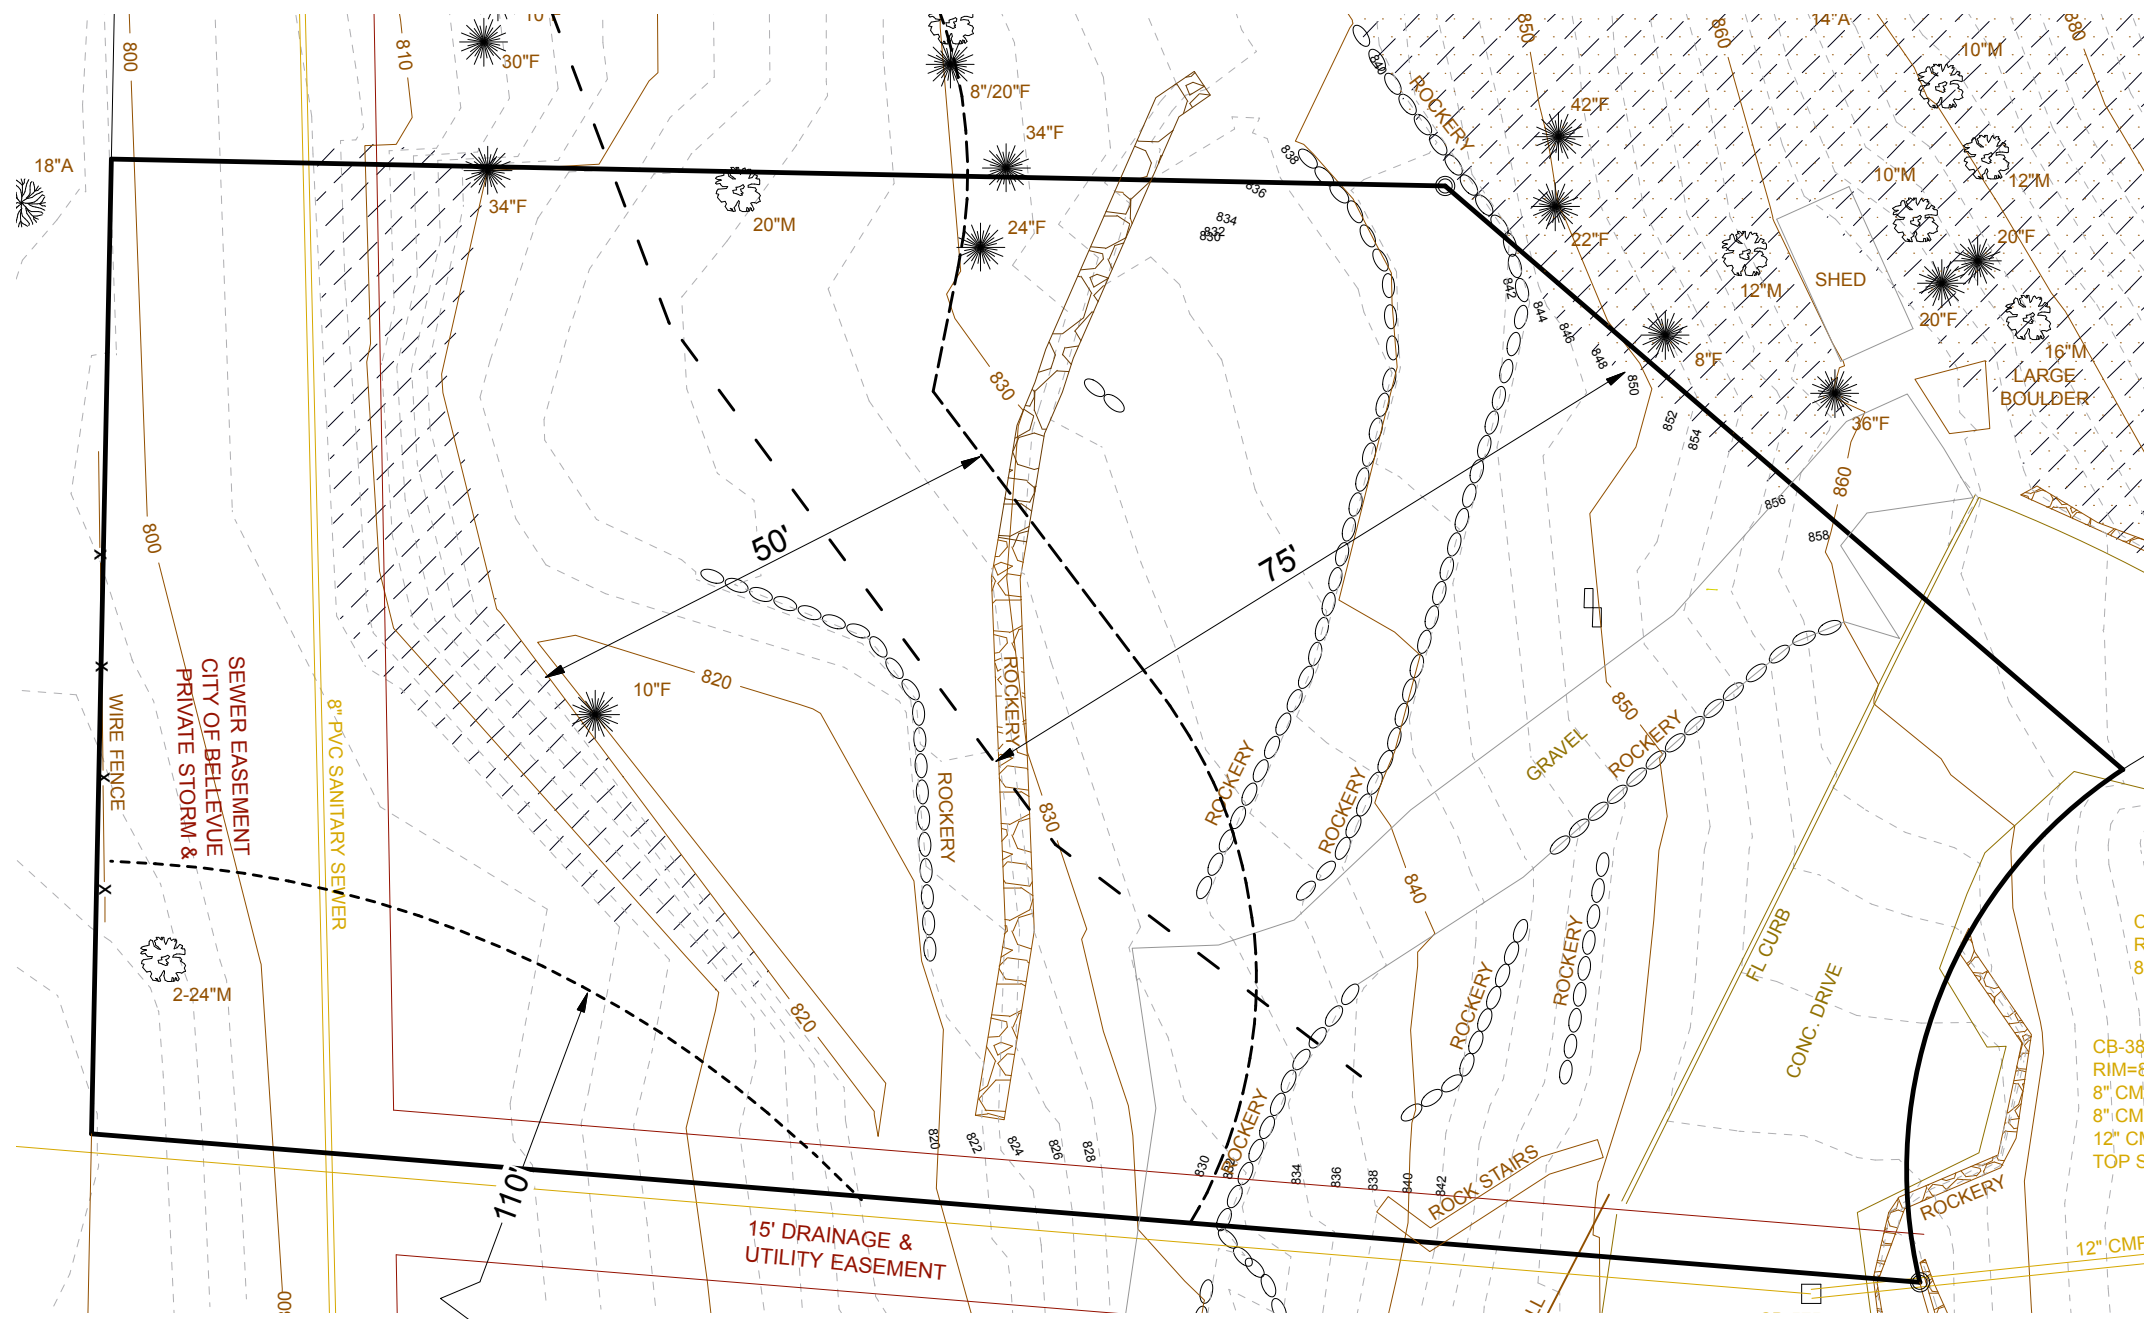
OFF-SITE WETLAND CATEGORY III
110' BUFFER

PLEASE NOTE: THIS MAP DEPICTS AN **APPROXIMATE** WETLAND BUFFER LOCATION FOR THE OFF SITE WETLAND.
