**City of Bellevue  
Development Services Department  
Land Use Staff Report**

**Proposal Name:** Cheng Vegetation Management Plan

**Proposal Description:** The applicant requests a Critical Areas Land Use Permit for vegetation management in a steep slope critical area to restore an area of unpermitted tree removal with native plants.

**CHENG RESIDENCE**  
**VEGETATION MANAGEMENT PLAN**  
**PREPARED FOR: KAI CHANG**  
PARCELS: 6205500580  
SITE ADDRESS: 12112 SE 26TH ST.  
BELLEVUE, WA 98008

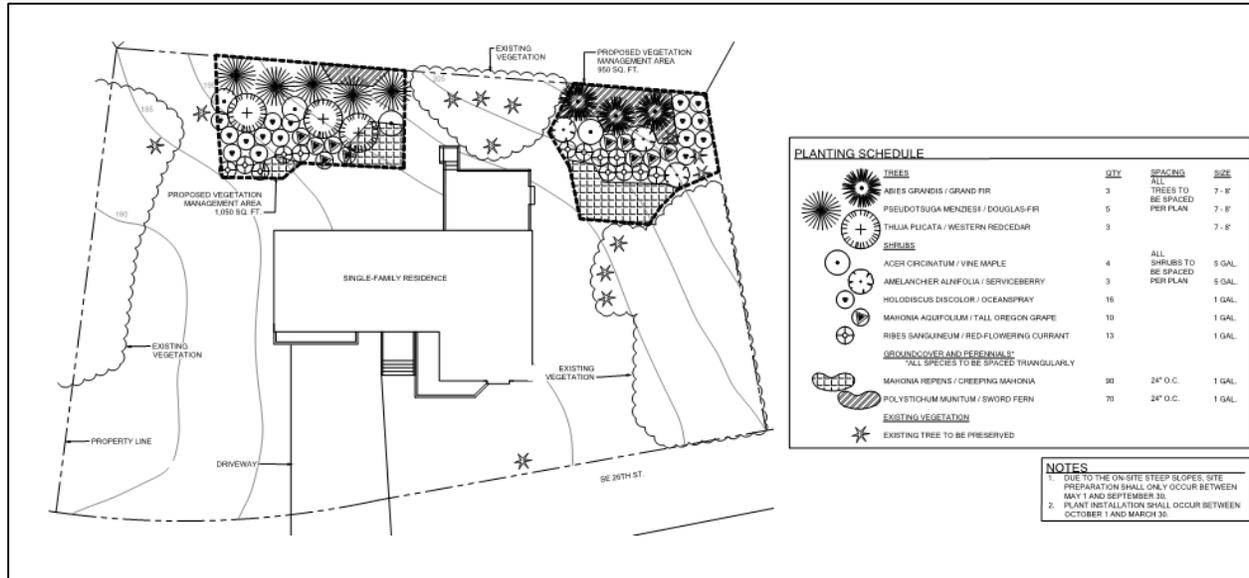
Figure 1

The applicant is proposing to manage vegetation within a steep slope critical area on their property located at 12112 SE 26<sup>th</sup> Street, in the Richards Valley subarea. The vegetation management plan will likely replace the habitat values lost by the unpermitted tree cutting which occurred and prevent erosion on the slope. See figure 1 below for proposal.

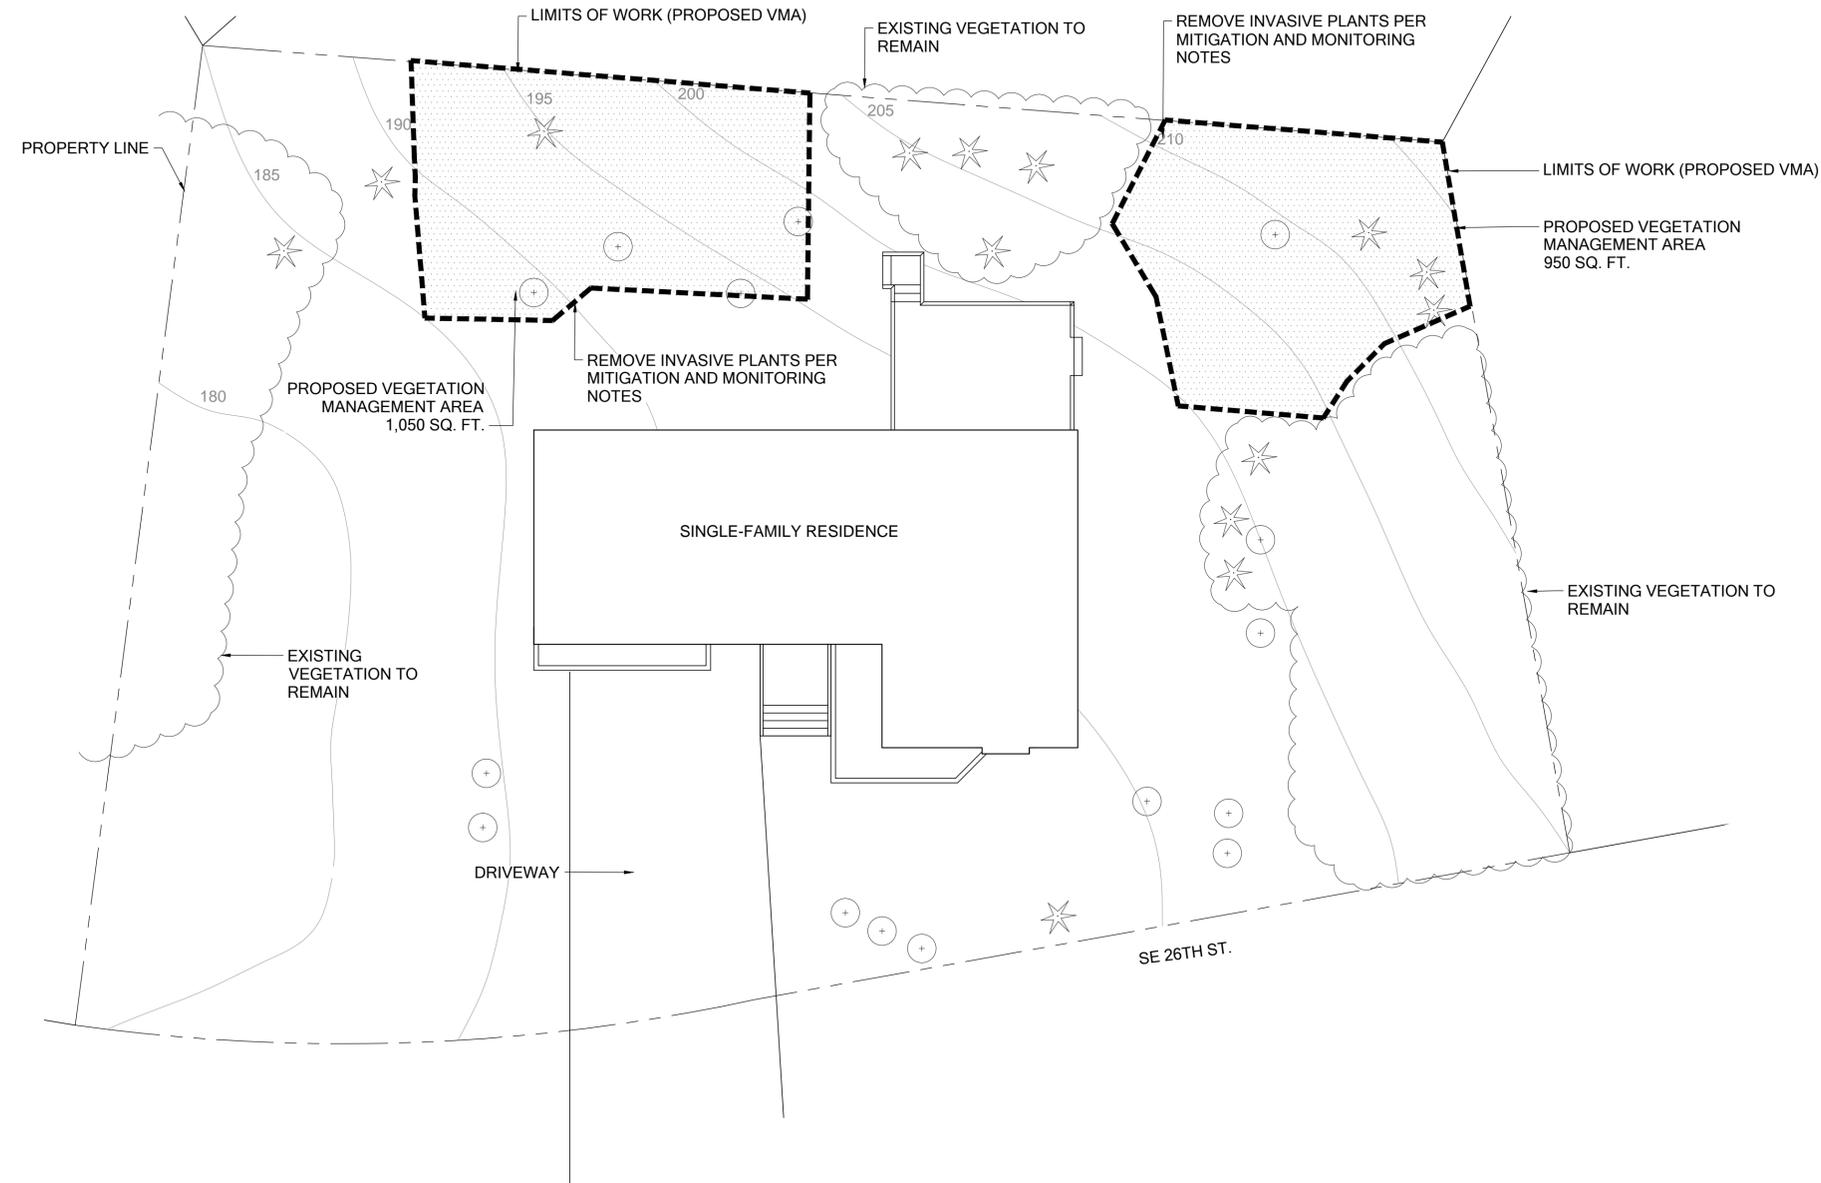
**EXISTING CONDITIONS**

**NOTES**  
1. DUE TO THE ON-SITE STEEP SLOPES, SITE PREPARATION SHALL ONLY OCCUR BETWEEN MAY 1 AND SEPTEMBER 30.

THE OBJECTIVE OF THE PROPOSED VMP IS TO REPLACE FUNCTIONS AND VALUES PROVIDED BY THE 2,000 SQUARE FEET OF LOST CANOPY IN THE CRITICAL AREA STEEP SLOPE. THE VMP SHOWN IN THIS ON SHEET 1 OF 5 IS LOCATED IN AREAS THAT 1) LOST CANOPY COVER FROM THE CLEARING VIOLATION, 2) ARE IN REGULATORY STEEP SLOPE AREAS, AND 3) DO NOT CURRENTLY CONTAIN NATIVE WOODY VEGETATION. A SMALL MARGIN AROUND THE DECK MEETS THESE CRITERIA, BUT WILL NOT BE INCLUDED IN THE VMP IN ORDER TO ALLOW FOR MAINTENANCE AND ACCESS.

FUNCTIONS LOST AS A RESULT OF THE UNPERMITTED TREE REMOVAL INCLUDE A LOSS OF HABITAT FOR WILDLIFE SPECIES, AND SLOPE STABILIZATION. THE PROPOSED PLANT SPECIES FOR THE VMP WILL BEGIN TO REPLACE LOST FUNCTIONS, INCLUDING SLOPE STABILIZATION, WILDLIFE FUNCTION, AND HYDROLOGIC FUNCTION.

The objective of the proposed VMP is to replace functions and values provided by the 2,000 square feet of lost canopy in the steep slope portion of the yard. The VMP shown on Sheet 1 of 5 in Appendix A is located in areas that 1) lost canopy cover from the clearing violation, 2) are in regulatory steep slope areas, and 3) do not currently contain native woody vegetation. A small margin of area that is adjacent to the backyard deck meets these criteria, but will not be included in the VMP in order to allow for a pathway around the deck and for deck maintenance without impacts to the VMP.

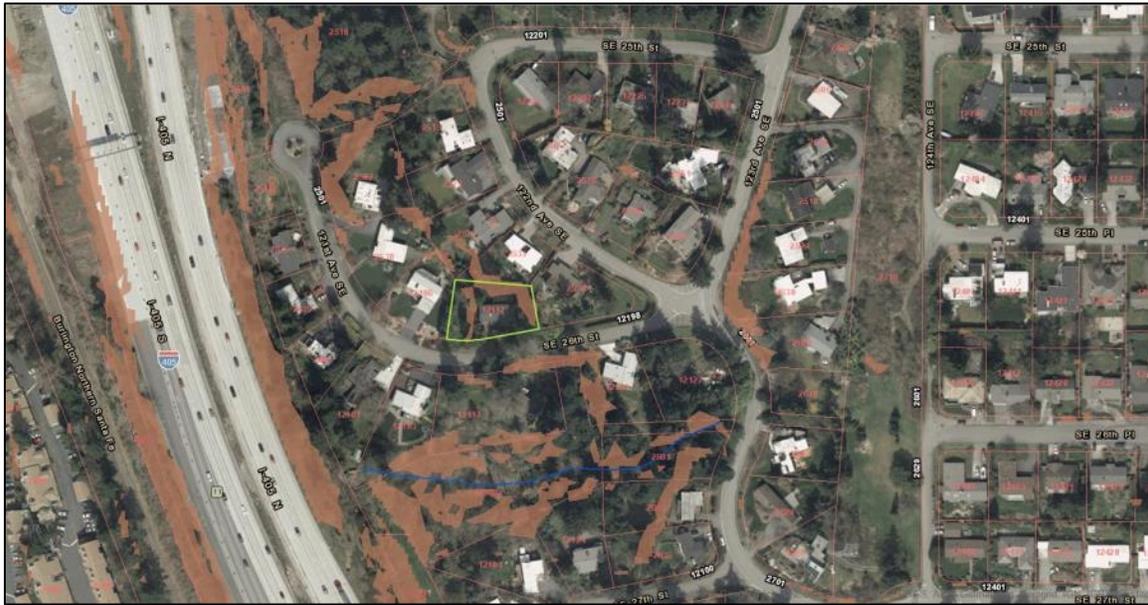
Figure 3 - Aerial photograph with critical steep slope overlay shown. The subject property is outlined in yellow. Two steep slope areas are located within or partially within the subject property. Only the larger of the two, located in the back and east side yards, meets the LUC steep slope definition.

Slopes of 40 percent or greater that have a rise of at least 10 feet and exceed 1,000 square feet in area are regulated as steep slopes, a geologic hazard area (Land Use Code (LUC) 20.25H.120.2). Steep slopes require a standard buffer of 50 feet from the top-of-slope and a structure setback of 75 feet from the toe-of-slope. As shown in Figure 3, regulated steep slopes encumber approximately 2,700 square feet of the subject parcel, north of the on-site home.

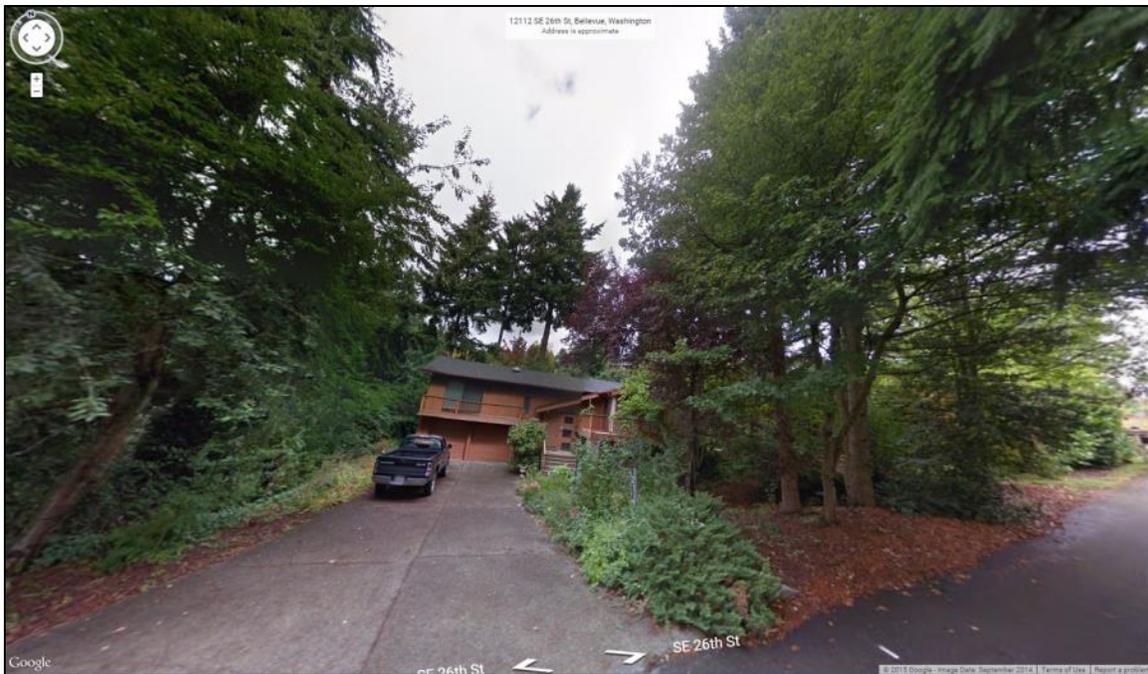
Figure 4 - Google street view image from September 2014 showing the subject property from SE 26th Street prior to tree removal.

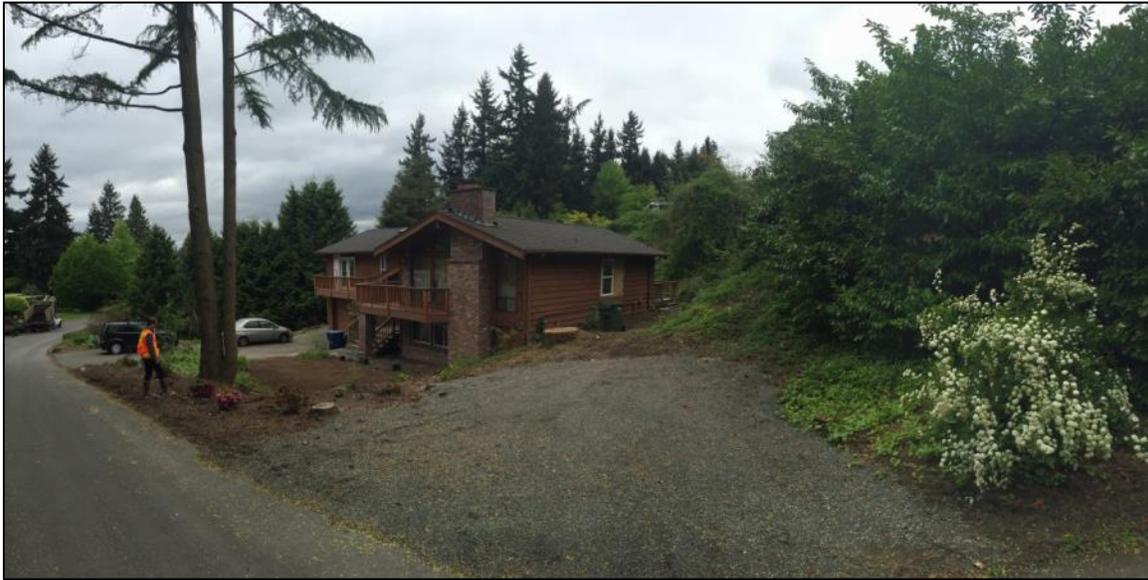
Figure 5 - View of the subject property after tree removal from SE 26th Street. A co-dominant Deodar cedar was retained near the SE 26<sup>th</sup> Street ROW. (4/28/2015)

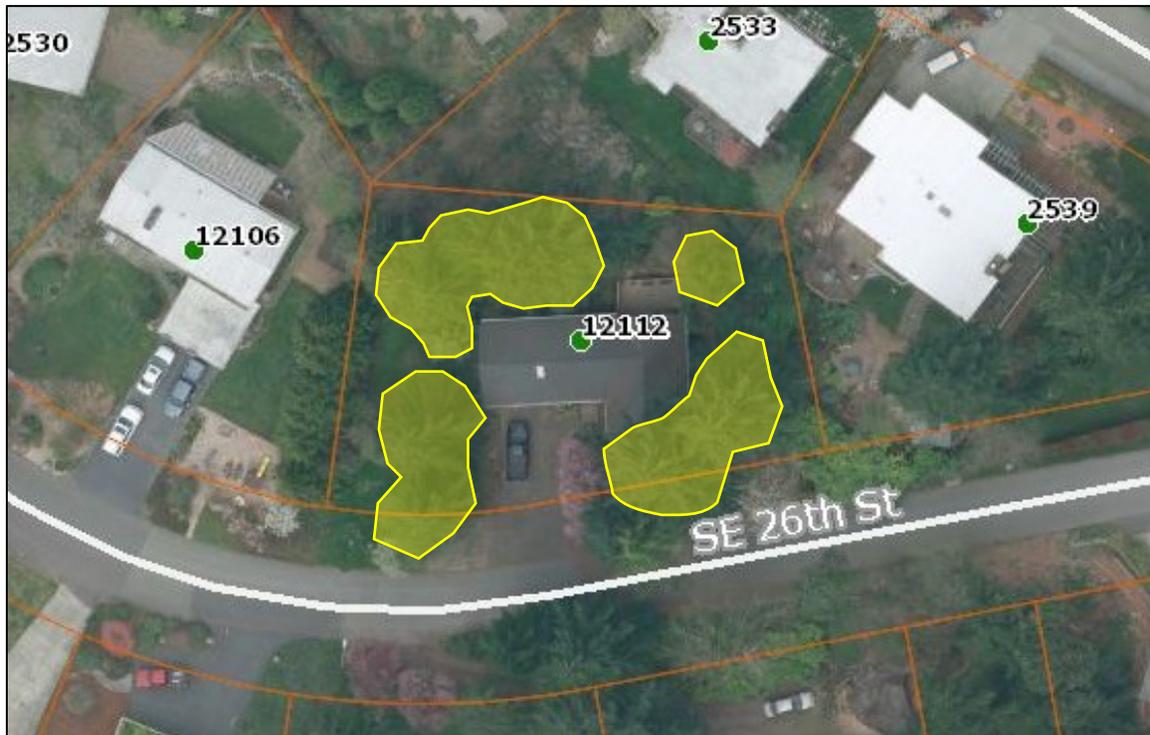
Figure 6 – A 2012 aerial photograph showing the approximate extent of canopy loss as a result of the recent tree removal.

The on-site home was constructed in 1978. The developed parcel was purchased by the applicant in 2014. Mr. Cheng then had 15 trees removed from the property in the early part of 2015. Six of the removed trees were located within or rooted near/provided canopy coverage over the regulated steep slope areas as shown in Figure 3 below. The VMP area is based on the canopy area of these six trees.

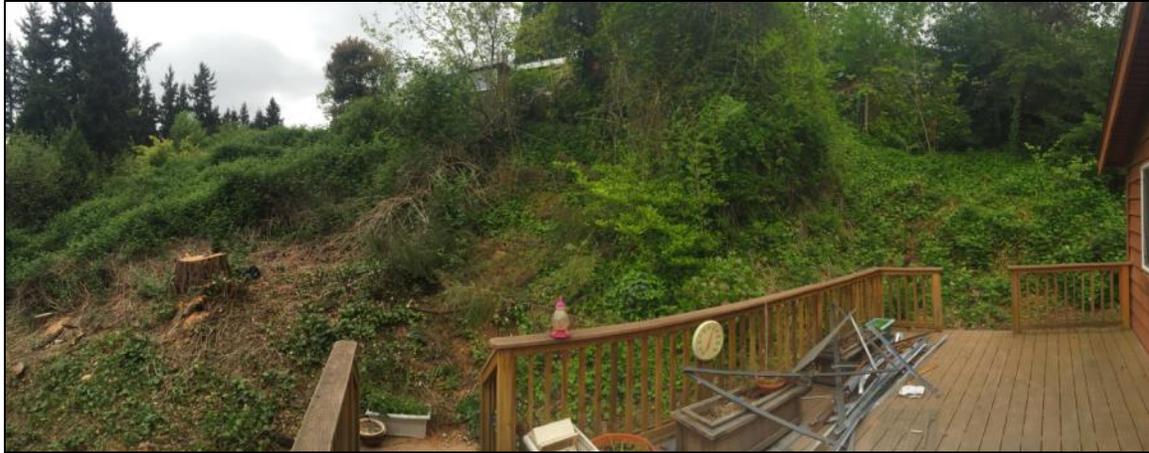
Figure 7 - A panorama from the deck overlooks the backyard steep slope area. Himalayan blackberry dominates the slope above the two visible Douglas-fir stumps; a star magnolia and beaked hazelnut are visible in the center right of the photo, but are overrun with Himalayan blackberry and English ivy.

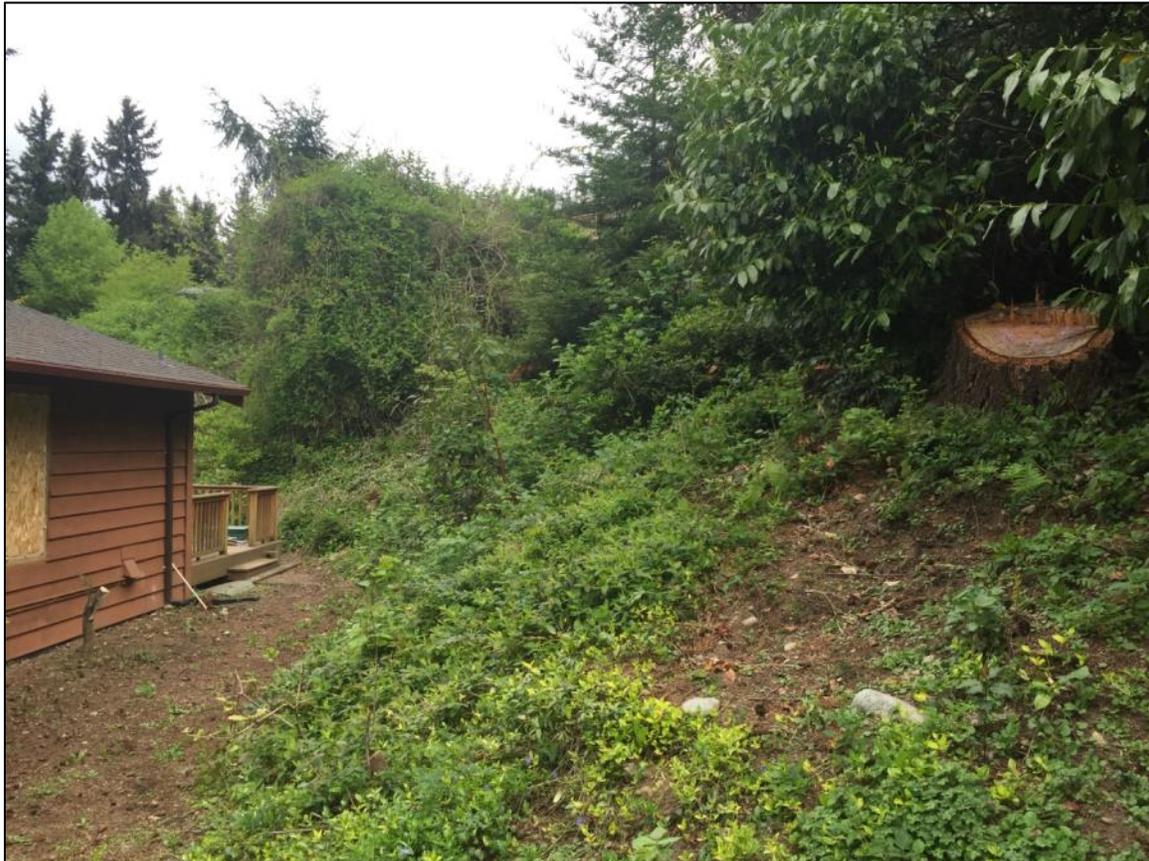
Figure 8 – The stump of tree number 14, a 36-inch Douglas-fir, is shown in this photograph of the side yard, with the steep slope area in the background. The understory is a mix of creeping St. Johnswort, English ivy, Oregon grape and Pacific dewberry. A large cherry laurel shrub is growing along the east parcel boundary. The small Pacific madrone and coastal redwood on the slope in the background will remain.

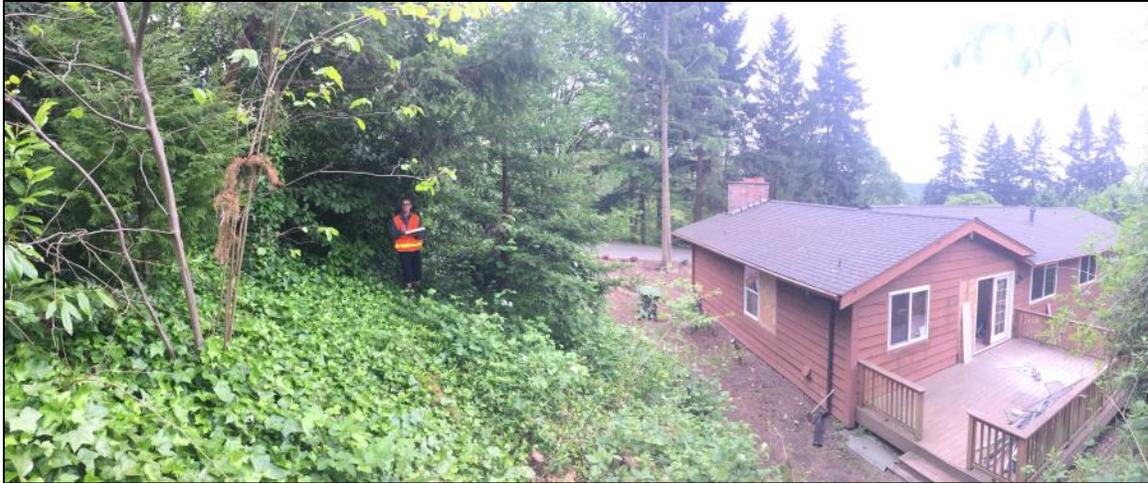
Figure 9 - A view from the northeast corner looking southwest shows an existing coastal redwood, western red cedar, and beaked hazelnut with an understory of primarily English ivy.

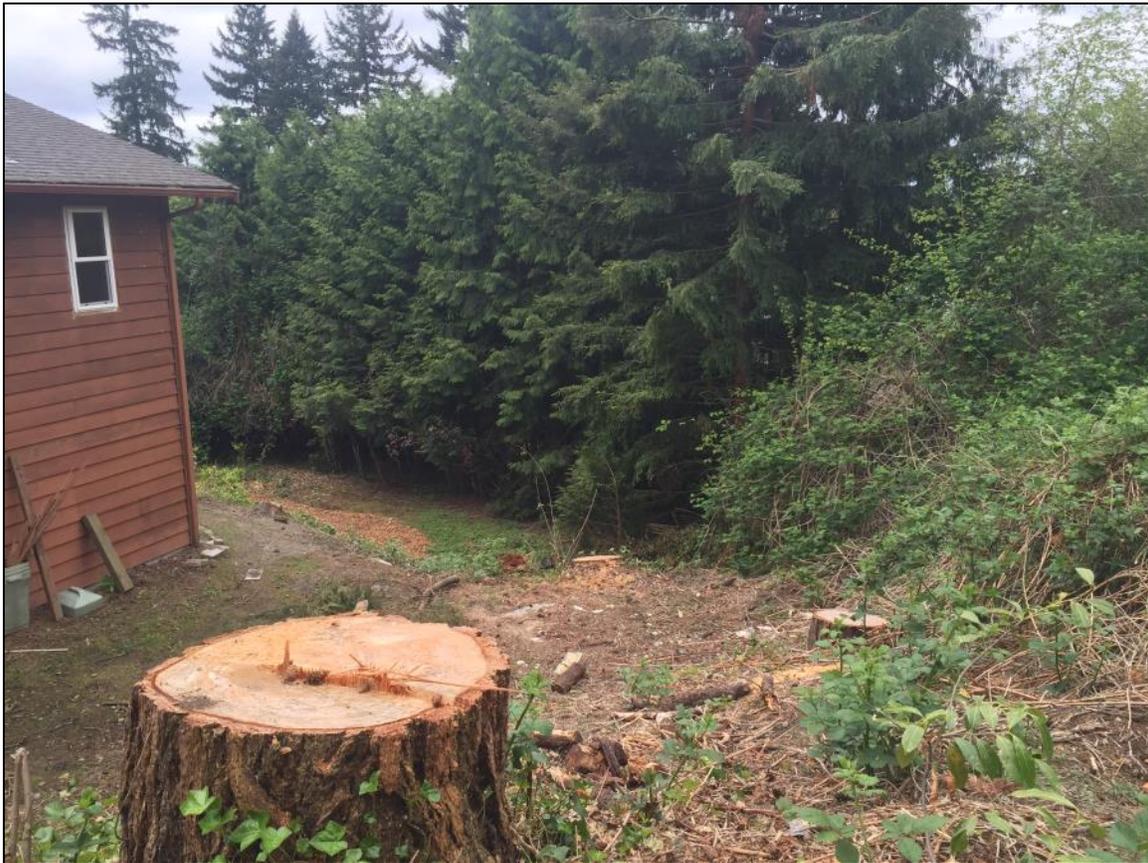
Figure 10 – A line of western red cedar and one coastal redwood remain along the west parcel boundary. A beaked hazelnut and a thicket of Himalayan blackberry characterize the steep slope area on the right side of the photo.
