**OPTIONAL DETERMINATION OF NON-SIGNIFICANCE (DNS) NOTICE MATERIALS**

File No. 15-129670-LO  
Project Name/Address: Auto Nation BMW  
11959 Northup Way

**ENVIRONMENTAL CHECKLIST**

# BMW of Bellevue Development Environmental Checklist

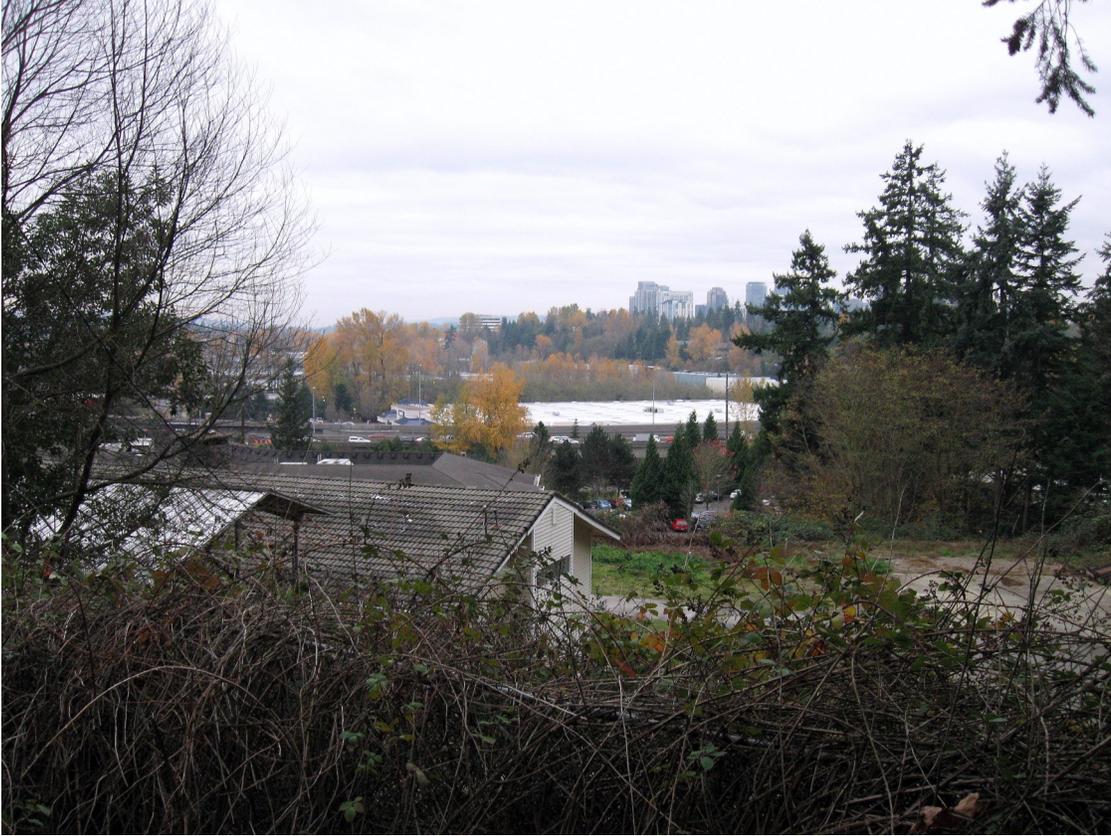
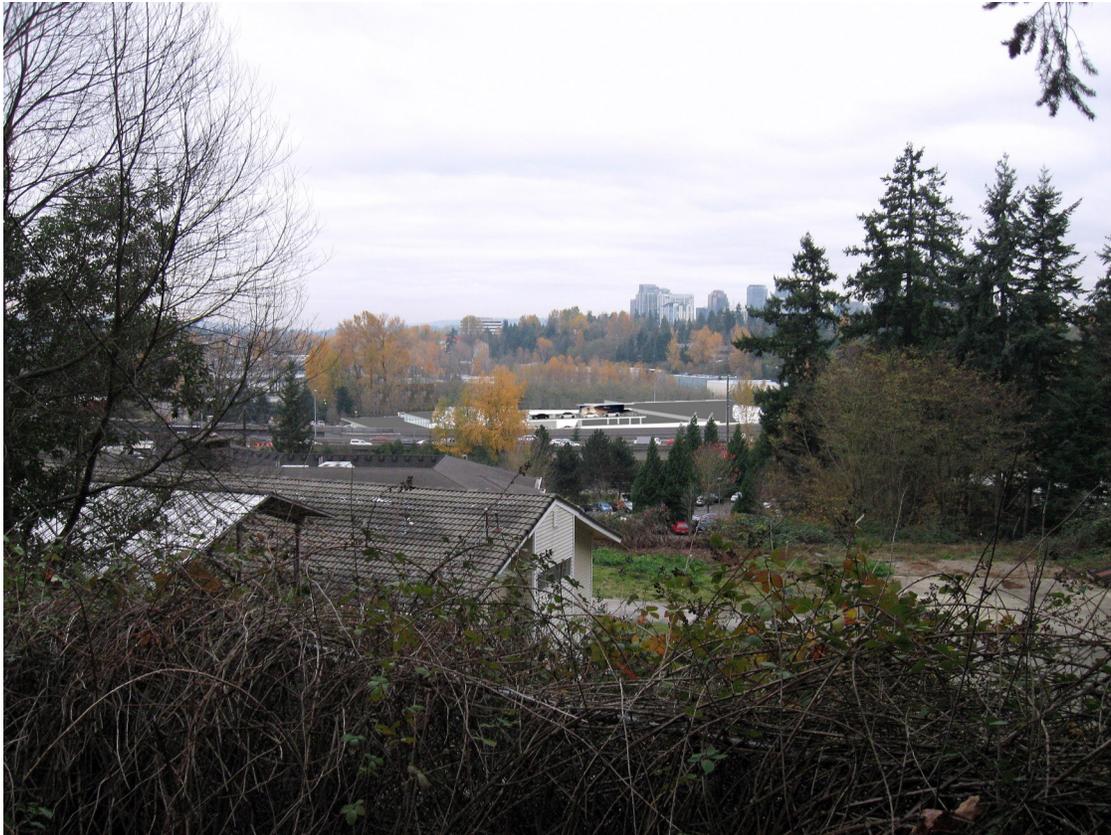
Existing

Proposed

As shown by **Figure 5**, the Existing View from this location features portions of the low-rise Lowe’s building in the mid-field view; mainly the white roof is visible. Under the Proposed View, existing development on the site would be replaced by the new **BMW of Bellevue** building. While the shape and color of the building would change, and some additional modulation and taller building levels would be visible, the general character of the view from this location would remain similar to existing conditions and no significant impacts would be anticipated.

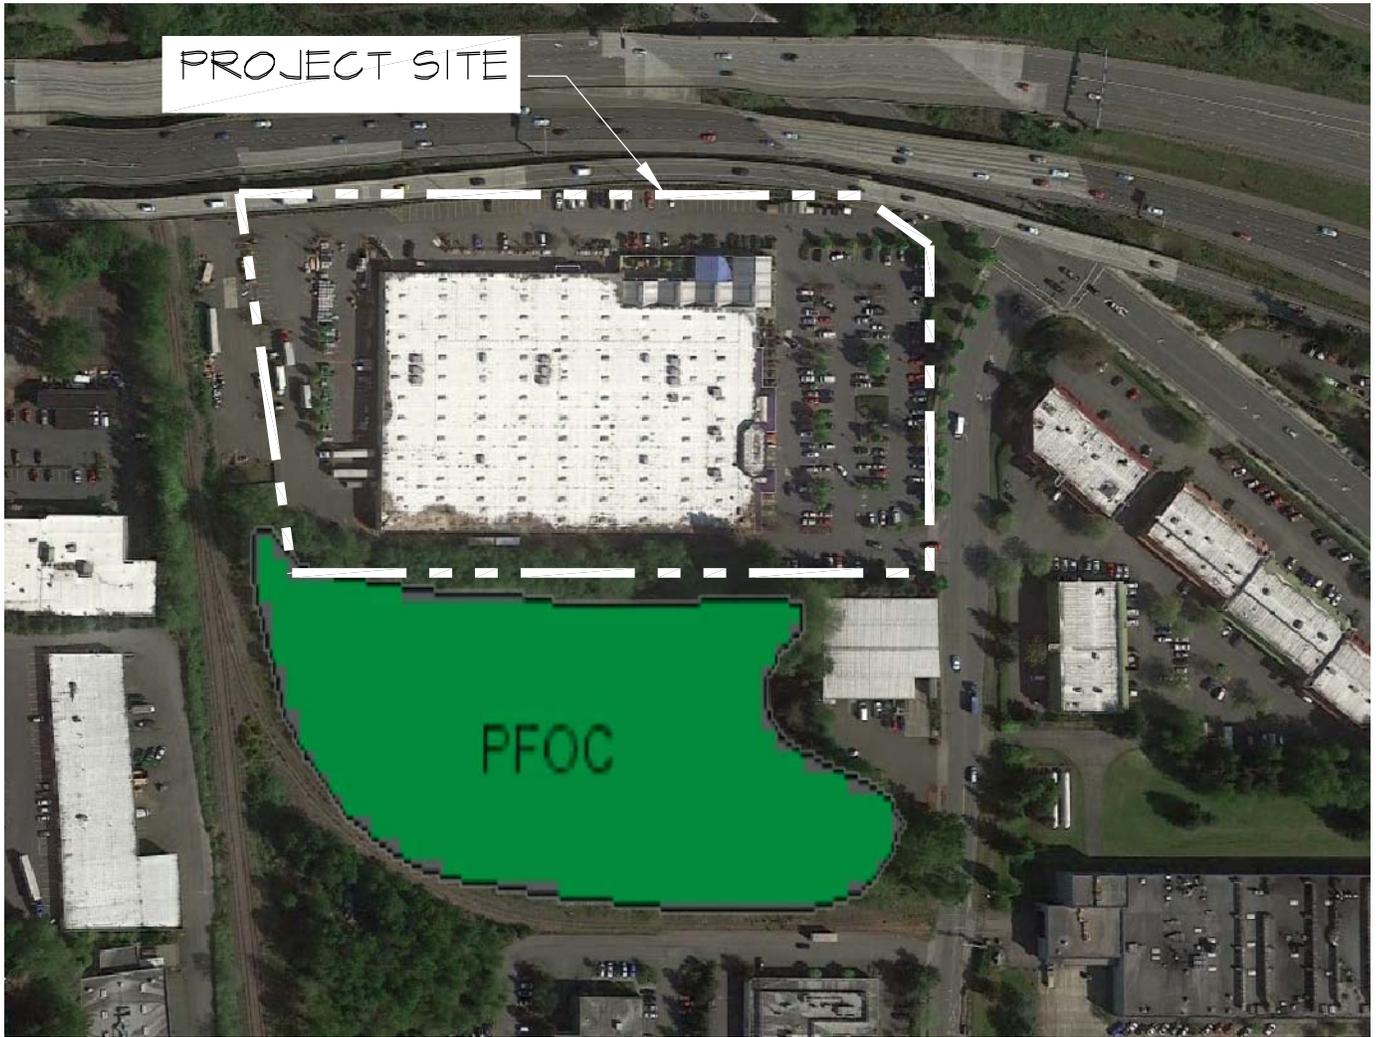
2

TYPE	DESCRIPTION
PFOC	PALUSTRINE FORESTED SEASONALLY FLOODED

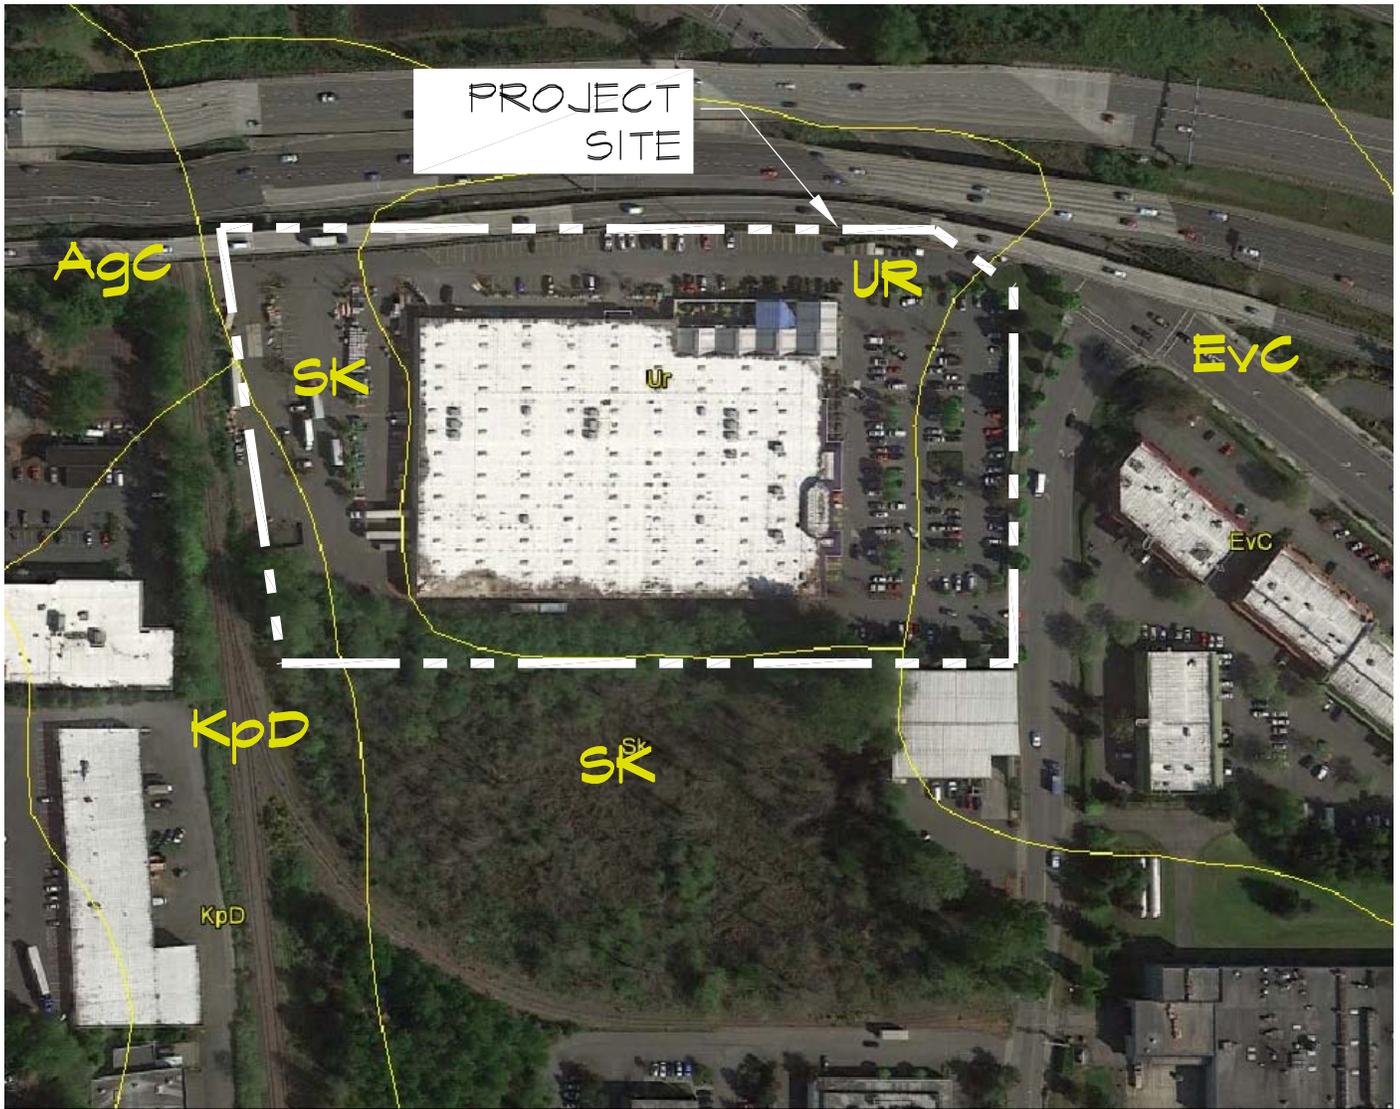
3

TYPE	DESCRIPTION, SLOPES
UR	URBAN LAND
SK	SEATTLE MUCK
KpD	KITSAP SILT LOAM
AgC	ALDERWOOD GRAVELLY SANDY LOAM
Evc	EVERETT GRAVELLY SANDY LOAM

Seattle Muck is made up of very poorly drained organic soils that formed in materials derived primarily from sedges. These soils are found in depressions and valleys on the glacial till plain and in river and stream valleys. The representative profile is a surface layer (approximately 11 inches) of black muck underlain by dark reddish-brown, black, very dark brown, and dark brown muck and peaty muck extending to 60 inches or more. Seattle Muck is listed as a hydric soil by the National Technical Committee on Hydric Soils. Only the a few portions along the Site’s southern boundary was found to exhibit this soil unit; most of the on-site area mapped as Seattle Muck is has been graded and filled by previous land uses.

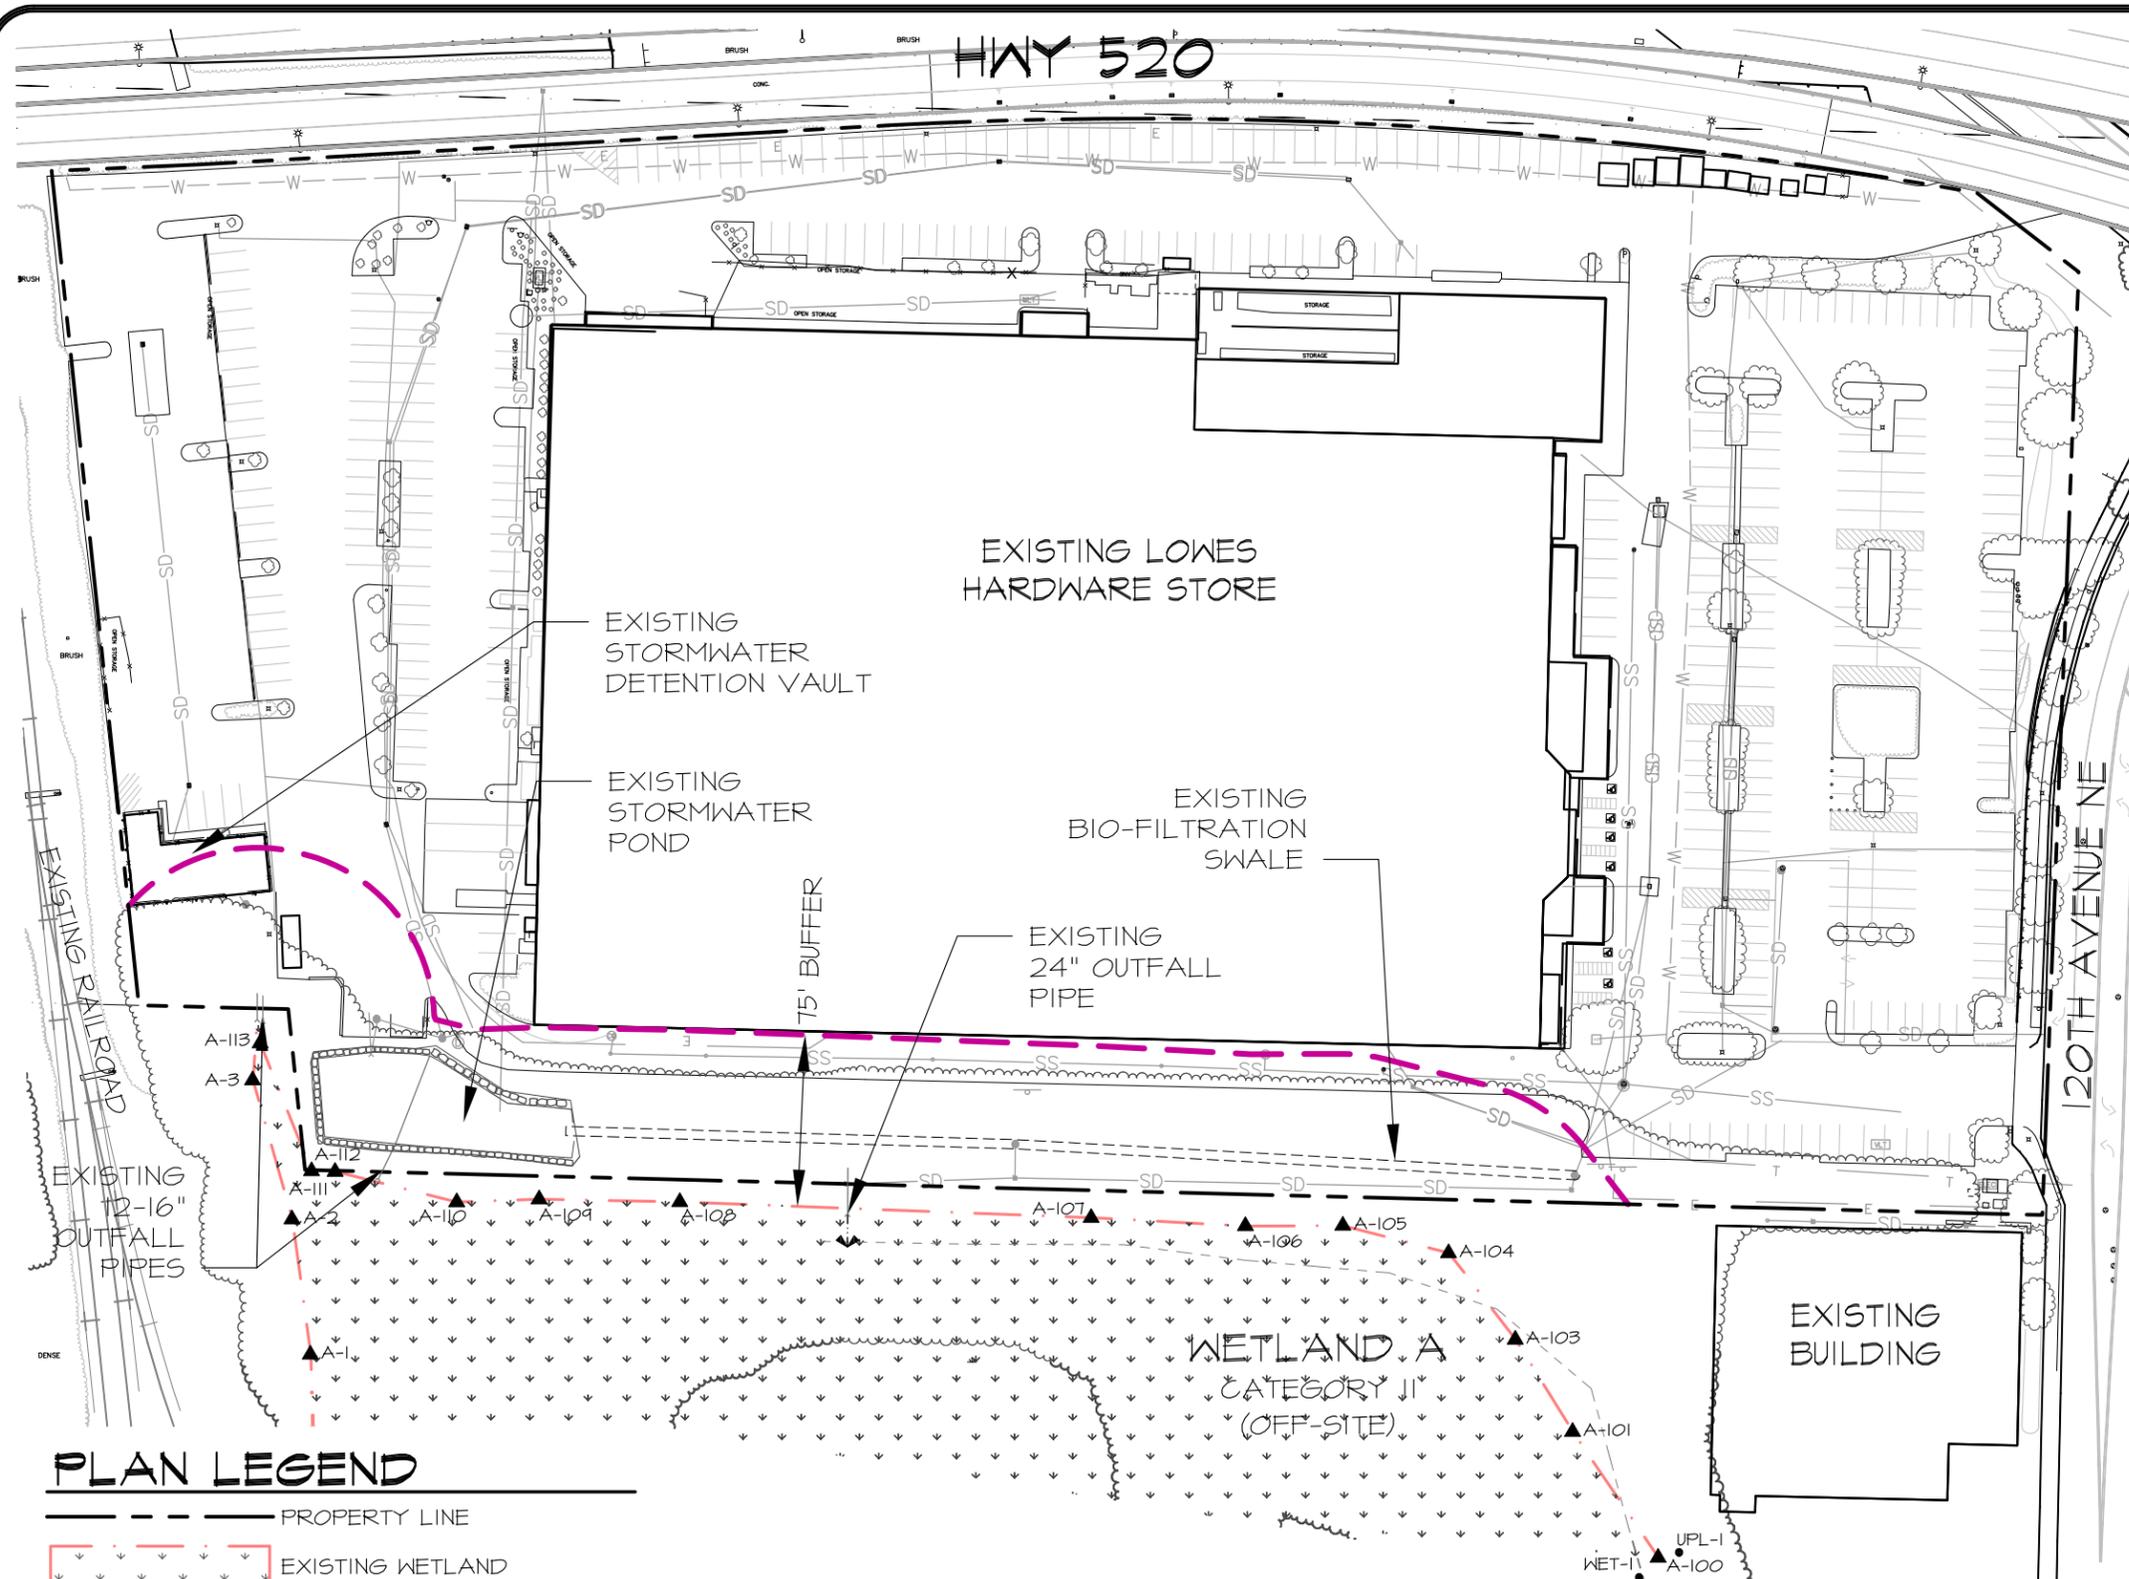
FIGURE #4  
 EXISTING CONDITIONS  
 CONCEPTUAL MITIGATION PLAN  
 BELLEVUE BMW  
 BELLEVUE, WASHINGTON

- PROPERTY LINE
- EXISTING WETLAND
- WETLAND BUFFER
- DITCH CENTERLINE
- EXISTING CONTOUR
- A-# WETLAND FLAG LOCATION
- TP-# SOIL TEST PLOT LOCATION
- EXISTING TREES

The Site is currently developed and used as a Lowe's hardware store with associated parking and infrastructure, and is mostly devoid of native vegetation except for a narrow strip along the southern property boundary. A Category II wetland occurs near the southern property boundary with a standard 75-foot buffer that extends onto the Site. The City of Bellevue and King County map a stream (West Tributary) as occurring through this large wetland though no evidence of a stream channel was observed in the field within the study area. A storm water bio-filtration pond is located on-site along the southern parcel boundary within the current wetland buffer on-site in an area formerly identified as a Native Growth Protective Area. A stormwater detention pond is located within the southwest corner of the Site, and collects stormwater from the western portions of the parking area that is then discharged into Wetland A.

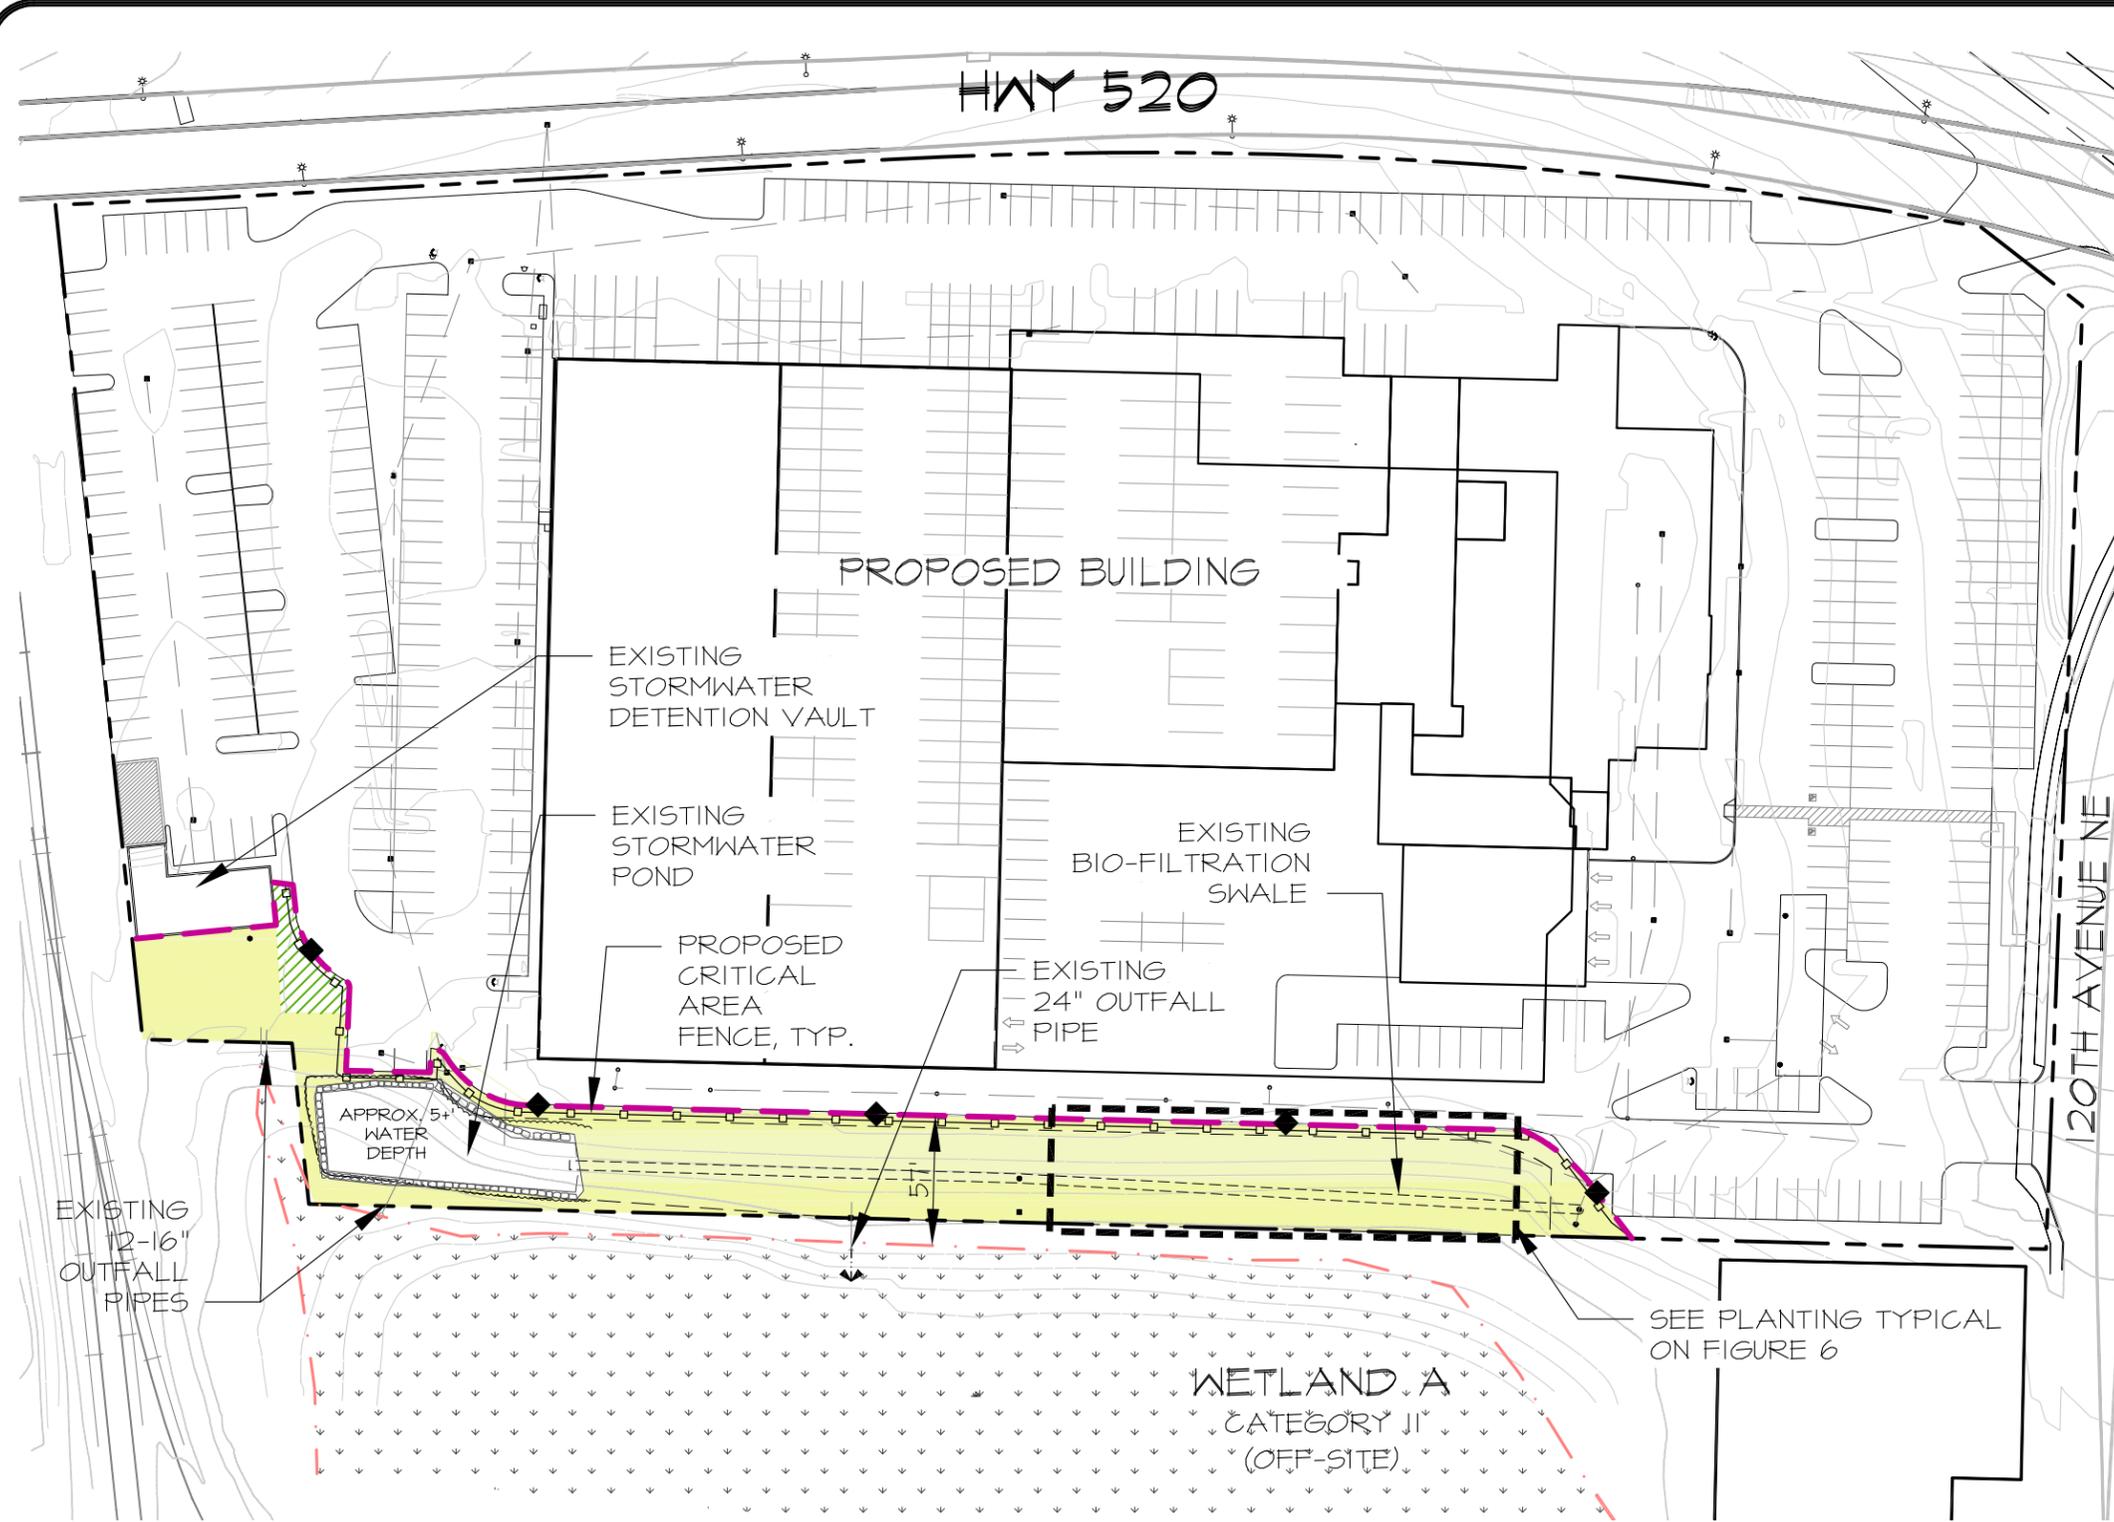
FIGURE #5  
IMPACTS AND MITIGATION  
CONCEPTUAL MITIGATION PLAN  
BELLEVUE BMW  
BELLEVUE, WASHINGTON

BUFFER ENHANCEMENT		
	BUFFER ENHANCEMENT	20,084 SF
	BUFFER REPLACEMENT	1,024 SF
TOTAL ENHANCEMENT: 21,108 SF		
	NGPA SIGNS

PROPERTY LINE
	EXISTING WETLAND
	POST CONSTRUCTION WETLAND BUFFER

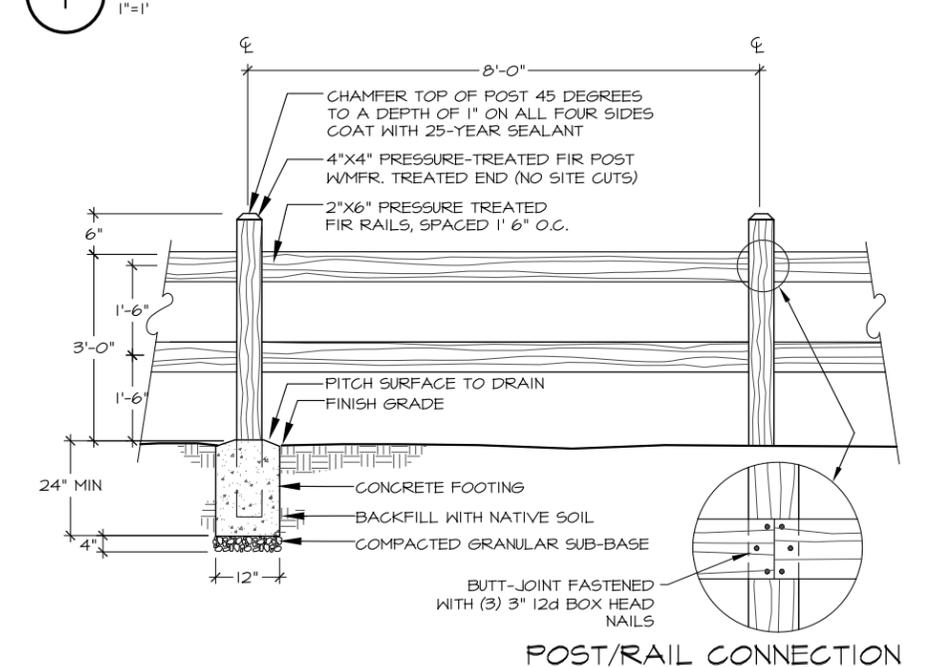
## 2 OPEN 2-BOARD FENCE DETAIL

NOTES:  
 1. RAIL FENCE TO ALIGN WITH LAND GRADIENT.  
 2. TREAT WITH CLEAR PRESERVATIVE UPON COMPLETION OF INSTALLATION.  
 3. ALL FASTENERS TO BE GALVANIZED STEEL.

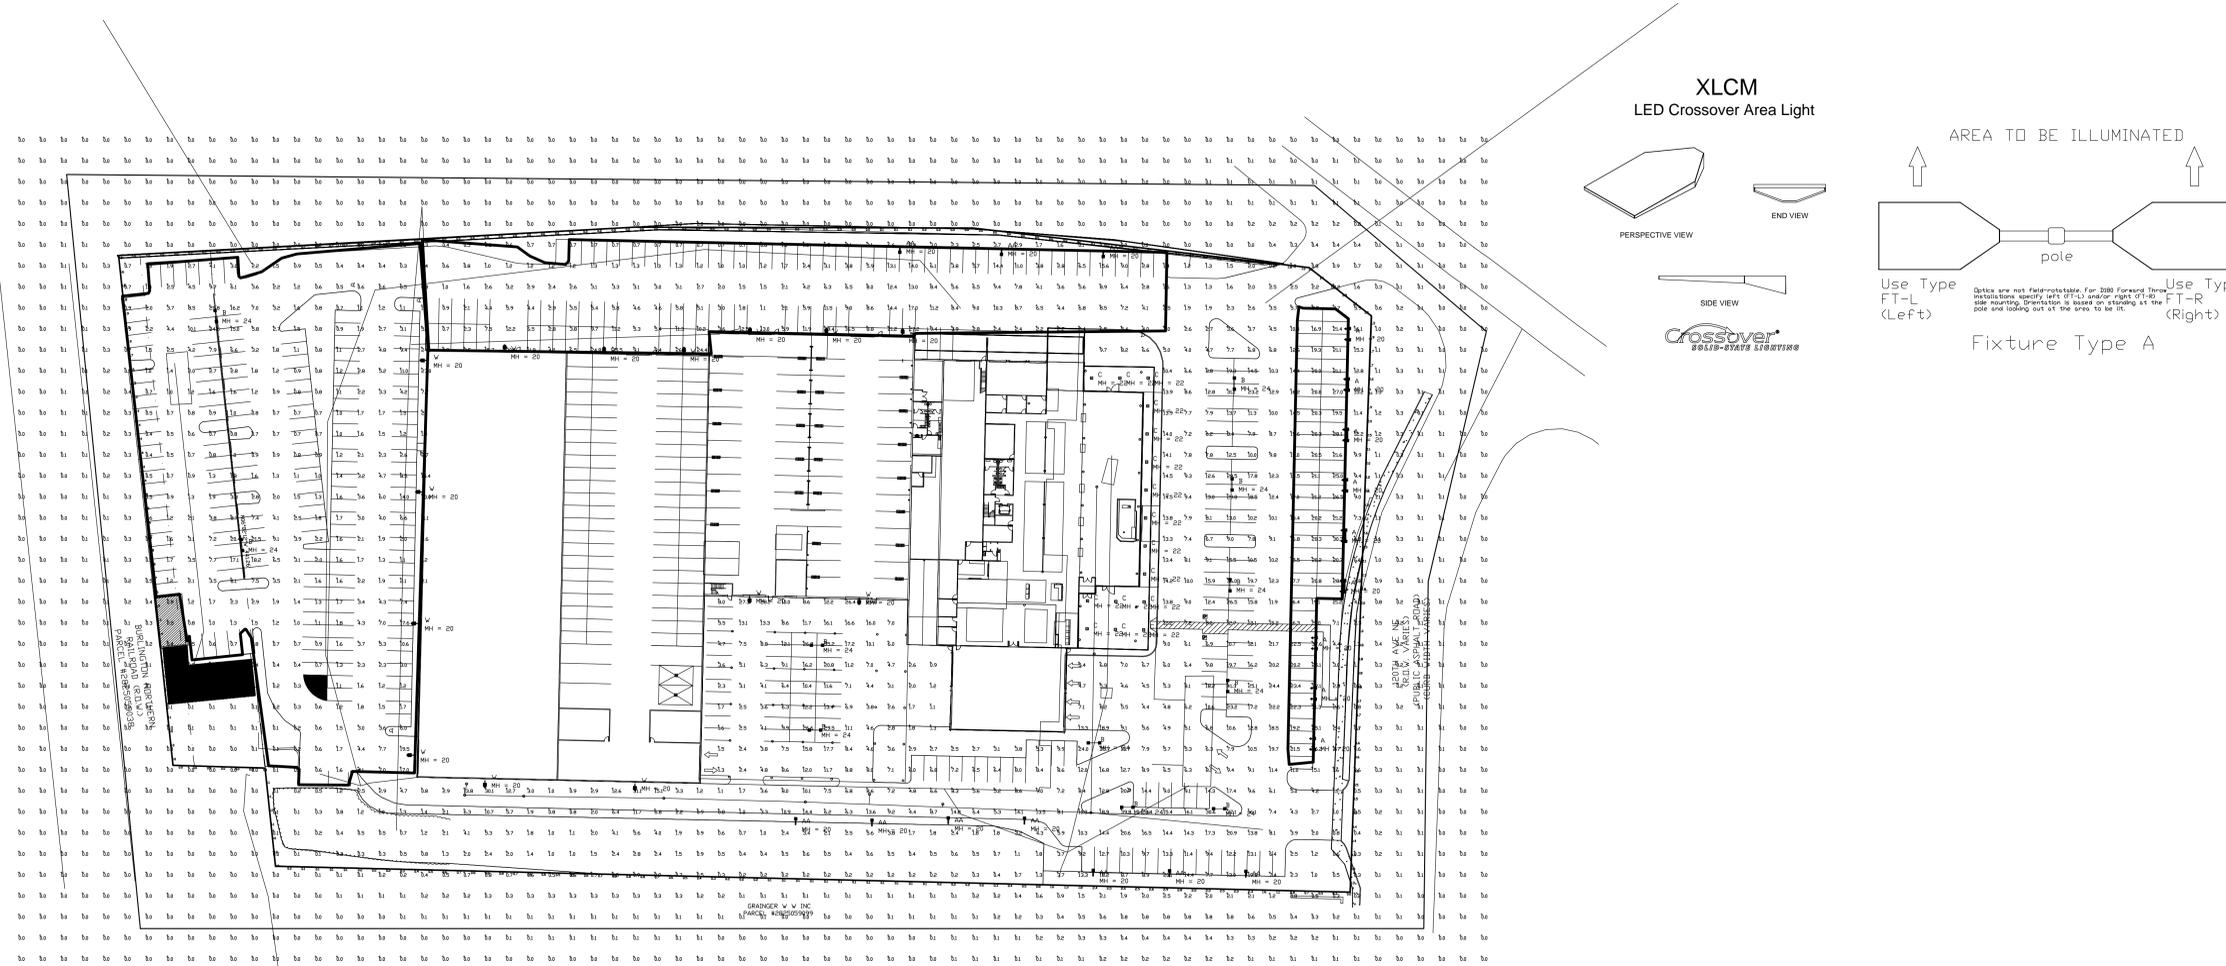
Label	CalcType	Units	Avg	Max	Min	Avg/Min	Max/Min
ALL CALCS @ GRADE	Illuminance	Fc	3.46	41.3	0.0	N.A.	N.A.
deck 1_1_Top	Illuminance	Fc	26.28	45.8	6.4	4.11	7.16
PROPERTY LINE @ 4' ABOVE GRADE	Illuminance	Fc	0.59	5.1	0.0	N.A.	N.A.
22' DISPLAY LEVEL	Illuminance	Fc	27.46	45.8	6.4	4.29	7.16
AREA 1- DISPLAY AND CUSTOMER	Illuminance	Fc	11.79	41.3	1.0	11.79	41.30
AREA 2	Illuminance	Fc	26.28	45.8	6.4	4.11	7.16
AREA 3- SERVICE AND EMPLOYEE	Illuminance	Fc	4.74	35.2	0.1	47.40	352.00
BACK LOT	Illuminance	Fc	3.32	30.0	0.1	33.20	300.00
FRONT LINE	Illuminance	Fc	23.08	37.6	16.3	1.42	2.31
SIDE LOT TYPICAL	Illuminance	Fc	6.27	30.6	0.4	15.68	76.50
