OPTIONAL DETERMINATION OF NON-SIGNIFICANCE (DNS) NOTICE MATERIALS

File No. 16-130929

Gardner Landscaping Project

RE-LANDSCAPING EVALUATION

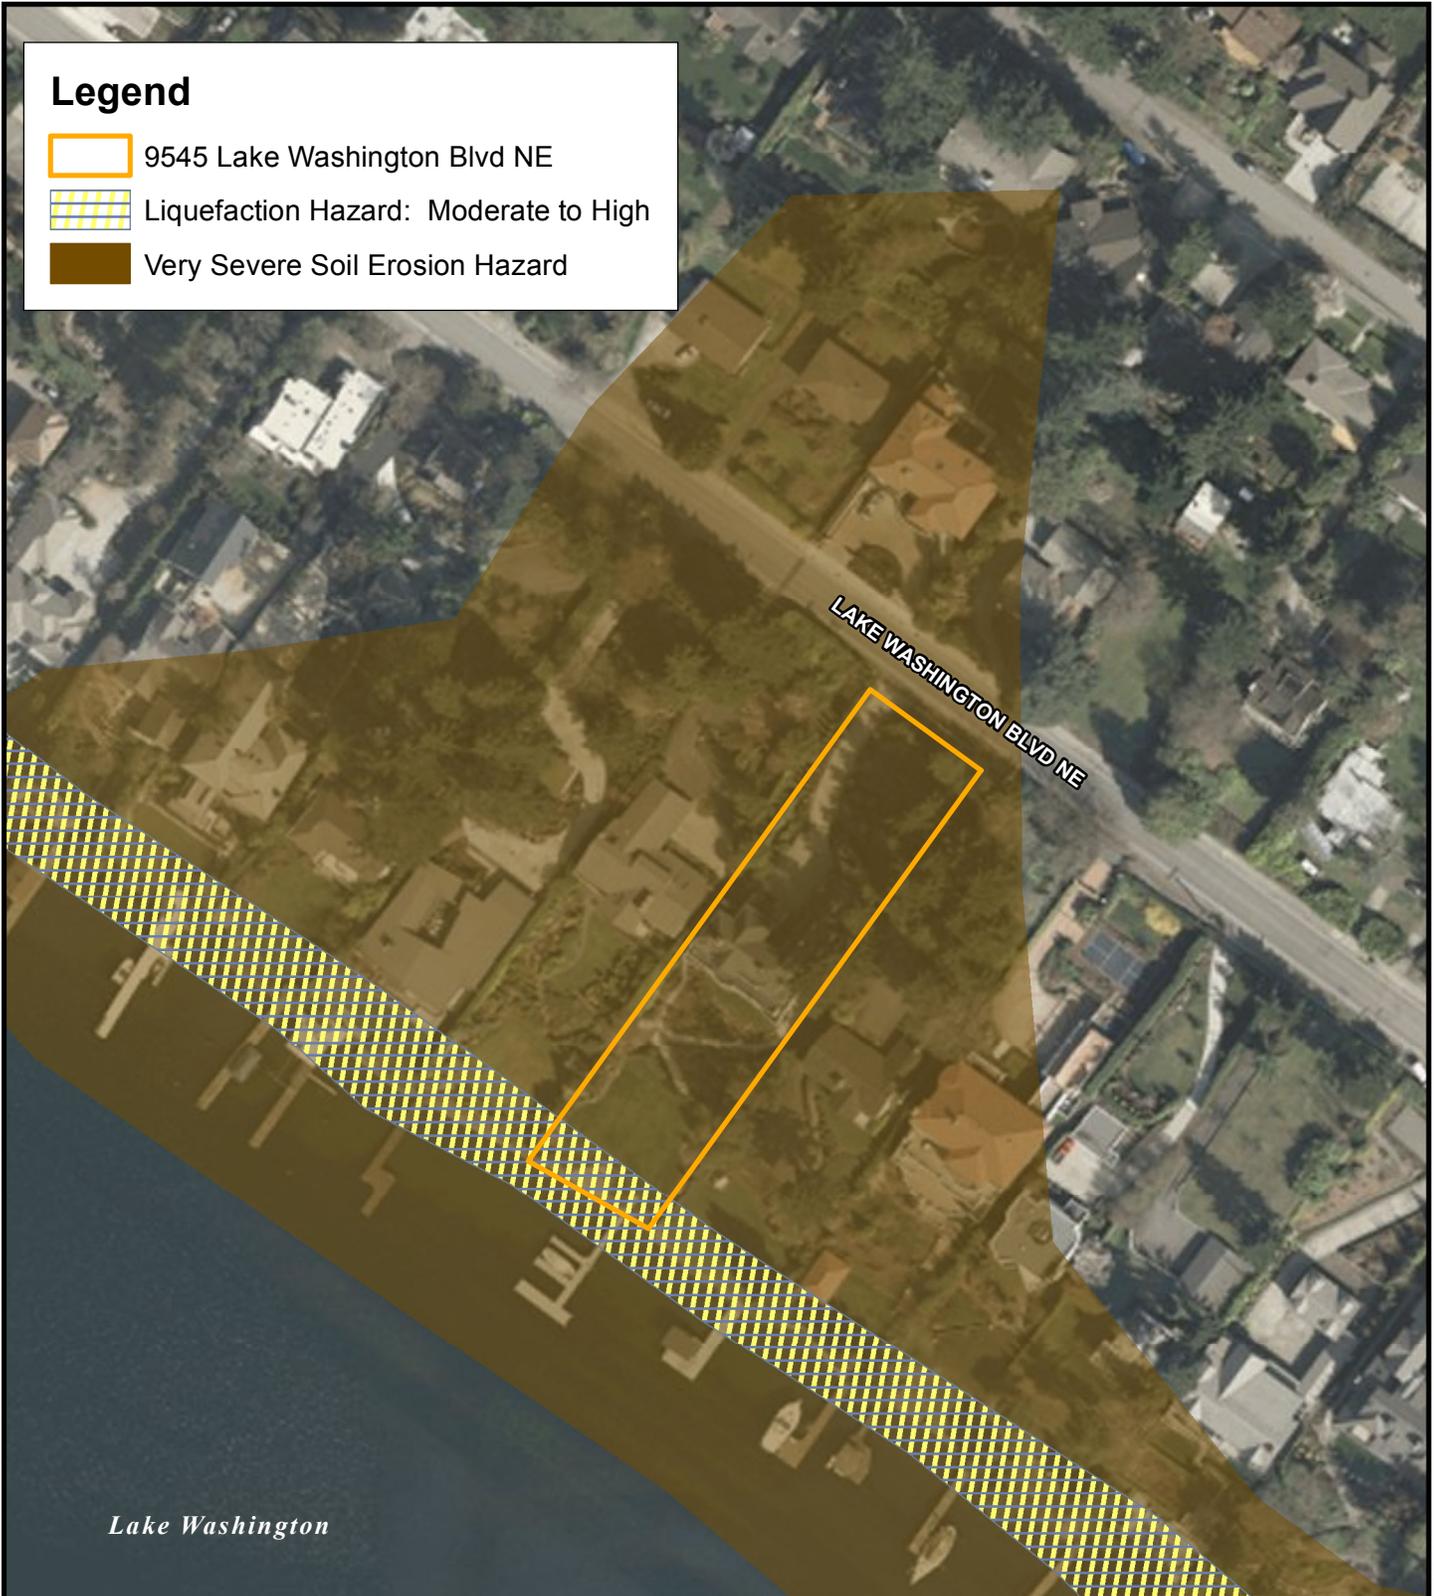
Critical Hazards Map		
<i>Gardner Landscaping Project</i>

Liquefaction Hazard: Moderate to High
-

Very Severe Soil Erosion Hazard

City of Bellevue Critical Hazards Maps designate the property as a "Very Severe Soil Erosion Hazard" area with localized areas of steep slopes greater than 40 percent. The area within approximately 25 feet of Lake Washington is designated as having a moderate to high liquefaction factor.

City of Bellevue Critical Hazards Maps designates the property as a "Very Severe Soil Erosion Hazard" area. The area within approximately 25 feet of Lake Washington is designated as having a moderate to high liquefaction factor. Five areas of designated steep slopes (greater than 40 percent) exist on the property:

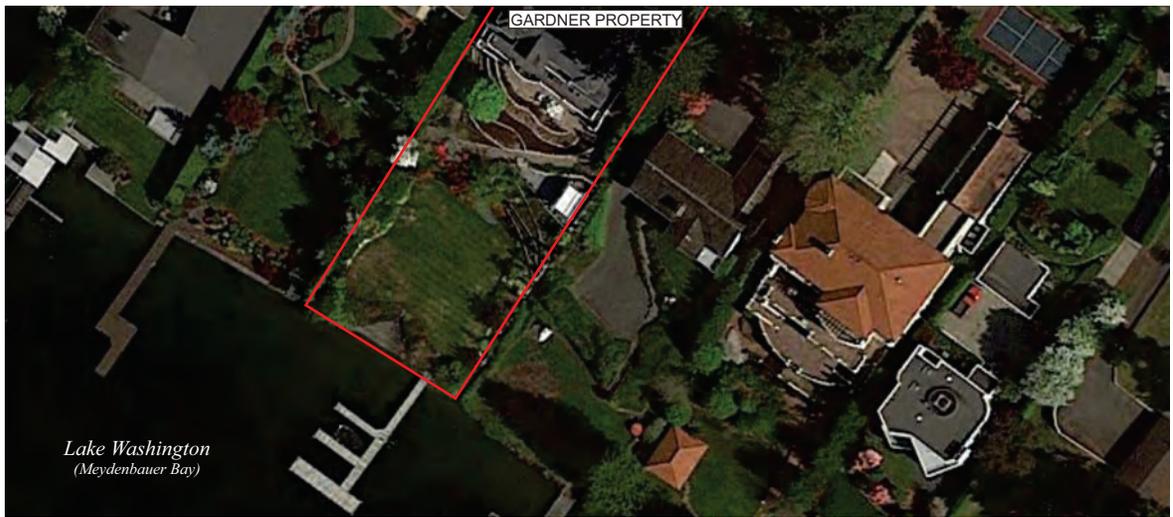
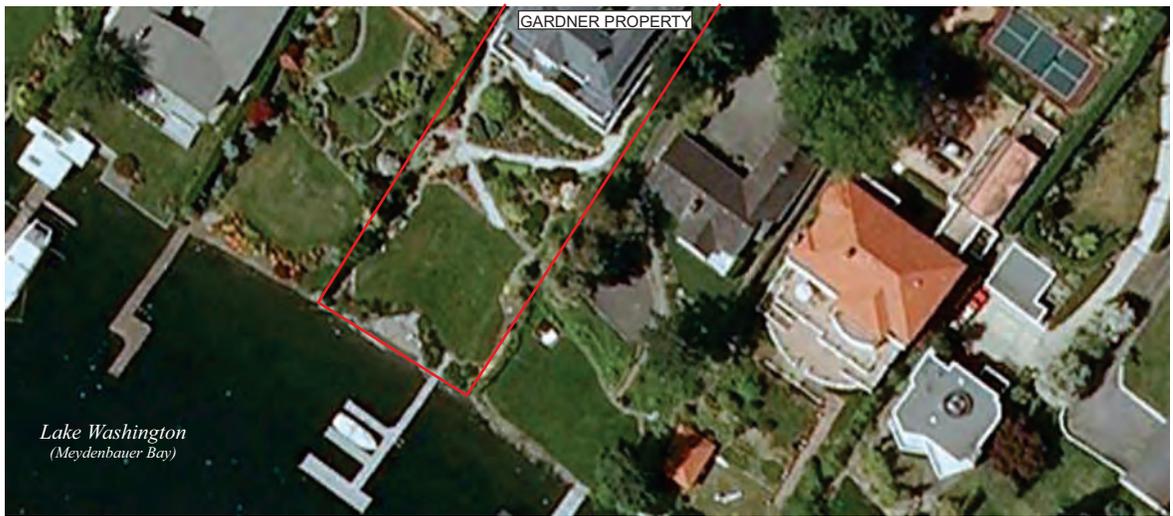
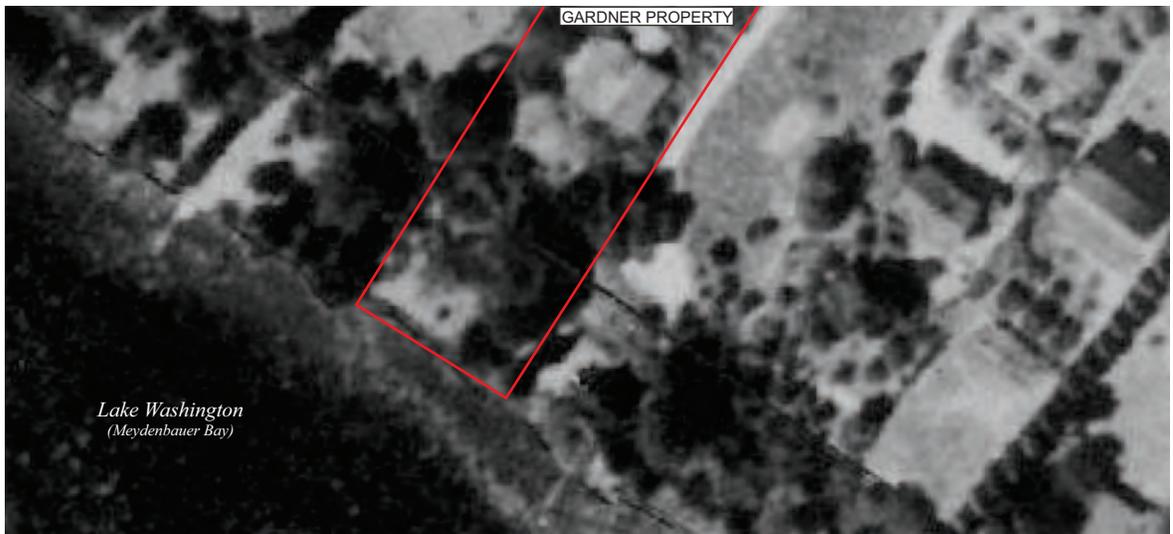
HISTORICAL AERIAL PHOTOGRAPHS

2015
(from Google Earth)

2009
(from Google Earth)

1936
(from King County iMAP)

Based on our review of historical aerial photographs from Google Earth (1990, 2003, 2005, 2007, 2009, 2012, 2014 and 2015) we observed the following sequence of Gardner property area changes, including the recent landscape walls, rockeries and gazebo addition. Selected photographs are shown on the Historical Aerial Photographs, Figure 3.

2005 Aerial Photograph – By 2005 it appears that some of the mature landscaping has been removed and replaced with new shrubs; the primary path that traverses and switches back down to the lower yard area appears to be grass covered.

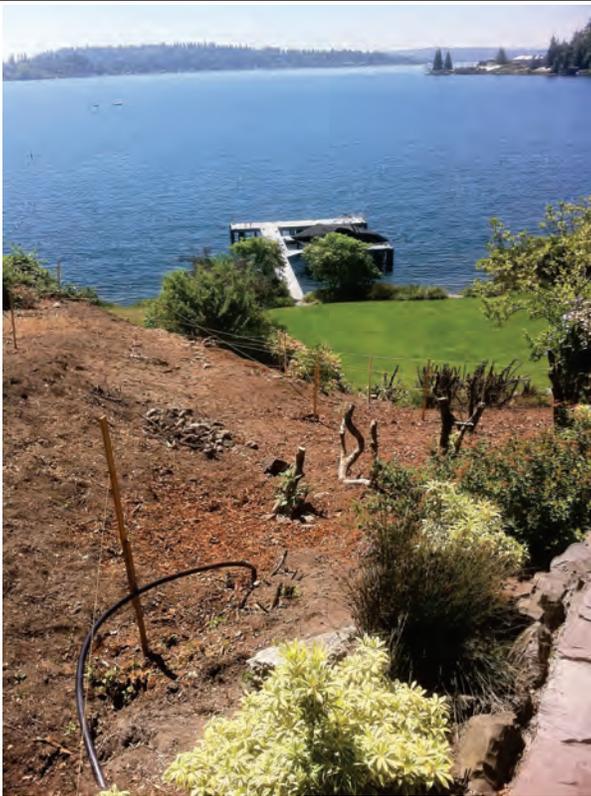
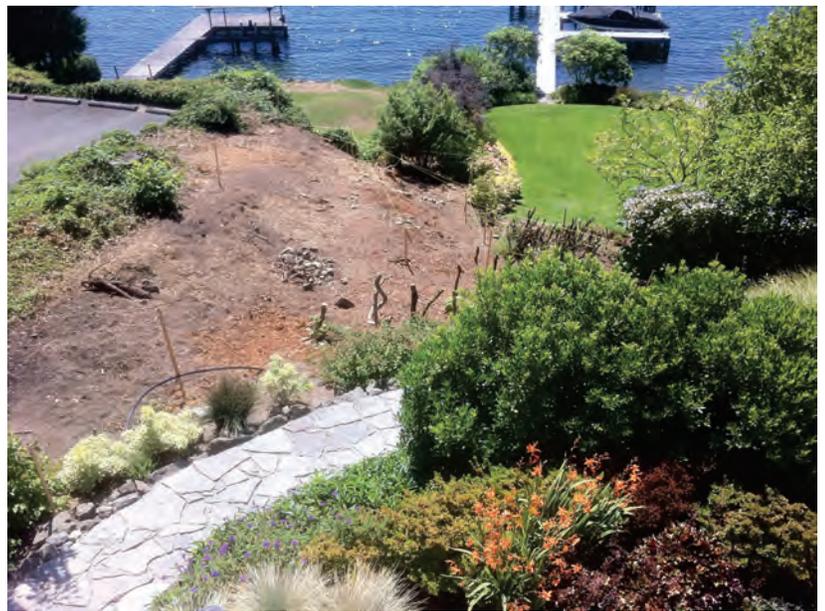
Views of the lower landscape wall area prior to construction showing the cleared "steep slope" area.

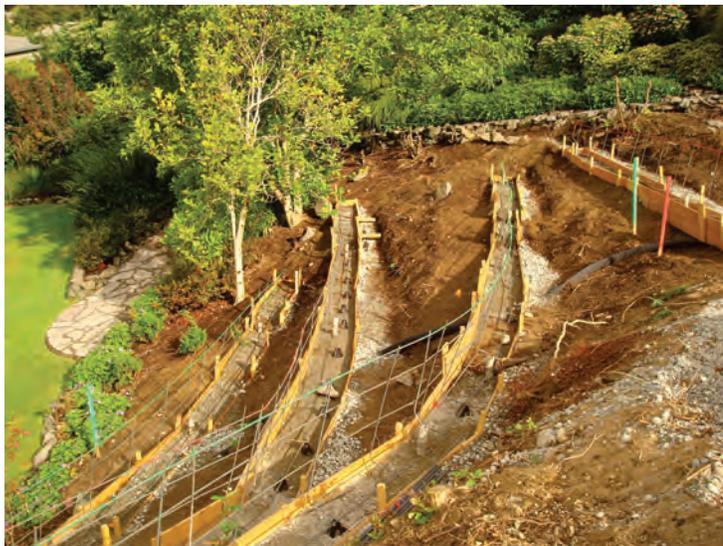
View to the northwest of the steep slope area that was terraced for landscape wall foundation preparation. A black colored drain pipe is visible crossing at a right angle to the foundation lines.

drainage test was inconclusive; it is possible that another discharge point exists that we were not able to locate, or that the drainage system has been damaged (crushed or broken). Irrigation has been installed in the planter areas of the tiered landscape and rockeries.

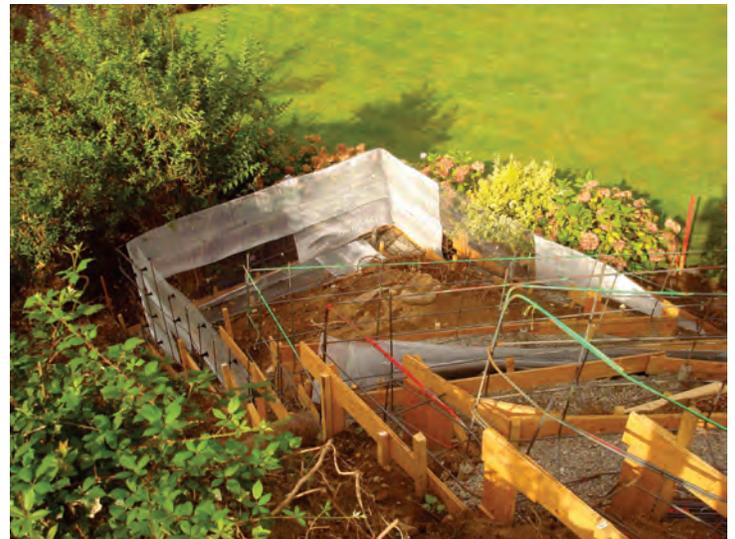
View to the south within the steep slope area that is terraced along with forms and reinforced steel/mesh for landscape wall construction. Note that the large wall at the base of the slope resulted in a block buttress for the slope.

Based on our review of the pin pile records (McDowell NW Pile King, Inc.), 28 piles were driven to a depth ranging from 5.25 to 10.5 feet in the area of the landscape walls. A penetration depth of 5.25 feet is consistent with shallow, unweathered Glacial Till being near surface. A penetration depth of up to 10.5 feet suggests that some fill is likely present. However, the overall thickness of looser soils is relatively thin in the landscape wall area.

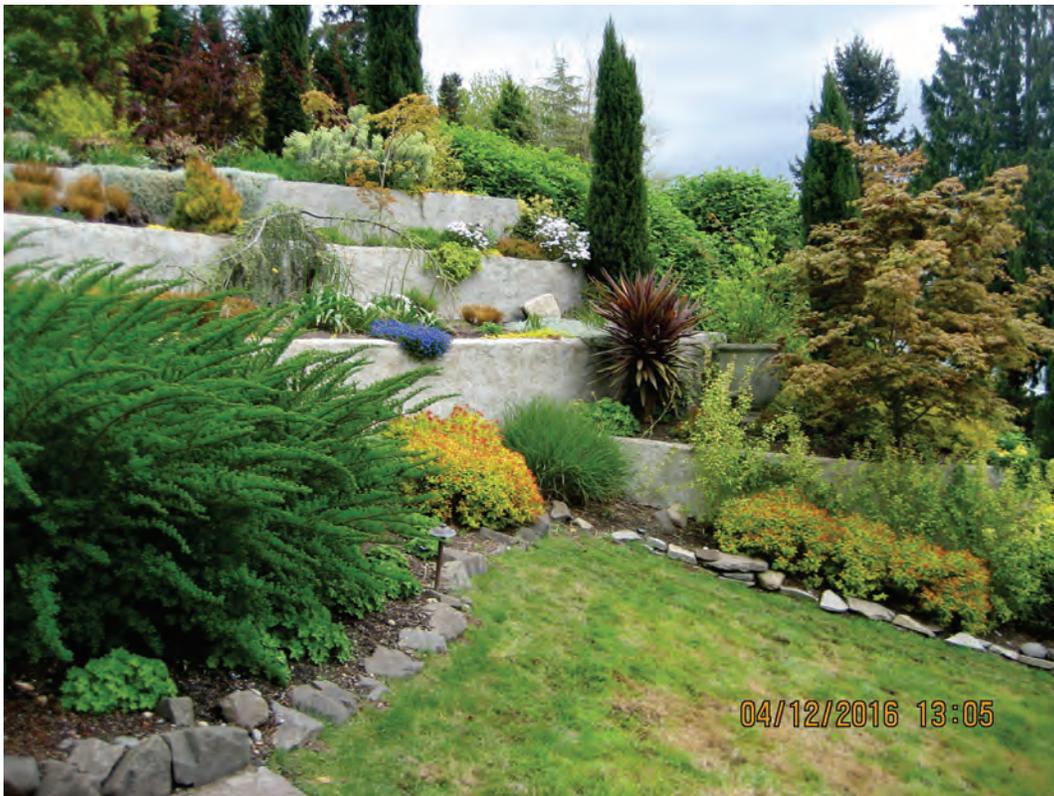
View to the northeast at the terraced slope using landscape walls that are less than 48-inches high.

The landscape walls and rockeries could be susceptible to shallow, localized failure considering the site conditions. However, this would most likely occur if the walls were poorly drained or if shallow groundwater was present. Based on our site observations, the landscape walls and rockeries are reasonably well-drained. The rockeries are constructed as an open-work face, therefore good drainage is implied. The landscape walls could restrict groundwater movement, especially considering that the installed drainage system could not be "proven" to be effective by the water flow test. However, the backfill materials are reasonably well-drained and no evidence of seepage was observed in the areas around or under the walls.

We recommend no further action. In our opinion, the terracing of the slope, as completed, would have been our recommendation for surficial soil stabilization should that have been a problem. Because of the geologic conditions of the Gardner property, an open slope with dense ground cover (the original landscape condition) or the current tiered slope with plantings are appropriate methods for stabilizing the slope area west of the Gardner house.

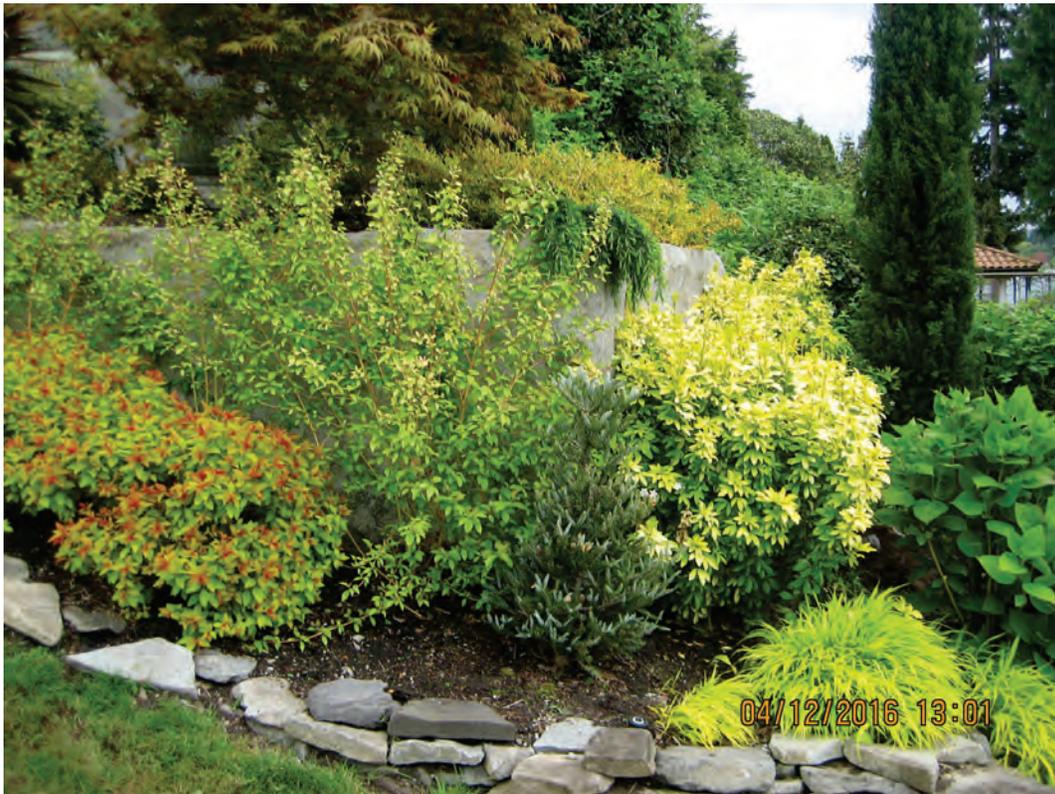
The box wall at the base of the slope was not built within the Steep Slope Critical Area. A drain pipe physically extends from under the base of the box wall so it should be adequately drained. The position of the box wall at the base of the slope is a favorable condition and provides a buttressing effect to the uphill area. The box-like shape (three-sided rectangle) is also a favorable geometry for maintaining slope stability. From a geotechnical perspective, the box wall appears to be satisfactorily constructed provided that the appropriate lateral soil pressures were used in the design (35 pounds per cubic foot (pcf) for active soil pressure (level backslope), 250 pcf for passive pressure (level to slightly sloping foreslope) and 0.35 for friction), and that the wall is drained.

View to the east of the landscape wall that is more than 48-inches high that forms a three-sided "box" at the base of the steep slope area (referred to as the "box wall" in the report).

The structural integrity of the box wall should be evaluated by a structural engineer. Alternatively, the base of the landscape wall could be buttressed by installing a lower wall backfilled with rock spalls to reduce the exposed face of the landscape wall to less than 48 inches and also to provide additional lateral support, if needed.

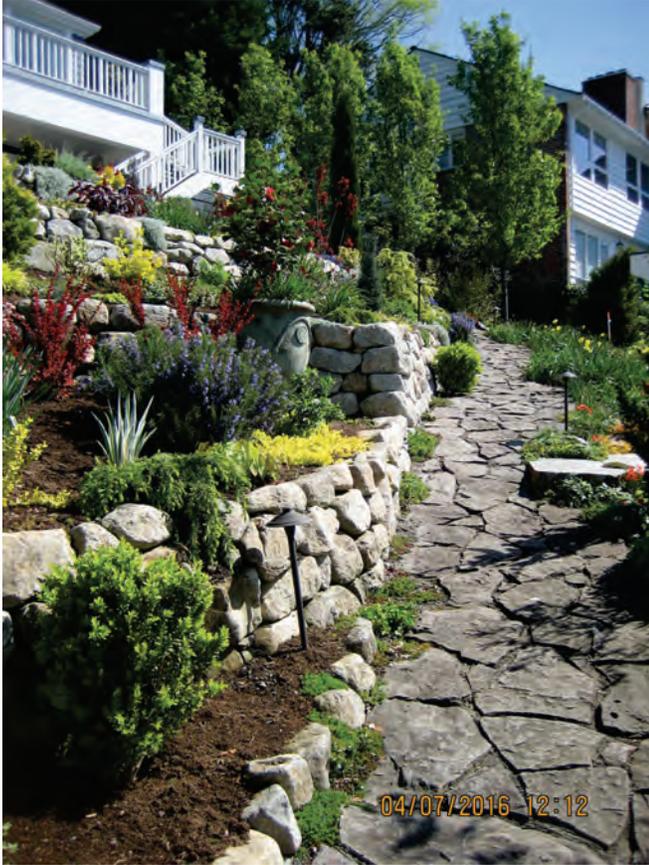
Based on our site observations, the rockeries are constructed of 10- to 16-inch diameter, subangular granite boulders. We understand that the boulders for the rockeries were placed by hand. The 24- to 30-inch high rockeries above the primary path were apparently backfilled with 5/8-inch-minus crushed rock "chinking" immediately behind the rockeries (we observed this material in the field in open spaces between the rocks), then backfilled with imported soil (same as described for the landscape walls). However, the higher rockery bordering the gazebo was backfilled with 3- to 5-inch diameter rock spalls in a 2-foot area immediately behind the rockery. Photographs of the gazebo area rockeries are shown in Figure 8. We understand that no drainage pipe was installed behind the rockeries. Based on our site observations, the rockery areas are dry (no visible seepage areas) despite a relatively wet period preceding our site visits.

View to the northwest of the foot path and rockeries.

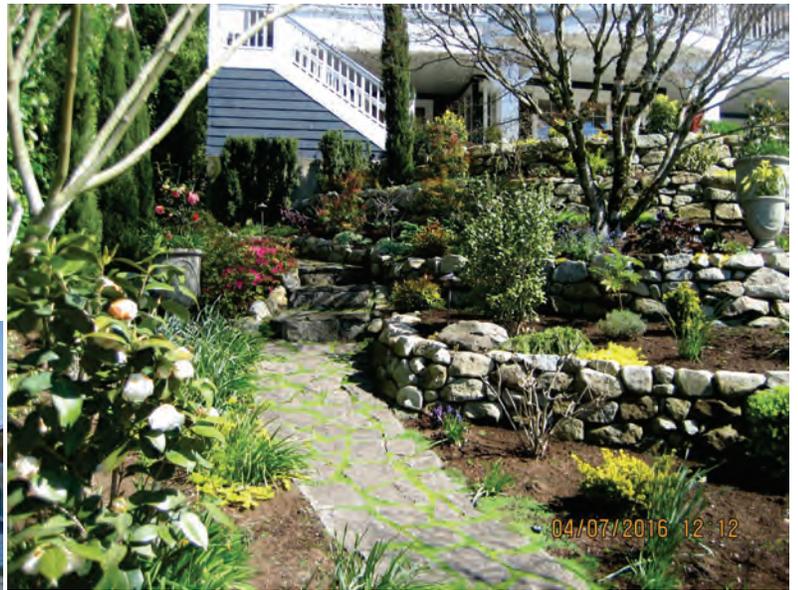
View to the northeast of rockery walls and the foot path that traverses below the rockeries.

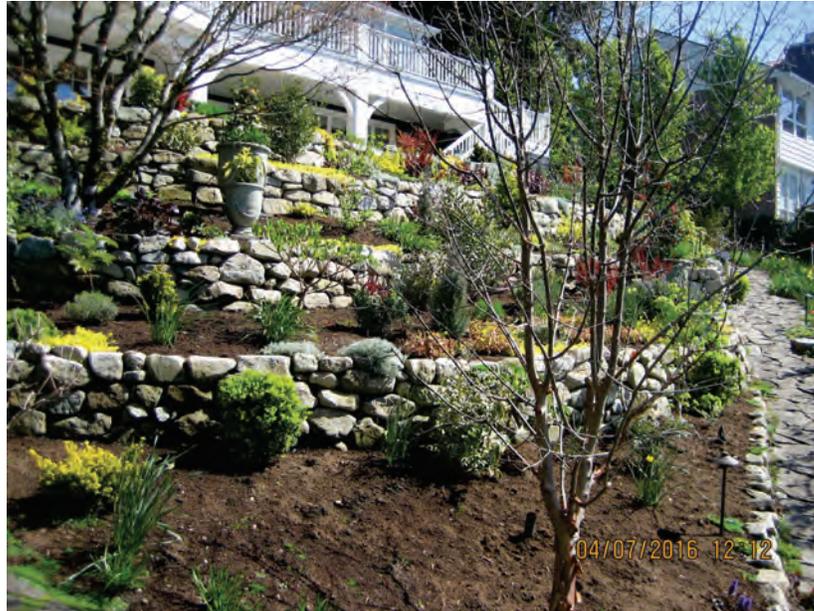
View to the east of rockery walls and the foot path that traverses below the rockeries.

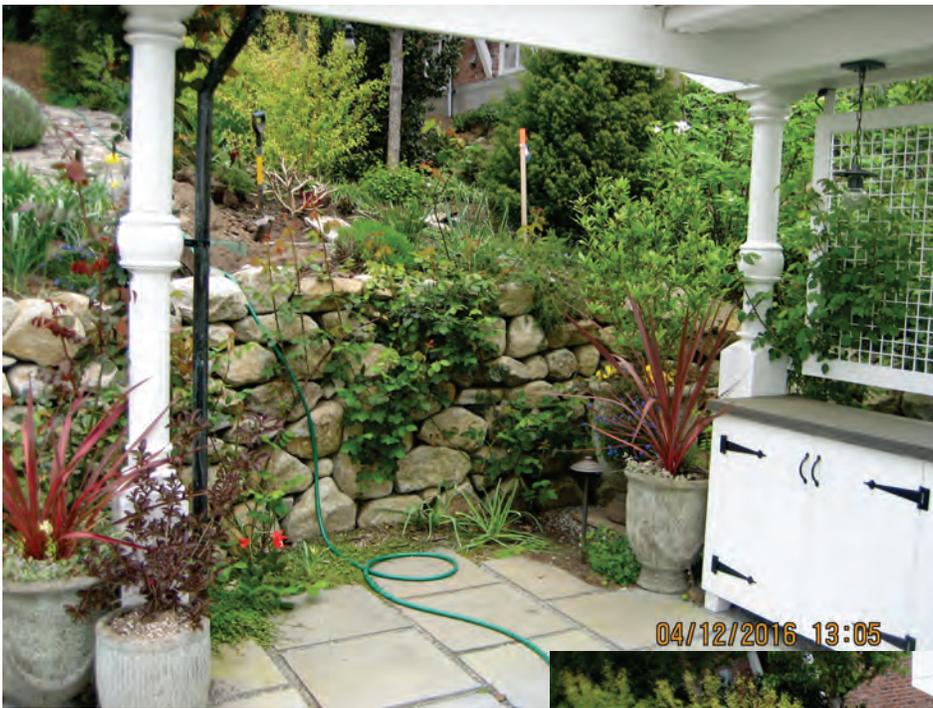
The rockeries that was constructed on the uphill side of the gazebo are not within a Steep Slope Critical Area with the exception of the rockery located uphill (east) of the gazebo. Also, the gazebo wall is over 48 inches in height, so structure standards apply as described in City of Bellevue, October 2010, Handout L-5. It appears that the rockery was constructed with the backfill consisting of 3- to 5-inch diameter rock spalls which improves the stability of the backfill and provides drainage. The rockery is also arch-shaped in plan over a relatively short distance which provides some additional lateral support. In our opinion, the rockery is adequately stable as constructed.

View northeast at the rockery that is more than 48-inches high.

We have no recommendations for modification of this rockery on the uphill side of the gazebo. If regulatory requirements override engineering design, then the top course of rocks should be removed to reduce the height to less than 48 inches.

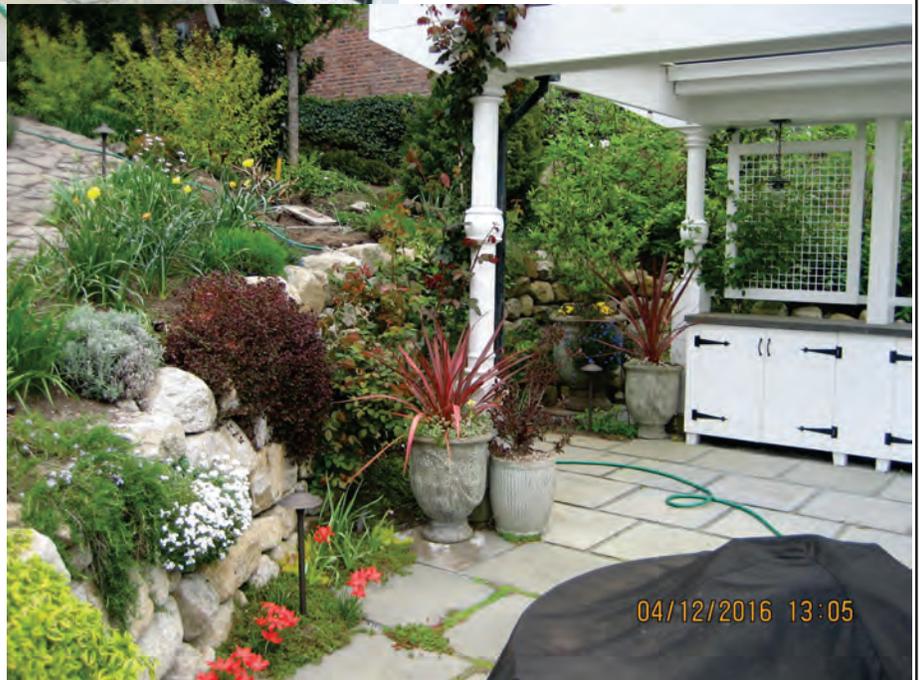
View southeast along the (curved) top of the rockery that is more than 48-inches high.

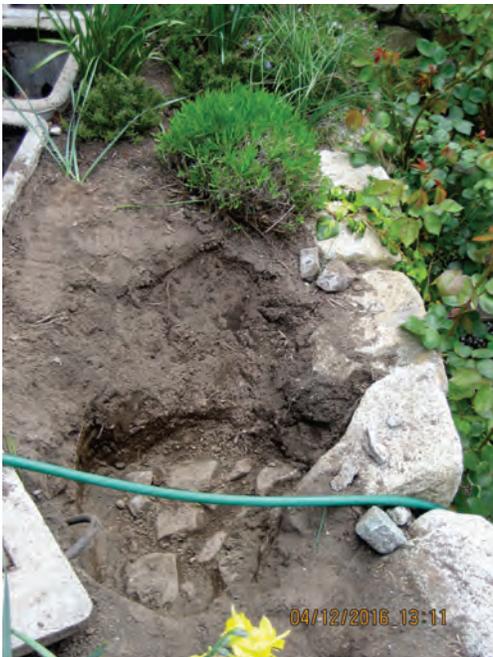
View of the 3- to 6-inch diameter quarry spalls that were used to backfill an approximate 2-foot wide area behind the rockery that is more than 48-inches high.

- F. **Any modification complies with recommendations of the geotechnical support with respect to best management practices, construction techniques or other recommendations.** Based on our site review, the result of the landscaping, including tiering of the slope (a recommended Best Management Practice by the City of Bellevue) has been completed consistent with standard recommendations for landscape walls and rockeries that are less than 48-inches high. The two areas where this maximum height has been exceeded (the box wall at the base of the slope and the rockery uphill from the gazebo) have been mitigated by the rectangular shape of the box wall and the curved (arch) shape along with quarry spall backfill of the gazebo rockery.
