City of Bellevue  
Development Services Department  
Land Use Staff Report

**Proposal Name:** Jewell Hedge Removal

**Proposal Description:** The applicant requests a Critical Areas Land Use Permit for removal of non-native, evergreen shrubs and restoration in a steep slope critical area buffer.

**File Number:** 10-111689 LO

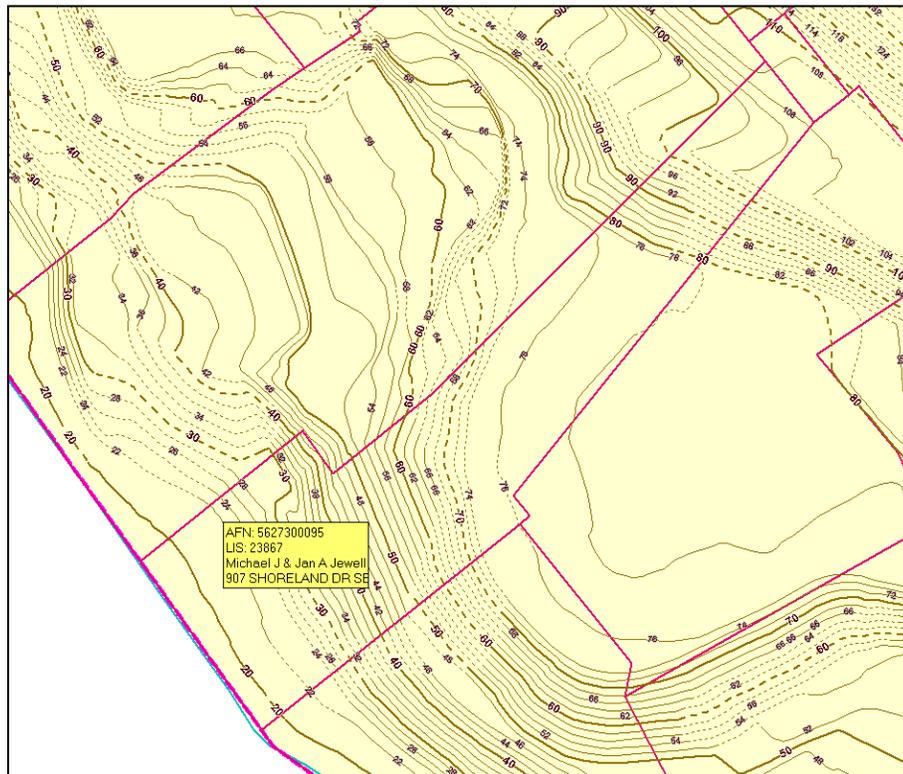
Figure 1: Property Map

The undeveloped, site is located at 907 Shoreland Drive SE (King County Parcel #5627300095). The property is irregularly shaped and constrained with two areas of steep slope critical area. One slope is on the northeastern edge of the property and the other is on the western third of the property. Both slopes are in excess of 40% slope and have the requisite elevation change and area to be considered critical area steep slopes. The property also abuts Lake Washington on the western edge.

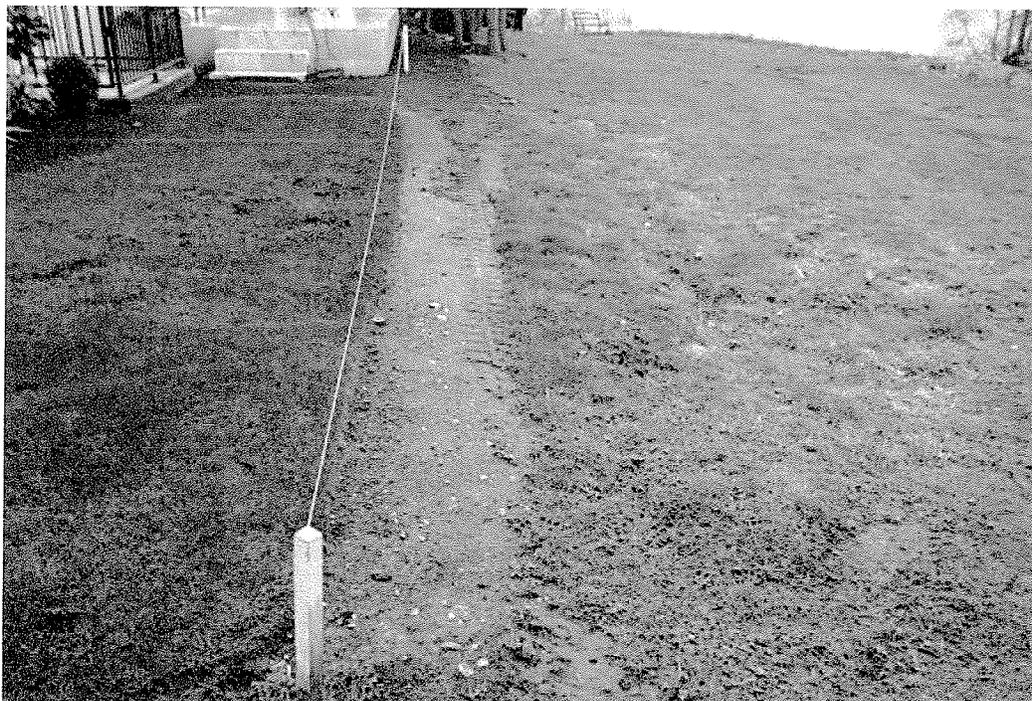
#### **Property Line Previous Disturbance**

**Disturbed dirt area on our property caused by the neighbor or landscaper of their newly constructed home. Photo also shows location of their side patio with table and chairs within a few niches of our property line providing us no privacy and is a potential liability risk for our property.**

It is also important to point out the area impacted by the fence posts and our arborvitae hedge had previously been disturbed by our neighbor or their landscaper as can be seen in the attached photo called Property Line Disturbance. This was done without any City of Bellevue permits and was done without our knowledge. It appears the owners of the new residence did this to prevent our grass and weeds from entering the new residence's lawn. We never complained about this event as we were not aware of the City of Bellevue rules and did not want to bother the new owners on our southern property line. The area previously disturbed by our neighbor is about 1 ½ to 2 feet wide and runs nearly the full length of our property's upper level area that adjoins their property. Please see photo attached; Property Line Previous Disturbance.

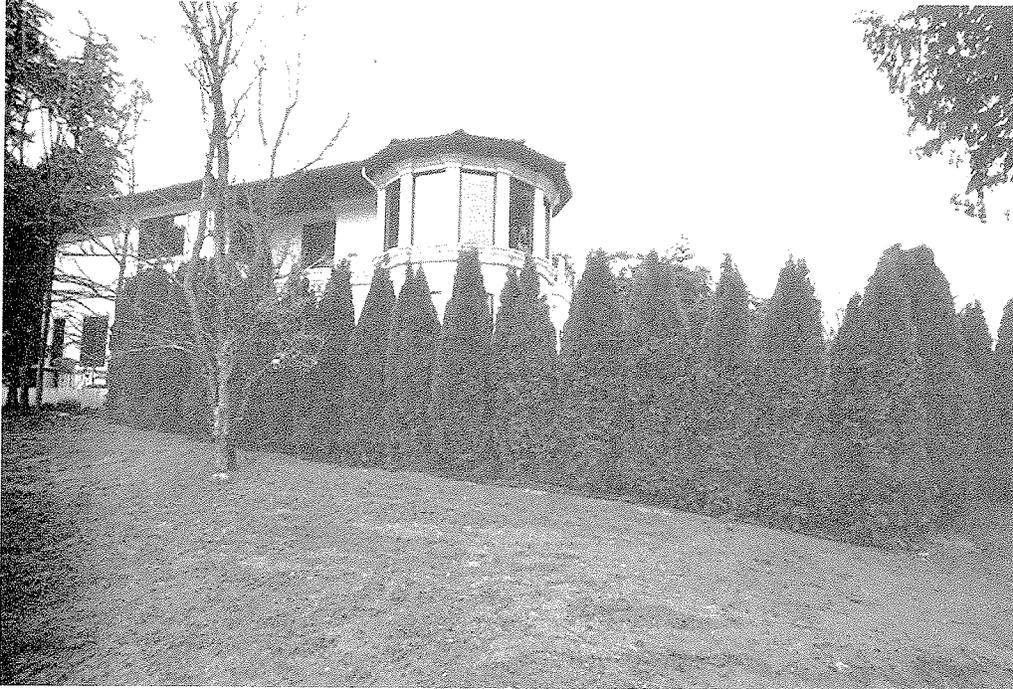
## Property Line Hedge

Current arborvitae hedge and new 12,000 square foot residence adjoining our southern property line. Our goal was to restore our privacy and improve safety of our property. Since the arborvitae plants are not native to the area we will be removing them at substantial cost.

We recently planted an arborvitae hedge, on our southern property line adjoining this new house to increase our privacy and property security. A photo of this hedge and new oversized residence is shown below. We had originally selected these plants as the identical arborvitae hedge is on the south side of our southern neighbor's property border and is used on many homes on Shoreland Drive for privacy. We have been informed our newly planted arborvitae are not a native plant. Per a new City of Bellevue rules, which were implemented in 2006, only native plants can be close to our slope.

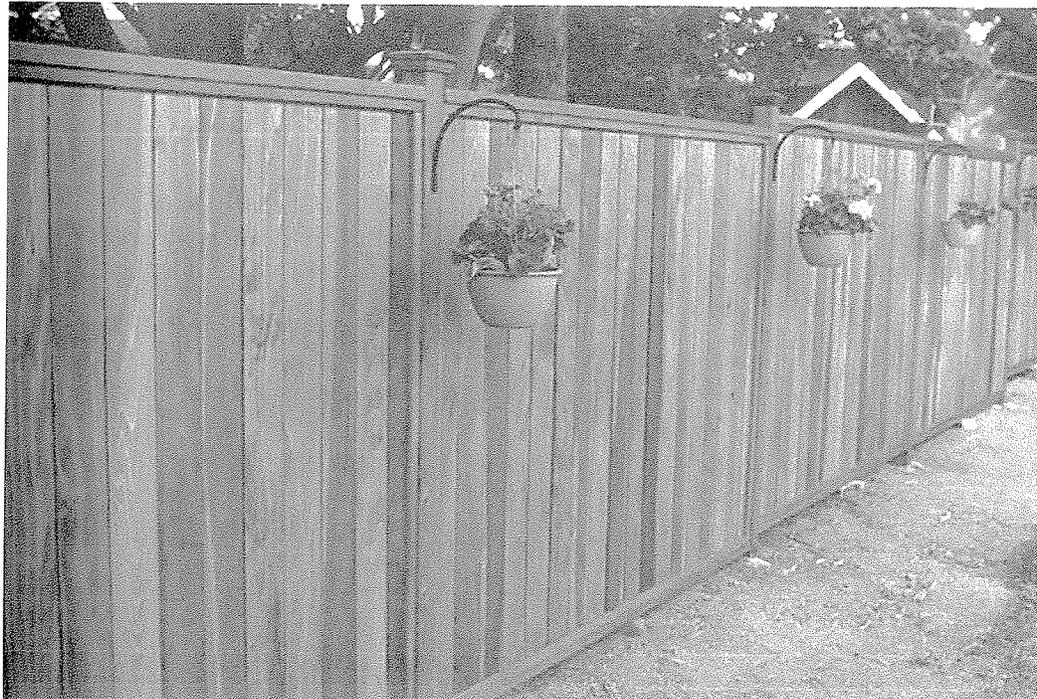
## Example of Fence Design

The fence will be like kind to what the City of Bellevue frequently uses and will have 4 inch by 6 inch wood posts with approximately 8 foot panel spans. Spans will be supported by 2 inch by 6 inch boards.

During the same week this hedge is removed, we plan to install a traditional wood cedar fence as shown below. The design of this fence will be "like kind" in appearance to the fence recently installed by the City of Bellevue on NE 8<sup>th</sup> going towards Clyde Hill. Both sides will have the same physical structure and we will be using high quality cedar boards with 4 inch by 6 inch posts sunk a minimum of 2 feet in the ground and set in concrete. The height of the fence will be within city regulations and not

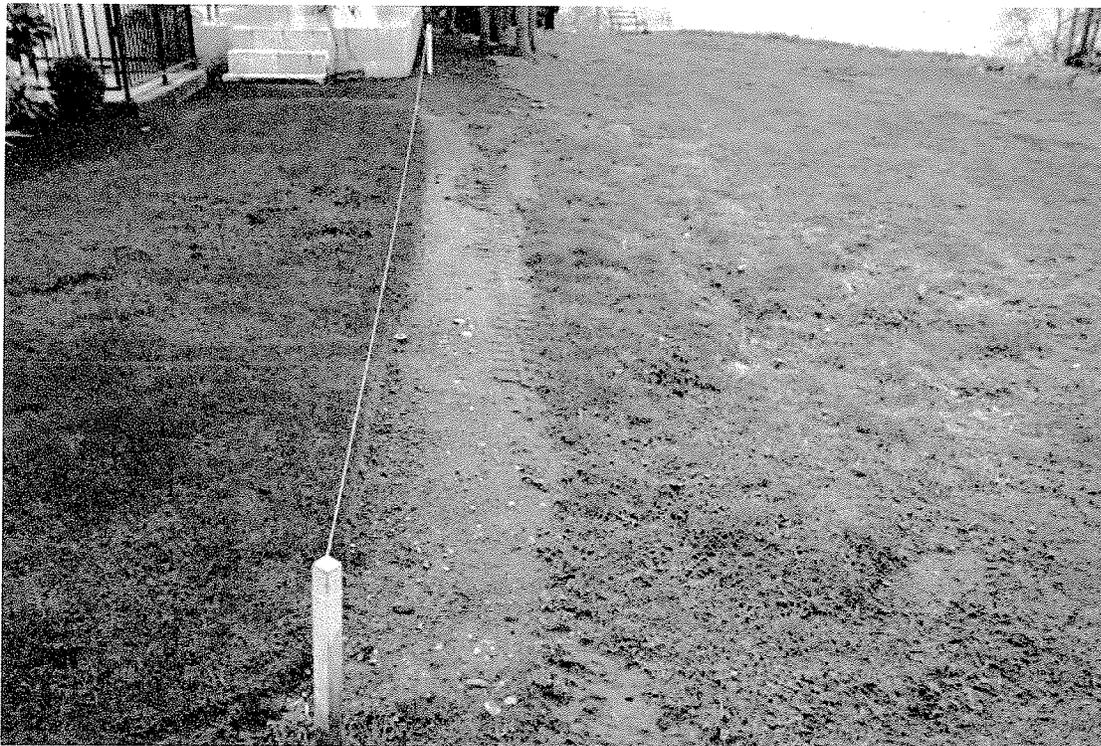
**Previously Disturbed Area (previously disturbed by neighbor or their landscaper/gardener).**

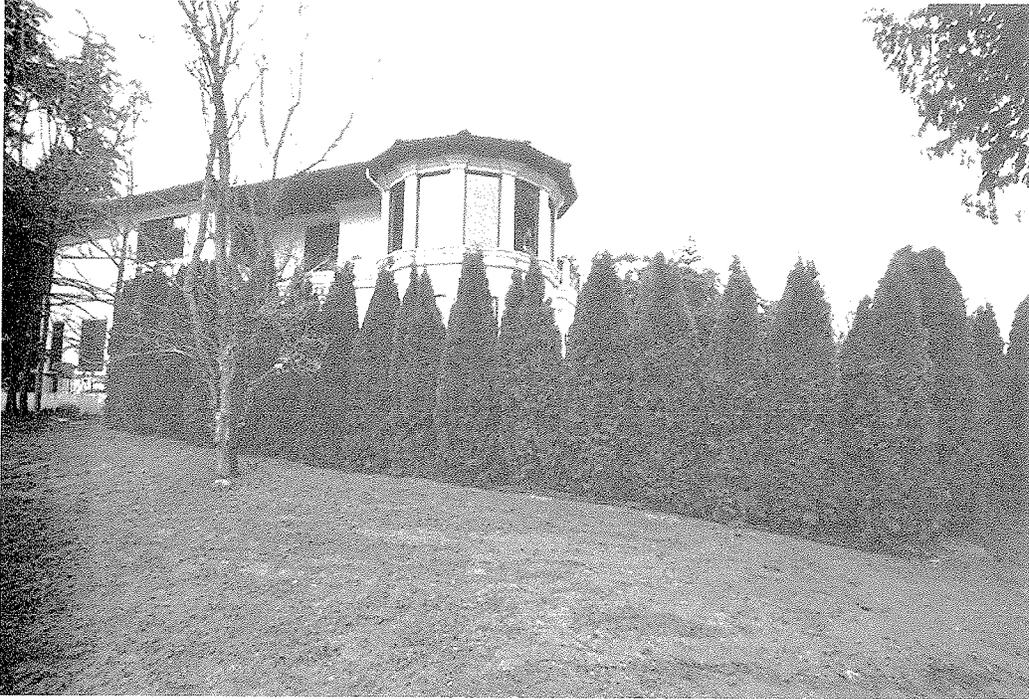
**Arborvitae plants to be removed and current lack of privacy and security with new 12,000 square foot house.**

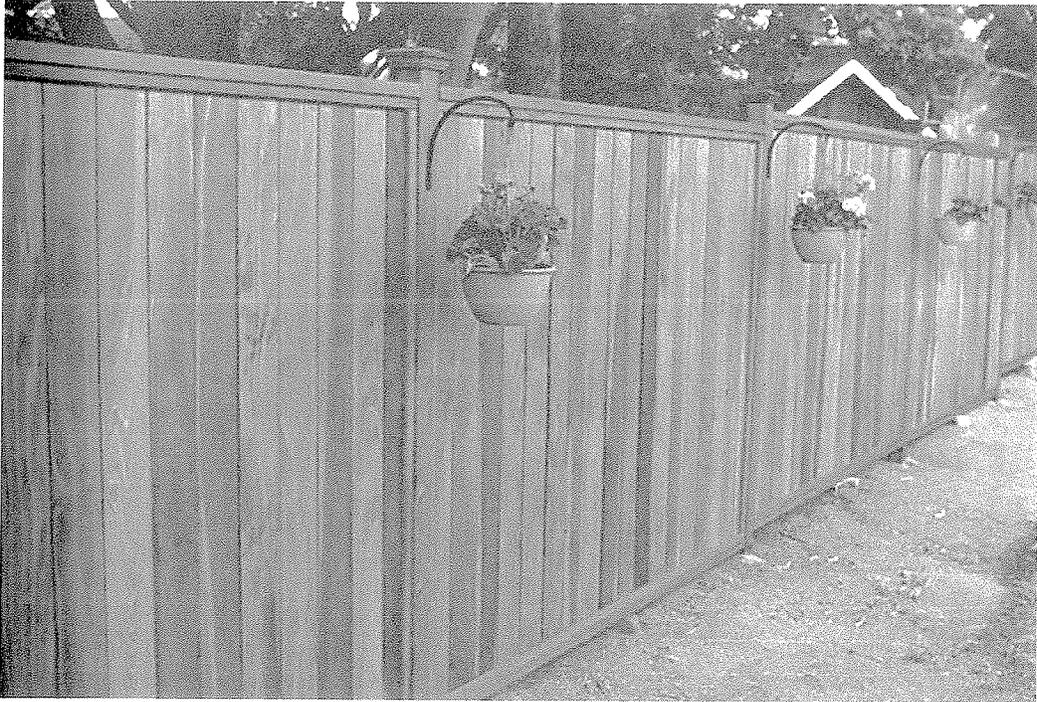
**Example of new cedar wood fence to be installed for privacy and security.**

As stated above, once the hedge is removed we will install a traditional wood fence as shown below. This fence will be supported by 4 inch by 6 inch wood posts and each post will be set in concrete. We will also re-seed any disturbed area with like kind grass. This way the ground and grass area will be restored as it did prior to planting the hedge.

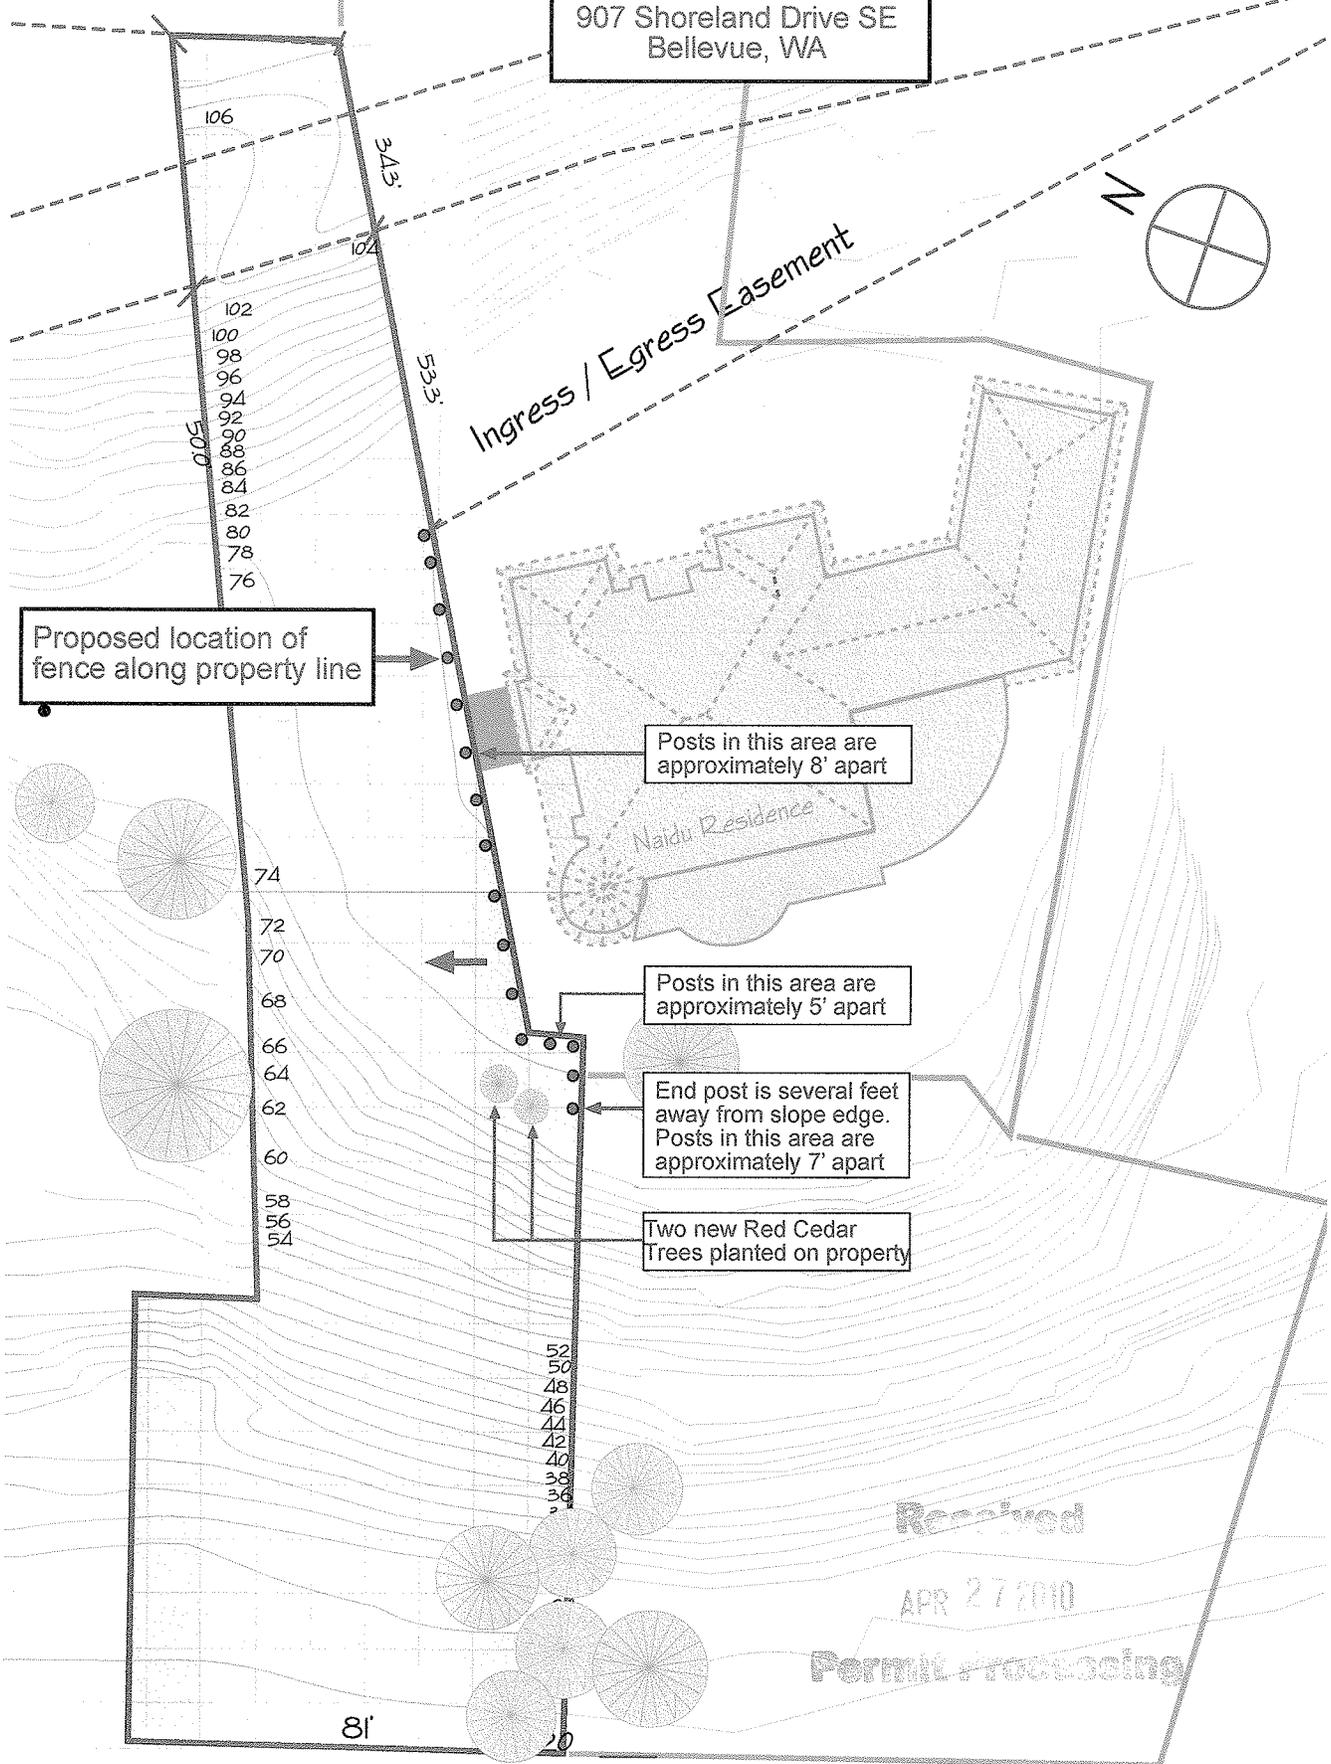
# Site Plan B / Site Sketch

Proposed location of fence along property line

Posts in this area are approximately 8' apart

Posts in this area are approximately 5' apart

End post is several feet away from slope edge. Posts in this area are approximately 7' apart

Two new Red Cedar Trees planted on property

A geotechnical study was conducted at a substantial cost to us to prove these posts will not impact the stability of the slope. In fact all posts will be placed on the level area of our property and not on the slope. They will not even extend as far as the current old fence post on the edge of the slope. A copy of this geotechnical study is provided in this package. The fence will be entirely on our property as we recently paid for a new survey. The surveyor had discovered our 2007 markers had been moved by a neighbor or landscaper adding as much as 2 feet to the neighbor's lot (near the back yard of the neighbor's house); the new survey has corrected this problem by placing new metal stakes in the ground and replacing the white stakes. The same surveyor was used in the 2007 survey and again in Spring 2010. A diagram of the fence location and two new Red Cedar trees has been provided in this package called Site Plan B/Site Sketch.

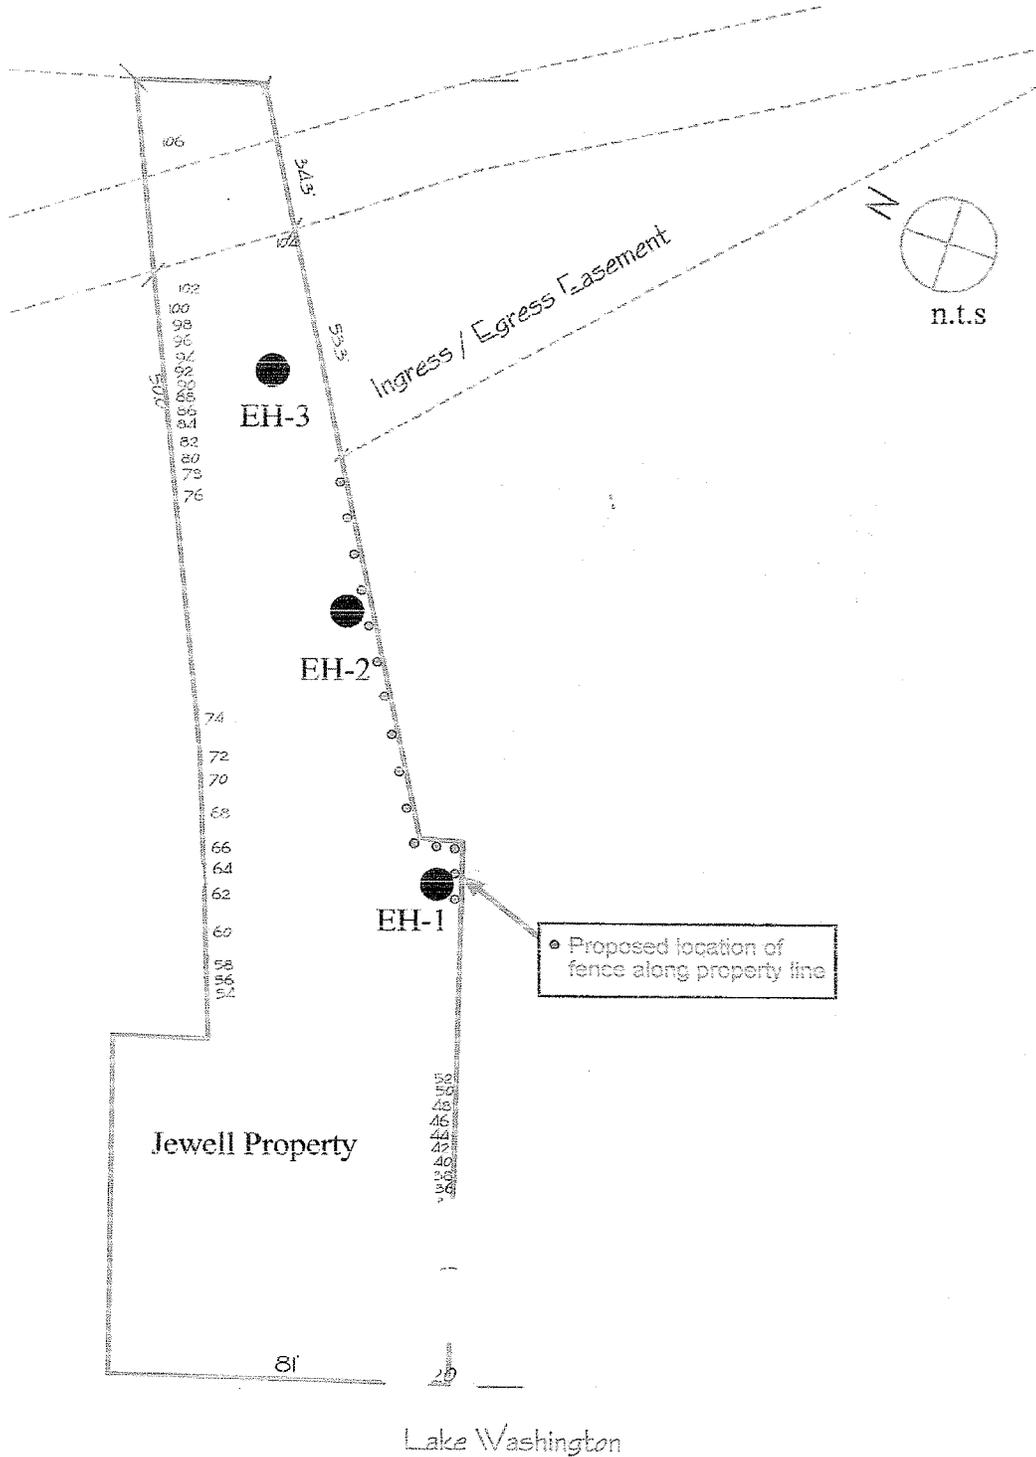
Figure 1

● Approximate location of exploration hole.

### Site and Exploration Plan

Three hand dug explorations were completed onsite as shown on Figure 1, Site and Exploration Plan. The exploration log of EH-1 is also attached to this letter. No logs were completed for EH-2 or EH-3 and these were only excavated to a depth of two feet and were completed to verify that the near surface sediments were consistent with the native sediments encountered in EH-1. The soils encountered in the explorations consisted of an approximate 12 inch layer of topsoil overlying medium dense to dense with increasing depth, damp, grey-brown, silty, fine to medium sand. The grain size distribution of the sediment was increasing with depth and by a depth of about 4 feet in EH-1 the sediment was primarily a fine to medium sand with trace silt and occasional gravel. The exploration EH-1 was completed to a depth of 6 feet below current ground surface while the other two holes were terminated at about 2 feet. This material has been interpreted as Vashon advance outwash deposited during the approach of the last ice sheet into the Puget Sound region approximately 12 to 15 thousand years ago. The outwash sand was subsequently over-run by several thousand feet of glacial ice resulting in a dense, glacially consolidated sediment.
