**Usui Vegetation Management
File Number: 10-129121-LO**

**City of Bellevue
Development Services Department
Land Use Staff Report**

Proposal Name: Usui Vegetation Management

Proposal Description: Land Use review of a Critical Areas Land Use Permit for restoration and vegetation management related to unpermitted tree removal in a steep slope critical area.

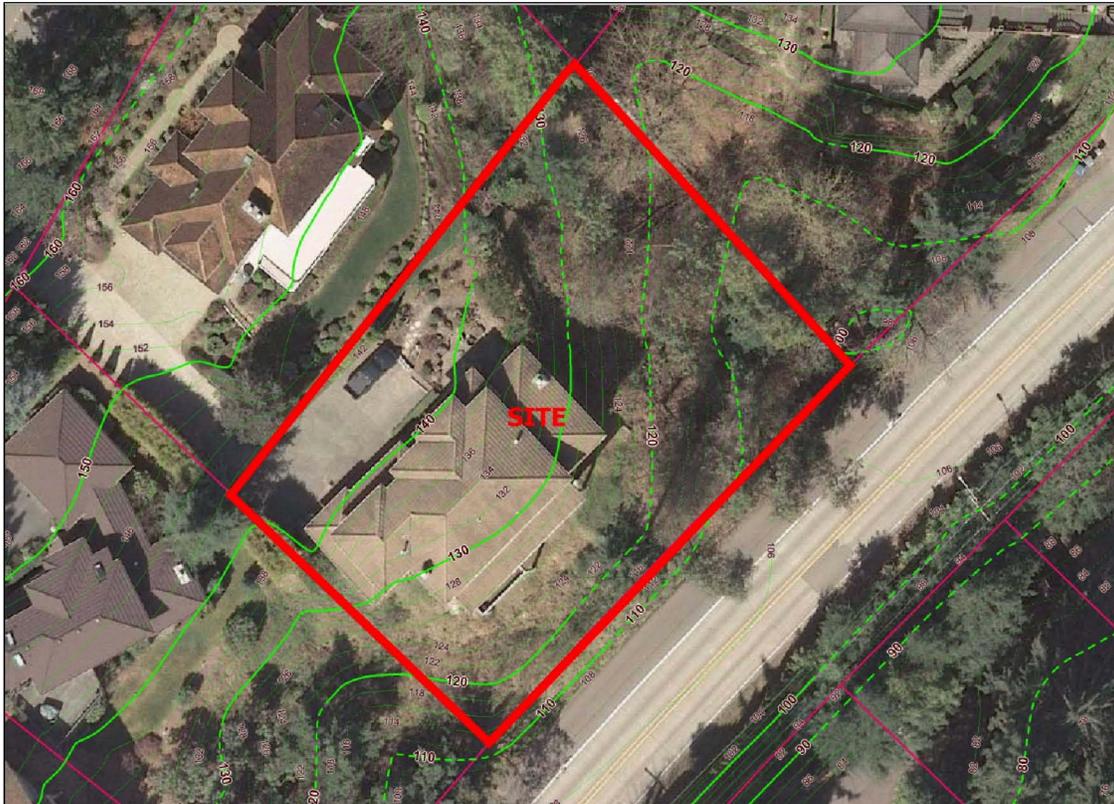
Figure 1

The project site is located at 336 Northup Way in the Northeast Bellevue Subarea of the City. The site is located in the NE quadrant of Section 36, Township 25 North, Range 5 East. The site has street frontage on West Lake Sammamish Parkway NE to the east, but due to steep slope obtains access from an easement connecting to Northup Way by crossing the adjacent resident property to the west. The property is adjacent to other residential property to the north, west, and south. The site has an existing single-family residence and improvements typically associated with a residence. The areas of steep slope on-site are located northeast and south of the house, sloping down to W Lake Sammamish Pkwy. NE. See figure 1 for existing site condition.

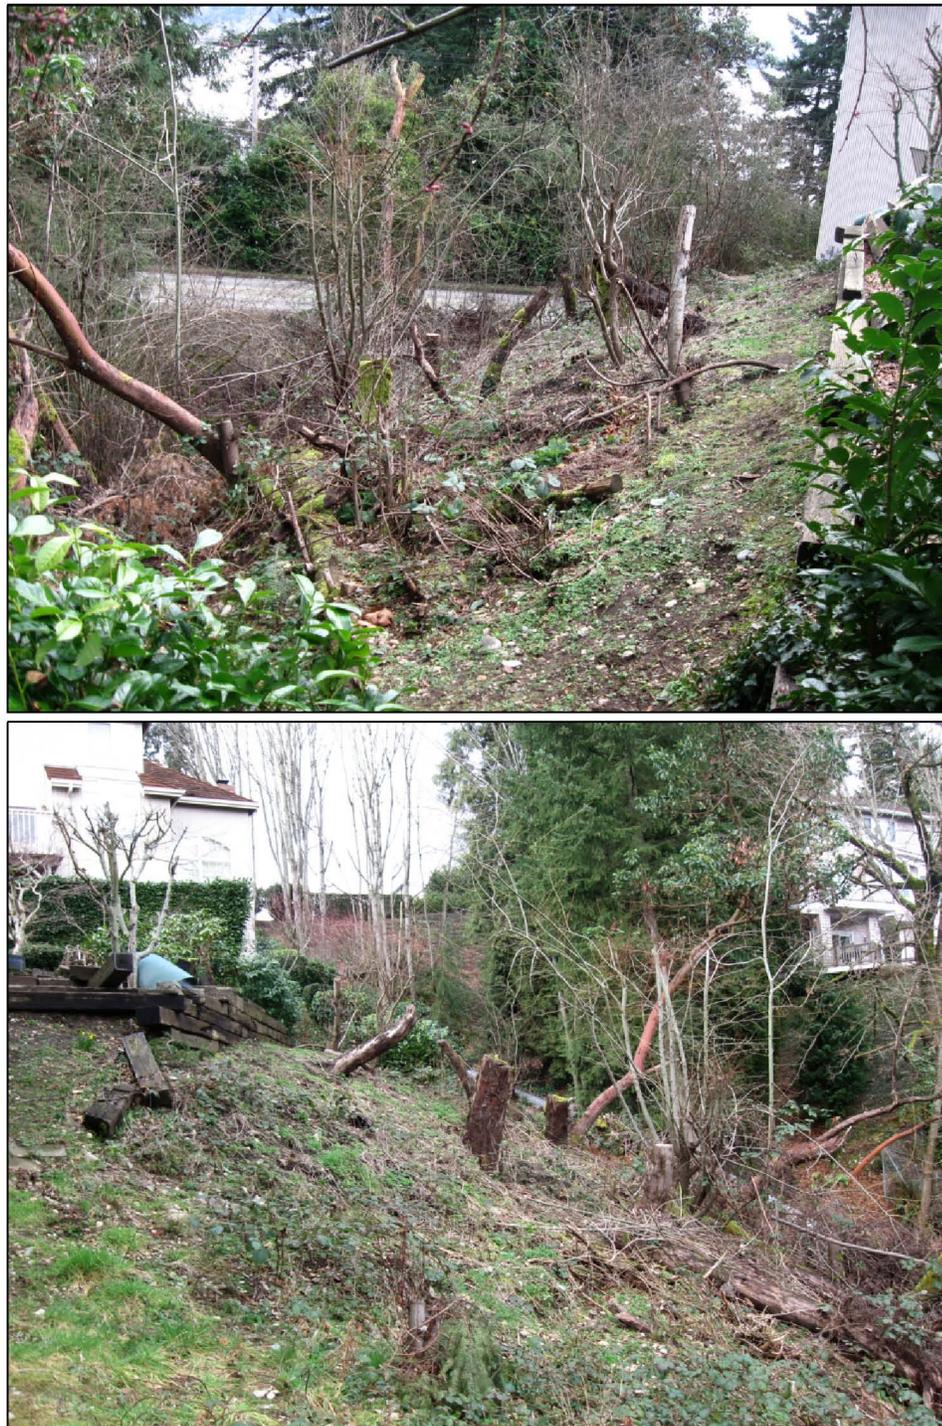
- 3. A discussion of the plan objectives;**
The objective of the vegetation management on this site is to replant the impacted area on the slope where trees were cut and to manage invasive species in the area. In addition, this plan establishes maintenance and monitoring of the proposed planting area over a three-year period, guaranteed by performance and maintenance sureties. Figure 3 below shows photos of the tree cutting areas. **See Attachment 2 for management plan.**

- 2. A site history;**
The 4 trees removed were an 8” dogwood, 2 12” pacific madrones and 1 10” red alder. The steep slope area and ravine along the northern property line has been the location of historic dumping of yard debris and has facilitated the spread of invasive species. **See Attachment 1 for the proposed planting plan which shows tree cutting locations.**

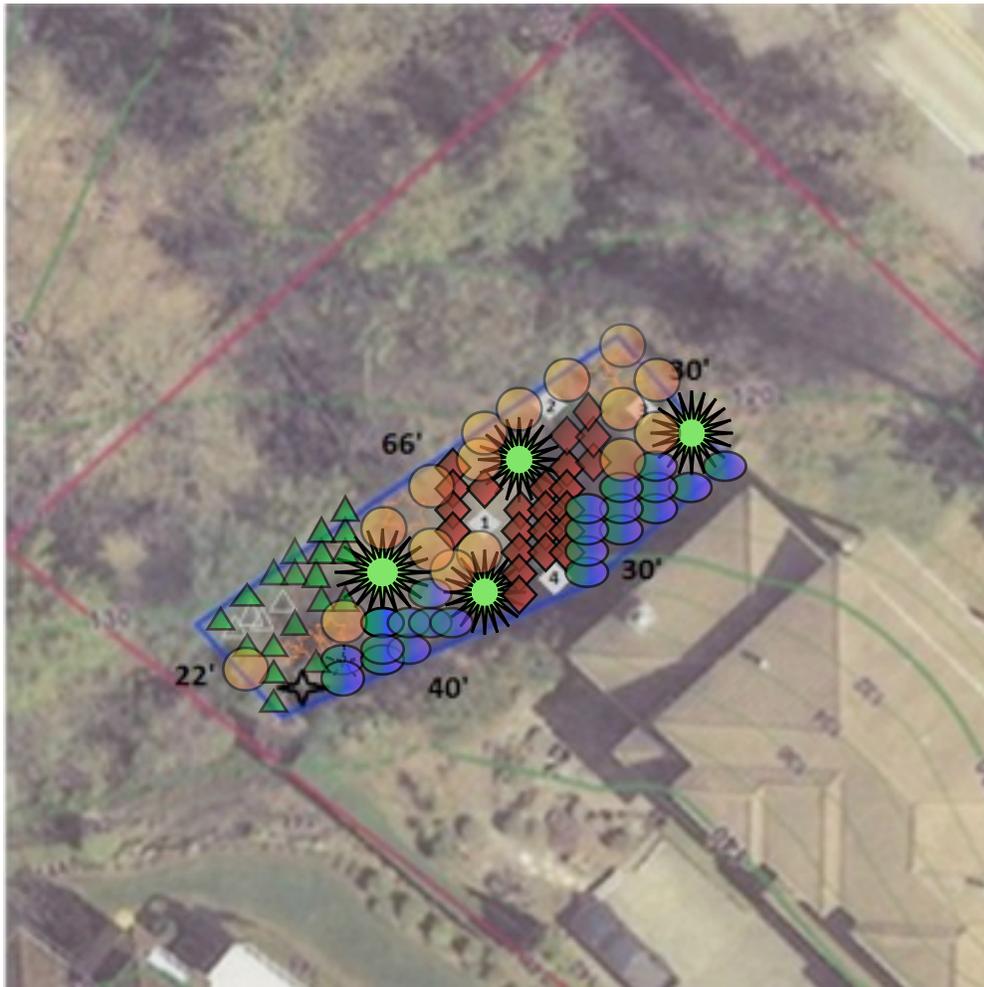
Planting Plan

Existing Plants:

Removed Tree:
8" Dogwood
-

Removed Tree:
10" Red Alder
-

Removed Tree:
12" Madrone
-

Removed Tree:
12" Madrone

For Installation:

The restoration area is 1500 ft² and is 70% covered with Bindweed, Himalayan Blackberry, English Ivy, and Creeping Buttercup which will need to be removed prior to installation of new material.

Species	Type	Quantity	Size
Vine Maple <i>Acer circinatum</i>	Tree	1	6'
Red Alder <i>Alnus rubra</i>	Tree	7	Multi-stem 4'-20'
Western Sword Fern <i>Polysticum munitum</i>	Shrub	6	2'

Species	Type	Quantity	Size	Spacing
Western Red Cedar <i>Thuja plicata</i>	Tree	4	2g	15'
Red Osier Dogwood <i>Cornus stolonifera</i>	Shrub	77	Live Stakes	3' O.C. (In Socks)
Tall Oregon Grape <i>Gaultheria shallon</i>	Shrub	46	1g	4' O.C.
Western Sword Fern <i>Polysticum munitum</i>	Shrub	46	1g	4' O.C.
Kinnickinnik <i>Arctostaphylos uva-ursi</i>	Ground Cover	200	4"	2' O.C.
