OPTIONAL DETERMINATION OF NON-SIGNIFICANCE (DNS) NOTICE MATERIALS

File No. 11-115142-LO
Project Name/Address: Century Link Slide Repair
158 W Lake Sammamish Parkway SE
Planner: Reilly Pittman
Phone Number: 425-452-4350

Global Slope Stability	
West Lake Sammamish Parkway Landslide Remediation Bellevue, Washington

QWEST Slide Repair at West Lake Sammamish Parkway S.E.

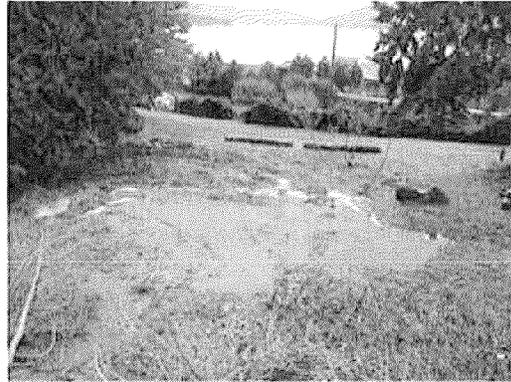
Landslide debris at the base of the slope.

We noted several points of groundwater seepage within the lower portion of the existing slope to the west of the landslide/erosion feature during our site visit to complete the geotechnical explorations. The daily precipitation totals for the week prior to our site visit to complete the explorations were generally low, ranging from no precipitation up to 0.14 inches with an average of 0.06 inches per day. Even with the relatively low precipitation totals, there were several seeps observed indicating that subsurface movement of water in the hillside may have been a factor in it becoming saturated.

The landslide occurred during or following a significant precipitation event in the Bellevue area that appears to have saturated the fill embankment and resulted in the observed failure. Based on the deltaic fan of material at the toe of the landslide feature, the slide mass was either saturated and essentially experienced a flow failure or there were also some erosional processes that occurred in conjunction with the slide that spread the material out. More likely than not, the slide feature resulted from a combination of sloughing of saturated fill material and erosion associated with surface or subsurface water flowing down the slope. The source of the water that saturated the fill soils likely was a combination of precipitation and surface water runoff as well as subsurface groundwater seepage.
