**City of Bellevue
Development Services Department
Land Use Staff Report**

Proposal Name: Petrescu Retaining Wall

Proposal Address: 16710 SE 34th Street

File Number: 13-111805-LO

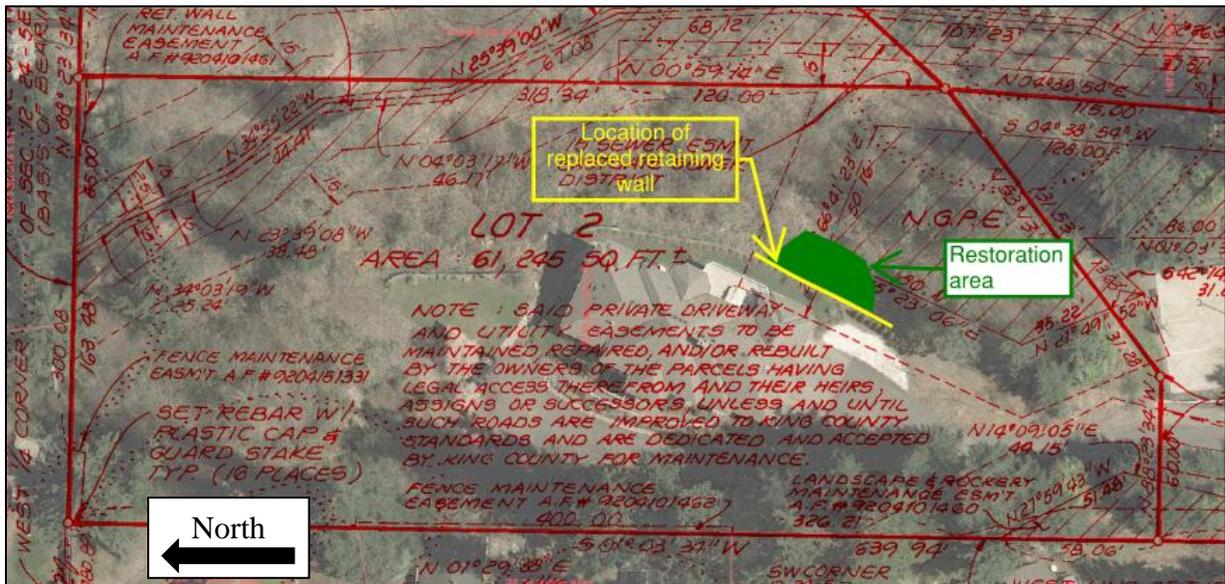
Figure 1: Short Plat Map Overlay with Project Area

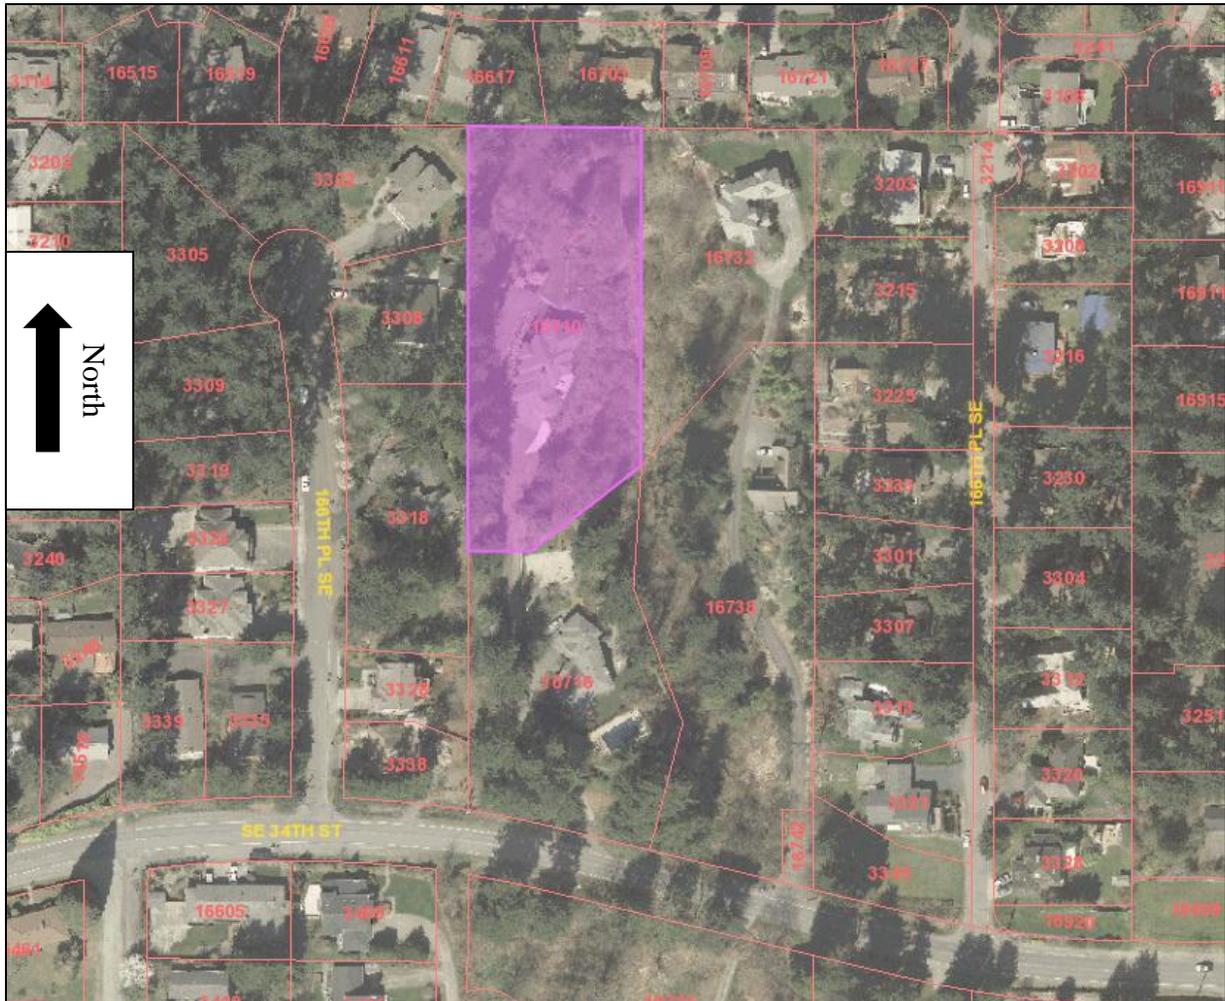
The property is 61,245 square feet and is developed with a single-family residential

structure in its approximate center. The property is nearly 164 feet wide (east-west) and 400 feet deep (north-south).

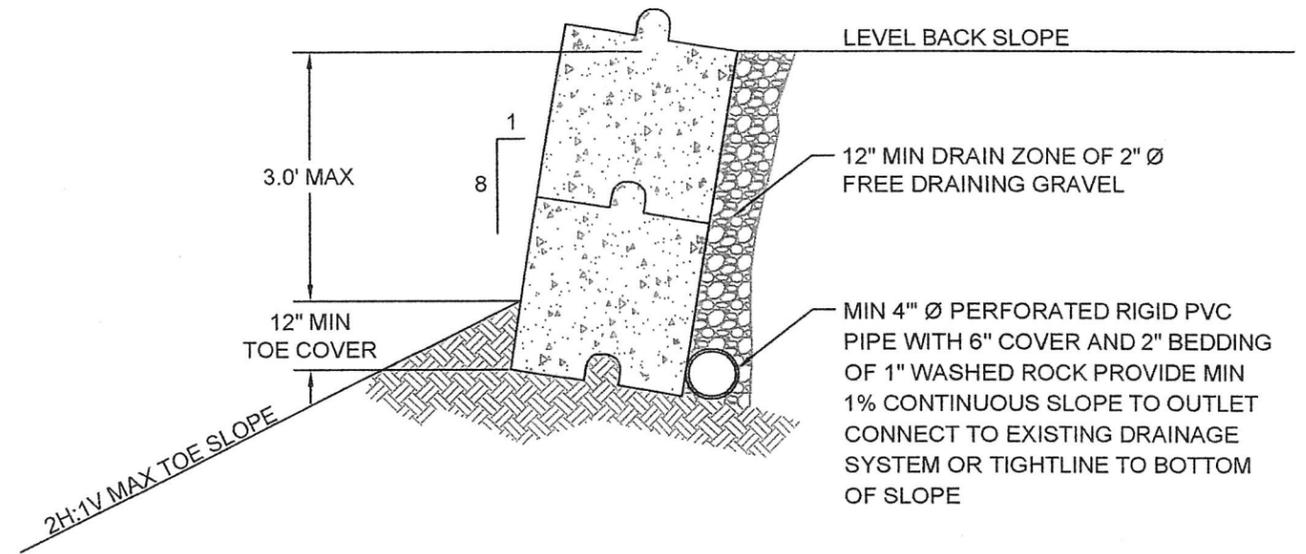
ECOLOGY BLOCK WALL DETAIL

- Figure 1 includes a recommended detail for the existing ecology block wall. A minimum 1-foot-wide blanket of 2-inch-diameter drain rock should be placed along the back face of the ecology block wall. A 4-inch-diameter, perforated drainpipe should be placed at the base of the drainage zone and routed by gravity to a suitable discharge. If not tied to the existing house drainage system, the wall drainage should be tightlined to the bottom of the existing slope east of the wall.
- We recommend that the affected portion of the slope below the ecology block wall be regraded to a maximum slope of 2H:1V, with the resulting ground surface compacted to a firm condition. Excess soil should be removed from the slope area. The distances shown on Figure 1 from the wall and recommended mitigation area to the residence should be considered approximate.

NOTE: OBSERVATION OF DRAINAGE INSTALLATION BY GEOTECHNICAL ENGINEER OR THEIR REPRESENTATIVE IS REQUIRED.

- i. A minimum 1-foot-wide blanket of 2-inch-diameter drain rock should be placed along the back face of the ecology block wall. A 4-inch-diameter, perforated drainpipe should be placed at the base of the drainage zone and routed by gravity to a suitable discharge. If not tied to the existing house drainage system, the wall drainage should be tight-lined to the bottom of the existing slope east of the wall.

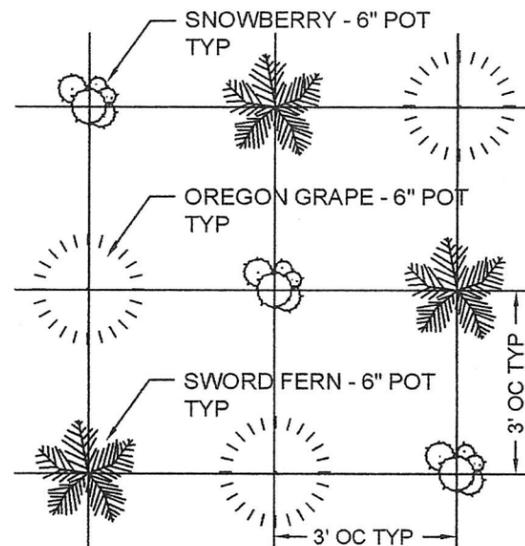
TESC NOTE:

BARK MULCH SHOULD PROVIDE SUITABLE EROSION AND SEDIMENTATION CONTROL. PLACE MULCH AT LOWEST PORTIONS OF REVEGETATION AREA IN SUCH A MANNER AS TO CREATE A PERIMETER BARRIER. AFTER LOWER REGION OF PERIMETER IS ESTABLISHED, REVEGETATE AND CONTINUE PERIMETER UPSLOPE. NO SILT FENCE IS NEEDED IF MULCH PERIMETER IS CORRECTLY ESTABLISHED.

- iv. Temporary erosion and sediment control (TESC) measures for the recommended mitigation area are also recommended. For most sites with active grading, the TESC measures include a perimeter silt fence. Since the "grading" at this particular site will be limited to regrading the upper portion of the slope and the placement of potted plants, we consider the trenching associated with silt fence installation to create a greater impact than the proposed re-planting activities. Instead, we recommend that the sequence of planting is arranged such that the plants planned for the lowest portions of the mitigation area are planted first. As these plants are placed, we recommend that bark mulch be spread in the low areas to provide a temporary erosion control perimeter for the re-planting area. Subsequent planting and mulching can then continue upslope through the mitigation/revegetation area.
