**City of Bellevue  
Development Services Department  
Land Use Staff Report**

Proposal Name: Bellevue Technology Center - PUD Amendment

File Number: **15-103369-LI**

KBS CAPITAL ADVISORS  
 BUILDING 'A' SITE IMPROVEMENTS FOR PARKING  
 2333 - 158th CT. NE, BELLEVUE, WA 98007  
**SITE PLAN**  
**BELLEVUE TECHNOLOGY CENTER**  
 APPLICATION #XX-XXXXXX XX  
 GRID L-5, SEC. 26, TWP. 25N, RGE. 5E, W.M.

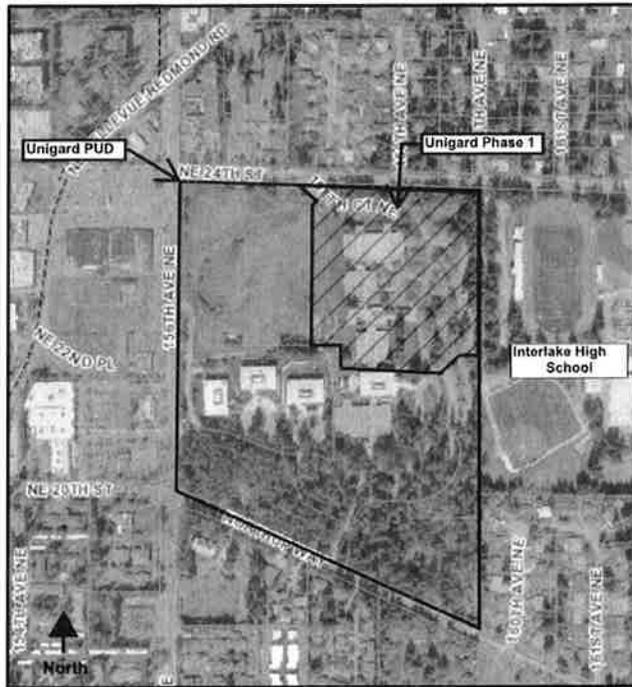
Figure 4 – Unigard PUD Aerial Photograph

The project site is located in the Crossroads Subarea, District B, of northeast Bellevue. The subject landscape area is located adjacent to Building "A" within Phase 1 of the 46-acre Unigard PUD. Phase I is approximately 12 acres in size. Primary access to Phase 1 is via NE 24<sup>th</sup> Street to the north, although there are two other access points into the PUD: one to the west off 156<sup>th</sup> Avenue NE and one to the south, off Northup Way. There are no Critical Areas on the site, as defined by LUC 20.25H.

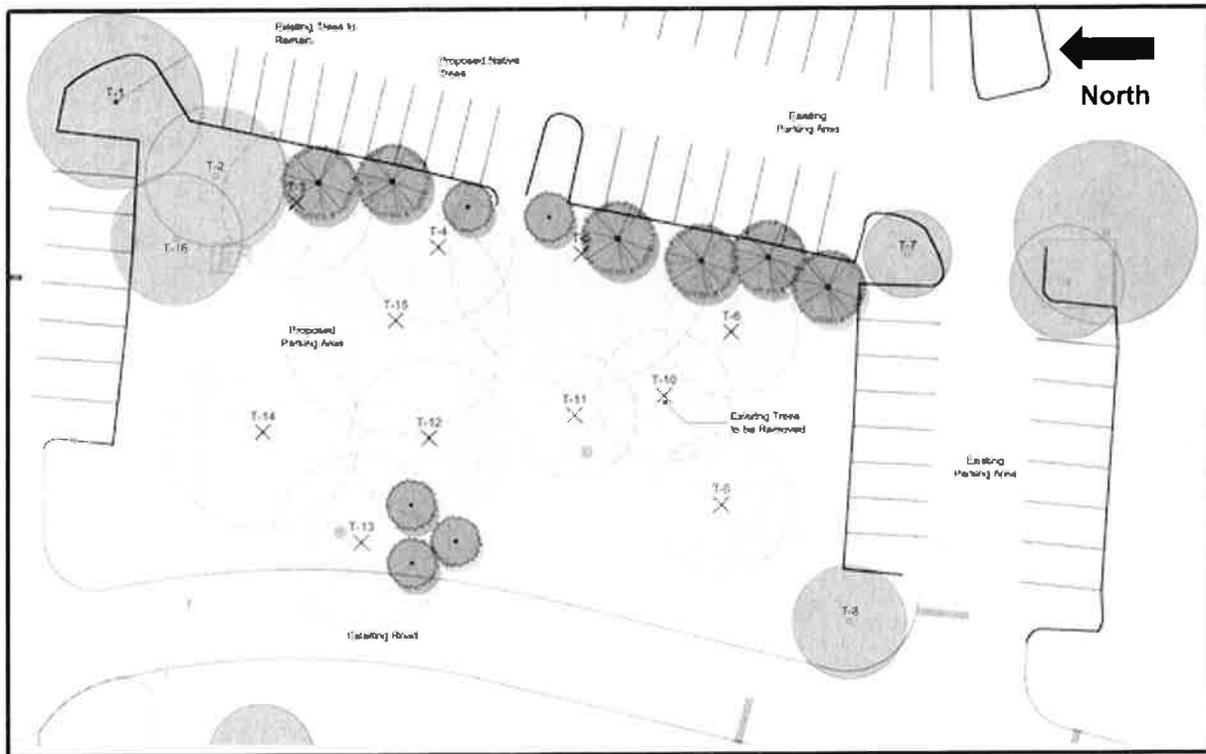
Figure 8 – Tree Removal Plan

The eleven (11) trees to be removed equate to 188.3 diameter inches, which is a 69% reduction in significant diameter inches from this small landscaped area. However, in comparison with the overall PUD campus which is heavily planted with a variety of tree species, including evergreen and deciduous trees, the area impacted by this proposal is considered minor.

It should be noted that the arborist for the project raised a concern regarding the likelihood of survival of tree T-16, due to the proximity of the proposed adjacent catch basin. Staff advised the applicant to modify the location of the catch basin in order to further protect the viability of tree T-16 to help ensure its survival during and after construction. This change is now reflected on Sheet C2 of the civil set of drawings, attached to this staff report.

As previously stated, the arborist report prepared by Gilles Consulting indicated a concern regarding the likelihood of survival of tree T-16, located in the north east corner of the subject area. With the proposed catch basin located adjacent to and within the tree drip line, the likelihood of survival is minimal. Therefore, Staff advised the applicant to slightly shift the location of the catch basin in order to save the tree. It should also be noted that tree protection measures will need to be in place during construction to ensure the survival of the remaining trees to be retained. **Refer to Section XI.B for Condition of Approval regarding Tree Protection.**

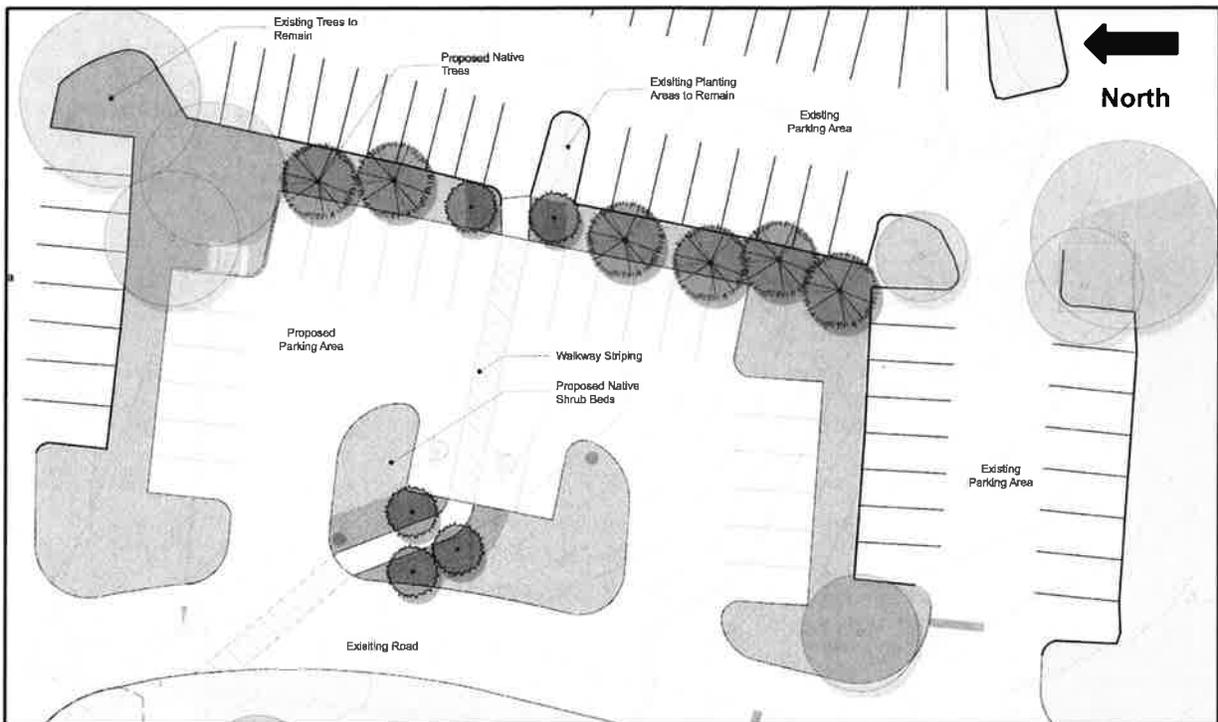
**Figure 9 – Tree Mitigation and Landscape Planting Plan**

In order to augment the tree loss, the applicant proposes a one-to-one replacement ratio which requires eleven (11) replacement trees at a minimum of 8-10 feet in height at installation. The replacement tree species proposed are Douglas Fir and Western Hemlock, which are native to the region and can also be found successfully growing elsewhere within the PUD campus. A significant number of Salal and Western Sword Ferns would also be planted within the revised landscape planters surrounding the parking area. Refer to Figure 9, below.

The Norway maple trees proposed for removal were likely installed during the construction of Phase 1 of the Unigard PUD. Historical plan sets from Phase 1 indicate Norway maple trees to be planted within the subject landscape area. However, there do not appear to be any specific conditions of approval from the original PUD that required these Norway maple trees to be preserved. The original PUD approval placed a heavy influence on preservation of both the meadow feature and the dense southern tree line, but not interior landscaping which was and continues to be more ornamental (non-native) in nature.

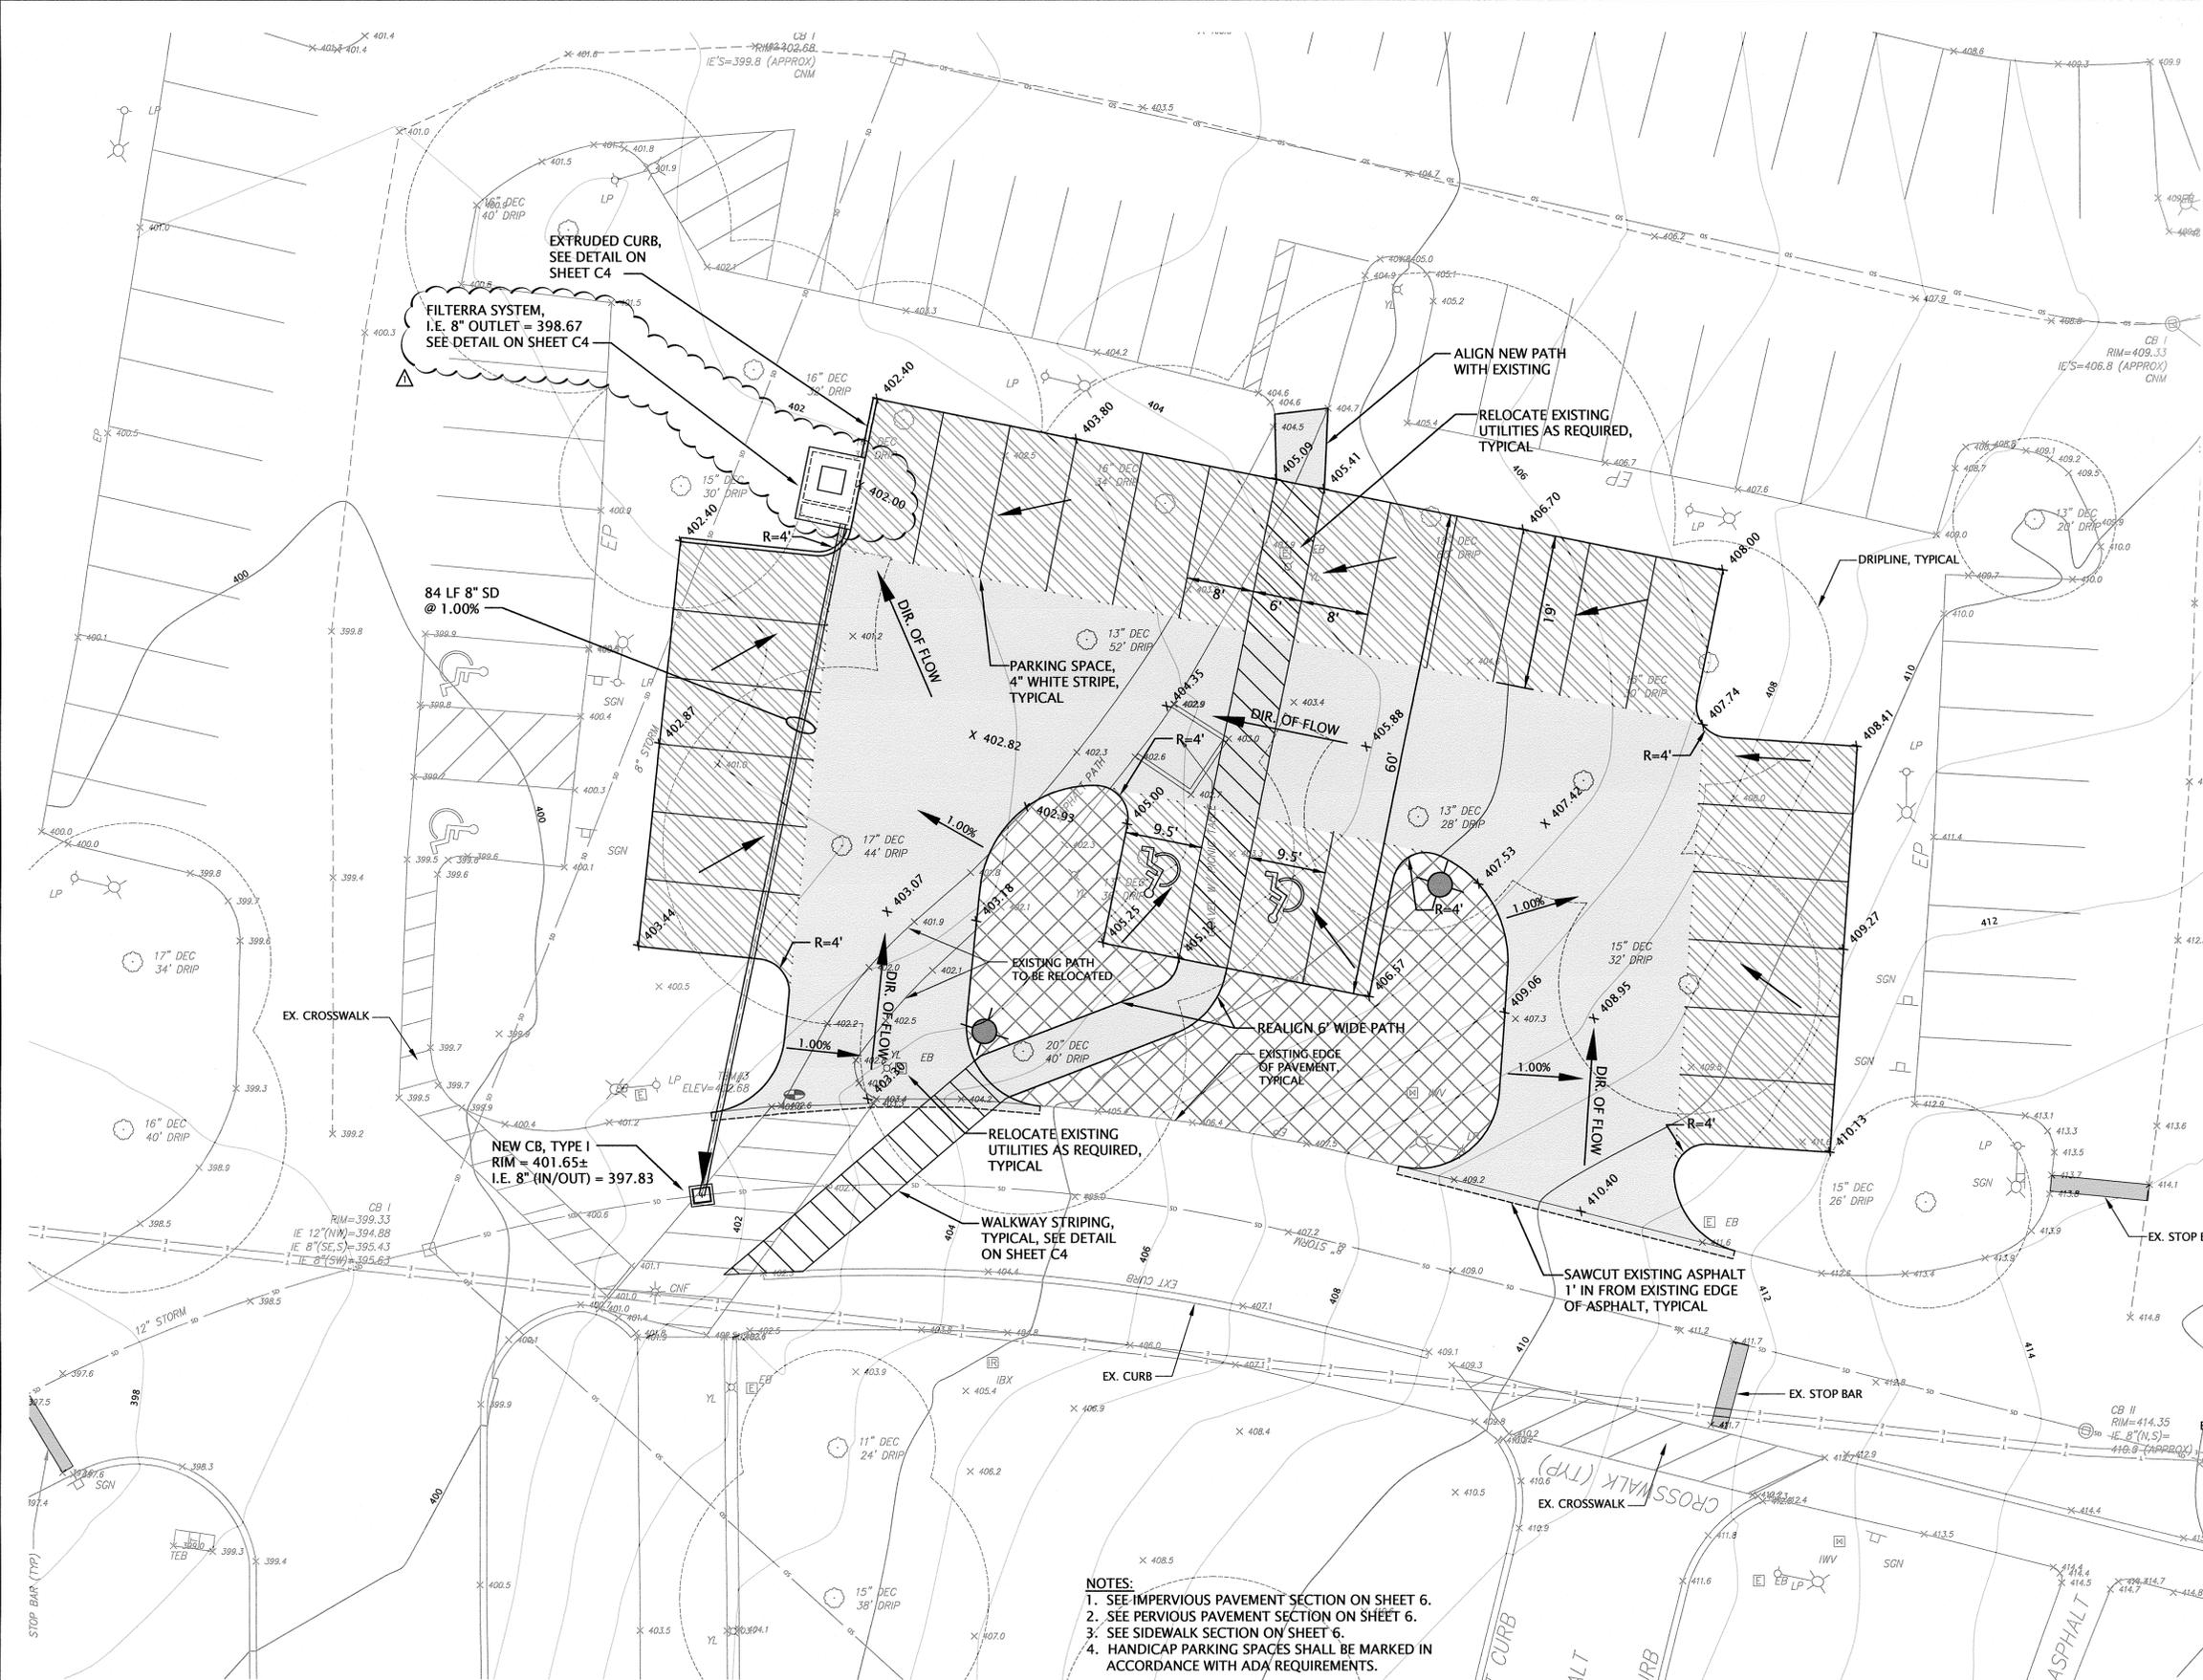
IMPERVIOUS PAVEMENT = 4,753 SF
	PERVIOUS PAVEMENT = 4,556 SF

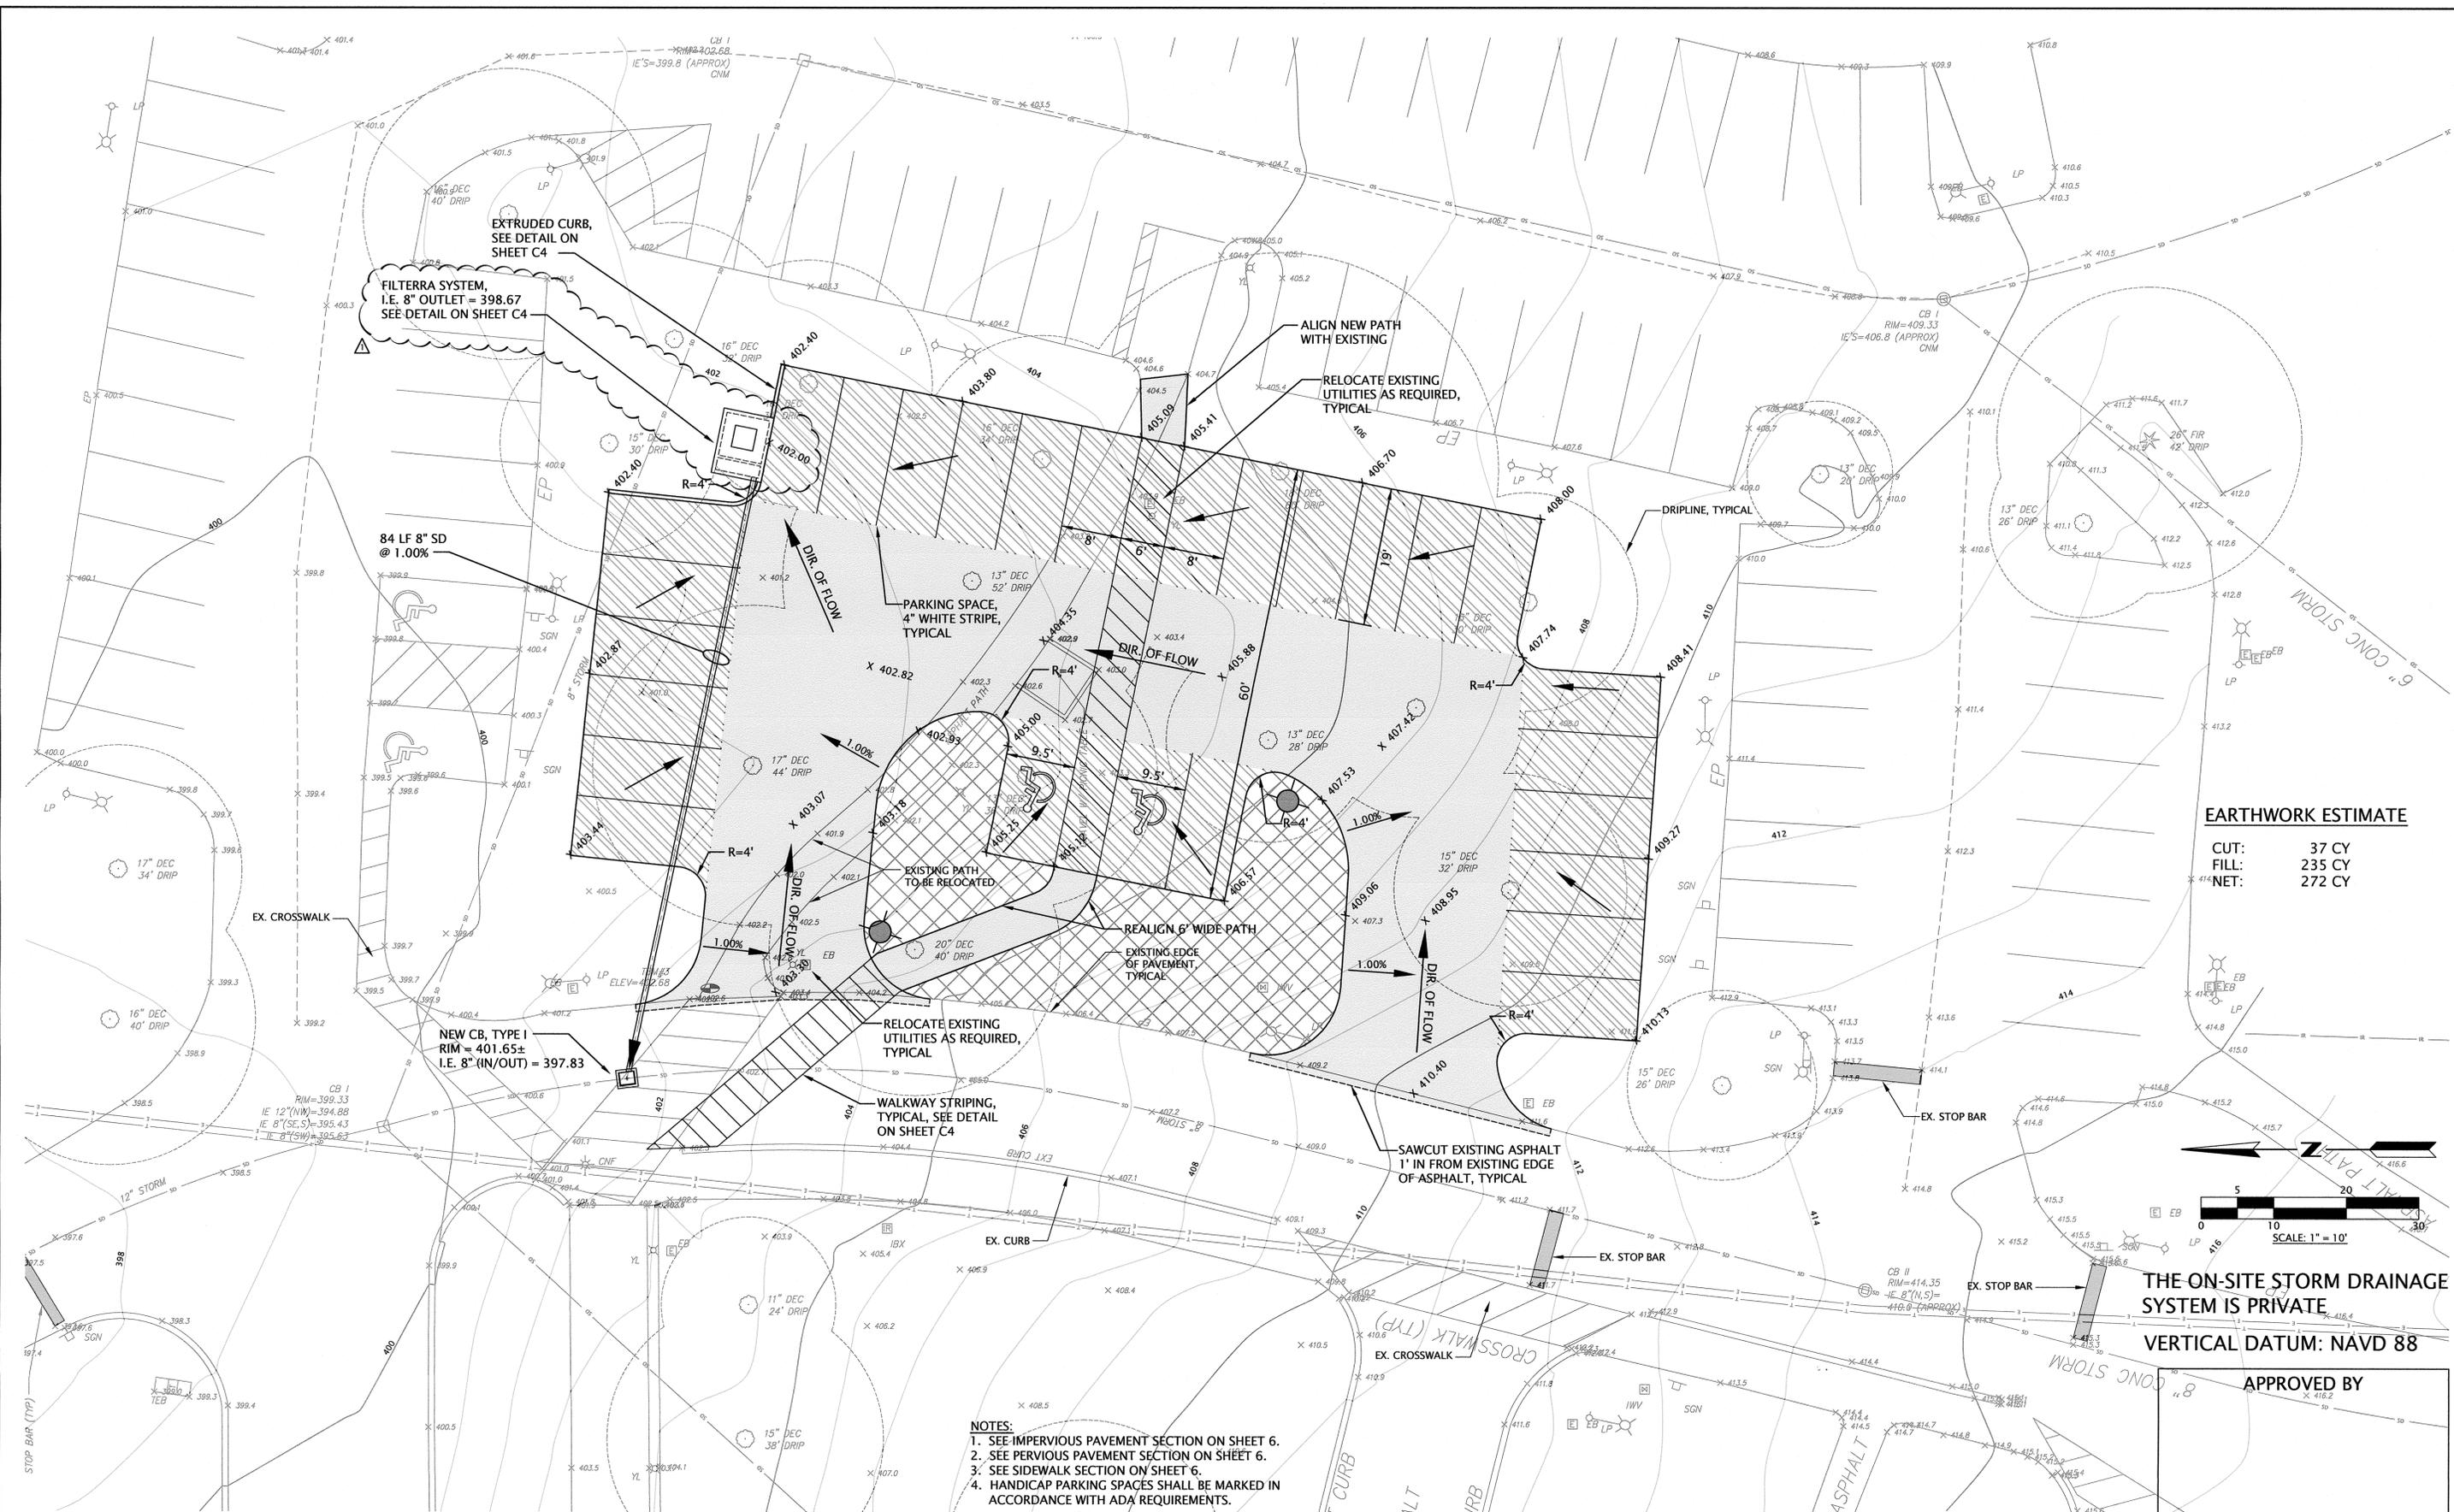
KBS CAPITAL ADVISORS  
BUILDING 'A' SITE IMPROVEMENTS FOR PARKING  
2333 - 158th CT. NE, BELLEVUE, WA 98007  
PRELIMINARY DRAINAGE AND GRADING PLAN  
BELLEVUE TECHNOLOGY CENTER  
APPLICATION #XX-XXXXXX XX  
GRID L-5, SEC. 26, TWP. 25N, RGE. 5E, W.M.

CUT:	37 CY
FILL:	235 CY
NET:	272 CY

During review of the proposal, Staff recommended that the proposed catch basin in the north east corner of the parking area be shifted outside of the required drip line of tree T-16. This will help to ensure the survival of tree T-16 during and after construction.

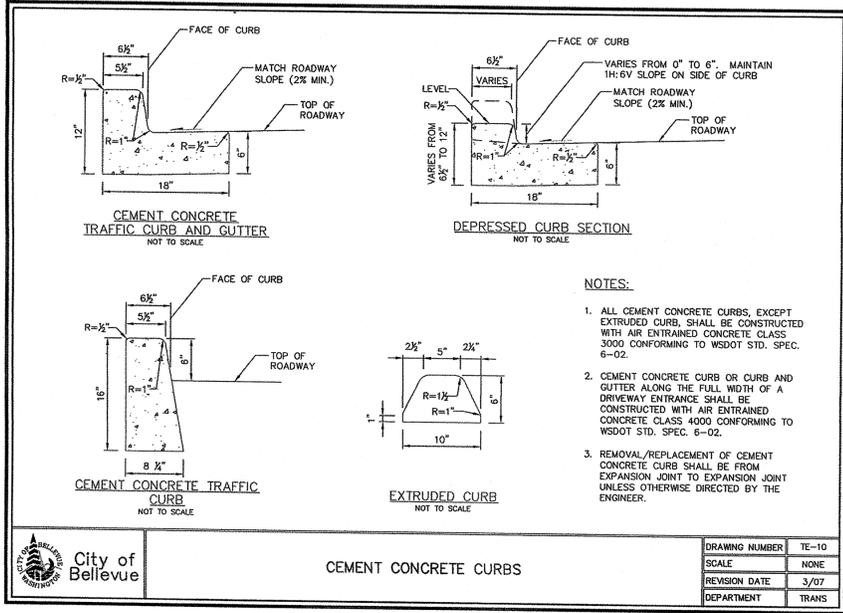
**WATER QUALITY TREATMENT BMP**

- TREATMENT LEVEL = ENHANCED
- WATER QUALITY DESIGN FLOW = 0.045 CFS
- DESIGN TREATMENT AREA = 12,200 SF
- PROPOSED TREATMENT AREA = 9969 SF (INCLUDES PERVIOUS PAVEMENT)

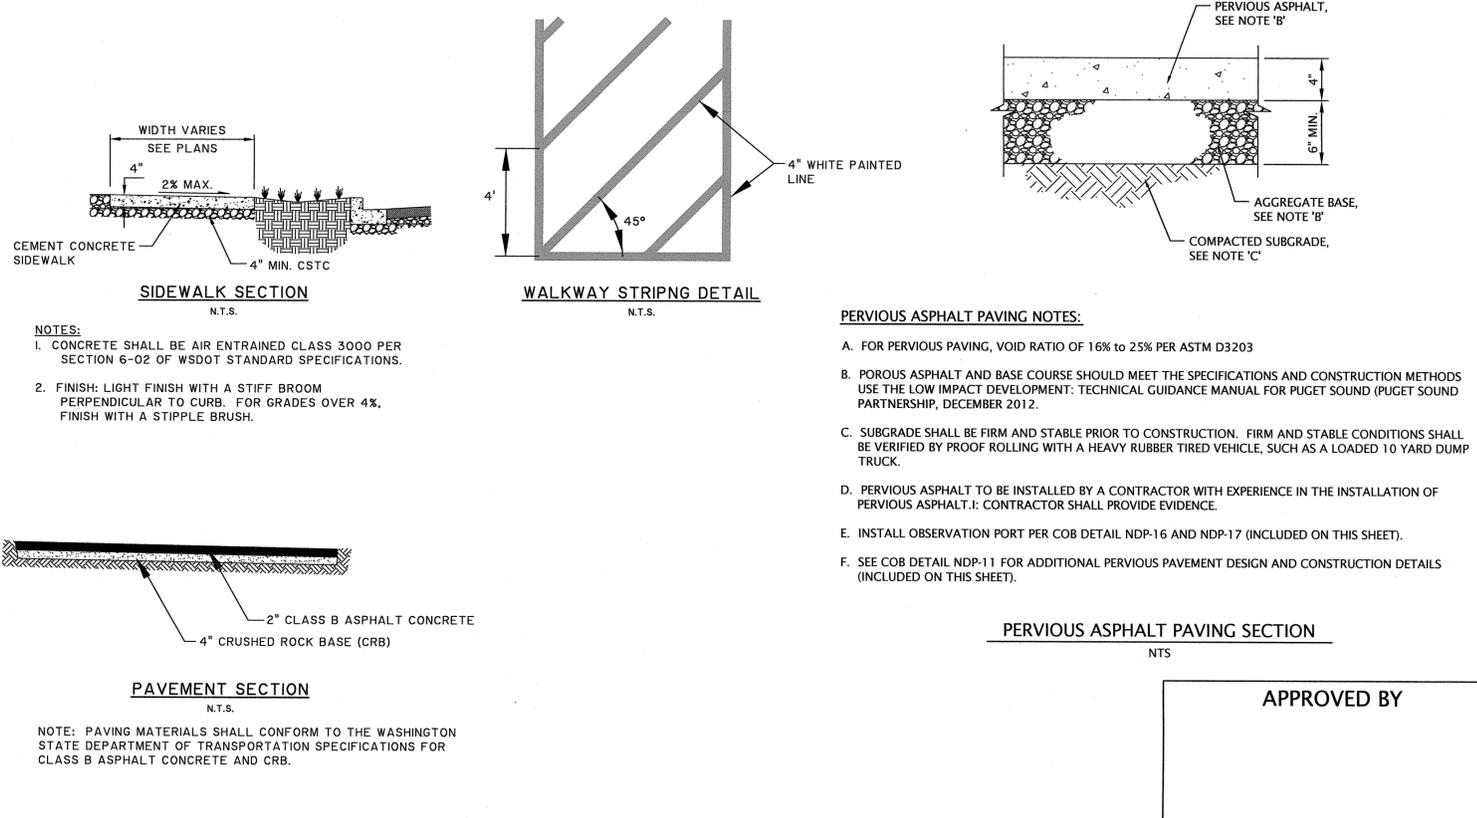
**PAVEMENT SECTION**  
N.T.S.

NOTE: PAVING MATERIALS SHALL CONFORM TO THE WASHINGTON STATE DEPARTMENT OF TRANSPORTATION SPECIFICATIONS FOR CLASS B ASPHALT CONCRETE AND CRB.

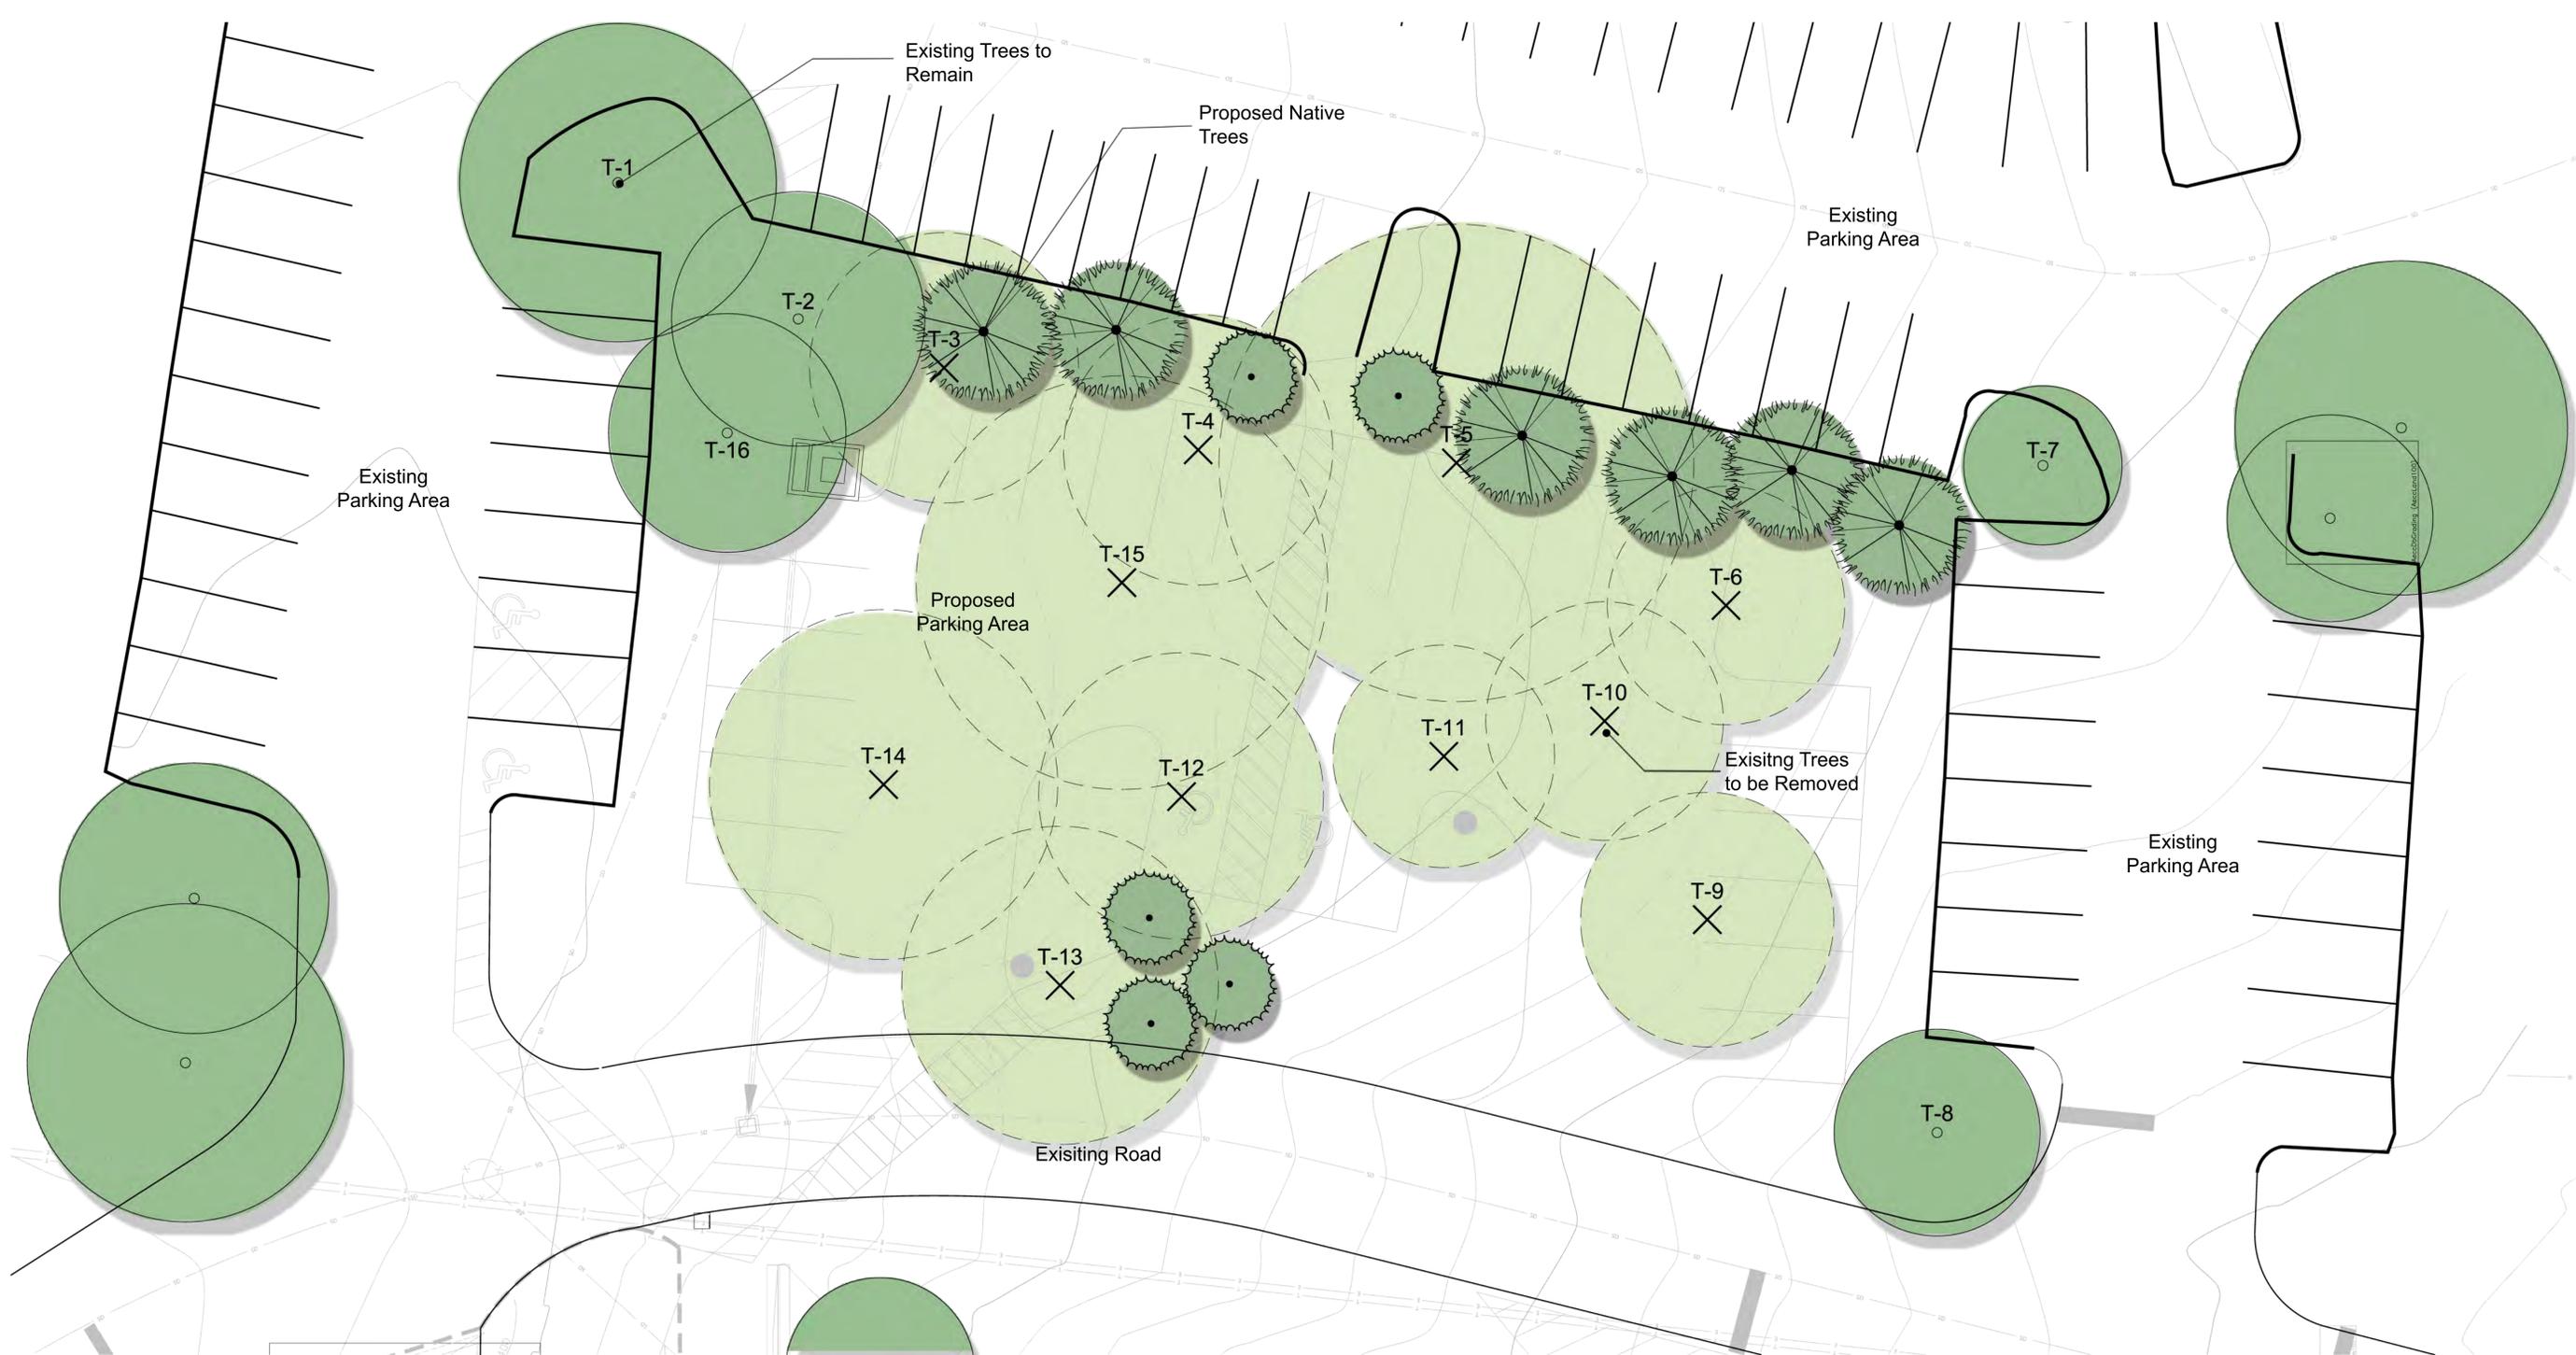
1 TREE INVENTORY PLAN

TREE	SPECIES	DIAMETER	TREES WITHIN SITE INTERIOR	TREES TO BE REMOVED
T-1	ACER PLAT.	18.7"	18.7"	
T-2	ACER PLAT.	16.4"	16.4"	
T-3	ACER PLAT.	16.0"	16.0"	16.0"
T-4	ACER PLAT.	16.5"	16.5"	16.5"
T-5	ACER PLAT.	21.3"	21.3"	21.3"
T-6	ACER PLAT.	16.1"	16.1"	16.1"
T-7	ACER PLAT.	13.7"	13.7"	
T-8	ACER PLAT.	15.7"	15.7"	
T-9	ACER PLAT.	16.5"	16.5"	16.5"
T-10	ACER PLAT.	16.3"	16.3"	16.3"
T-11	ACER PLAT.	14.5"	14.5"	14.5"

TREE	SPECIES	DIAMETER	TREES WITHIN SITE INTERIOR	TREES TO BE REMOVED
T-12	ACER PLAT.	14.8"	14.8"	14.8"
T-13	ACER PLAT.	21.7"	21.7"	21.7"
T-14	ACER PLAT.	21.2"	21.2"	21.2"
T-15	ACER PLAT.	13.4"	13.4"	13.4"
T-16	ACER PLAT.	17.0"	17.0"	
TOTAL		269.8"	269.8"	188.3"
SITE INTERIOR TREE RETENTION REQUIREMENT, 15% OF DIAMETER INCHES 269.8 x 15% = 40.47"				
TOTAL SIGNIFICANT TREES RETAINED: 81.5" OR 30%				
TOTAL SIGNIFICANT TREES ON SITE: 269.8"

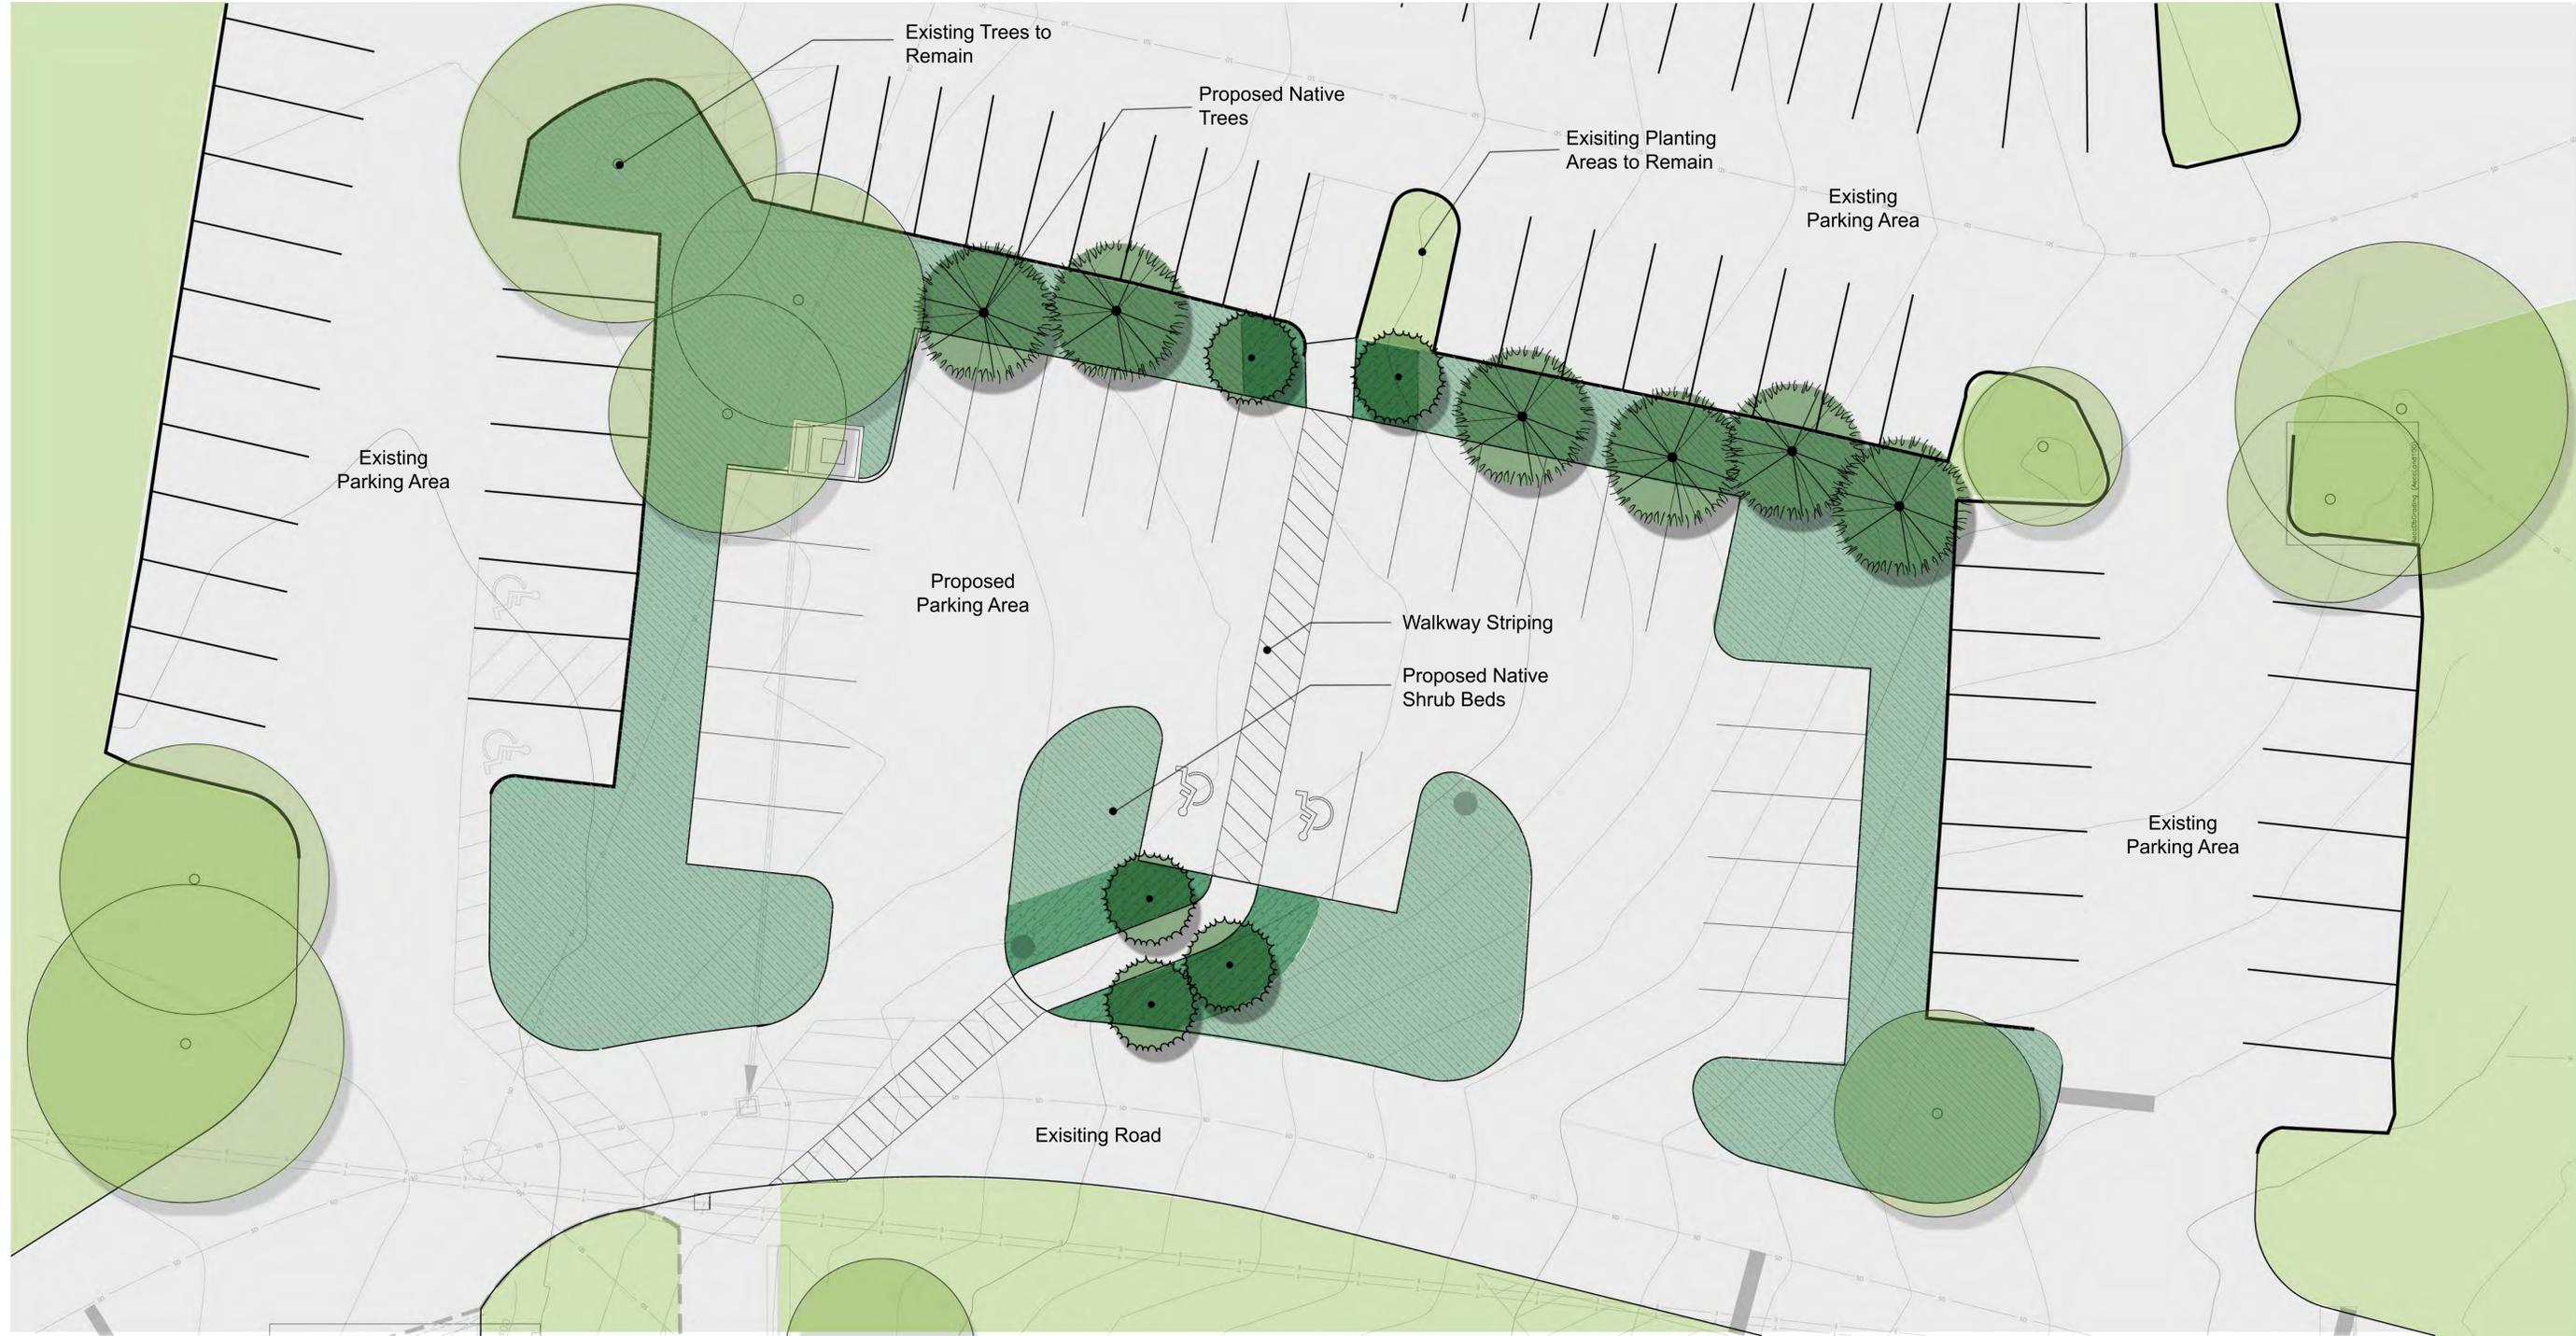
1 PLANTING PLAN

PM2	Polystichum munitum / Western Sword Fern	1 gal		24" o.c.	156

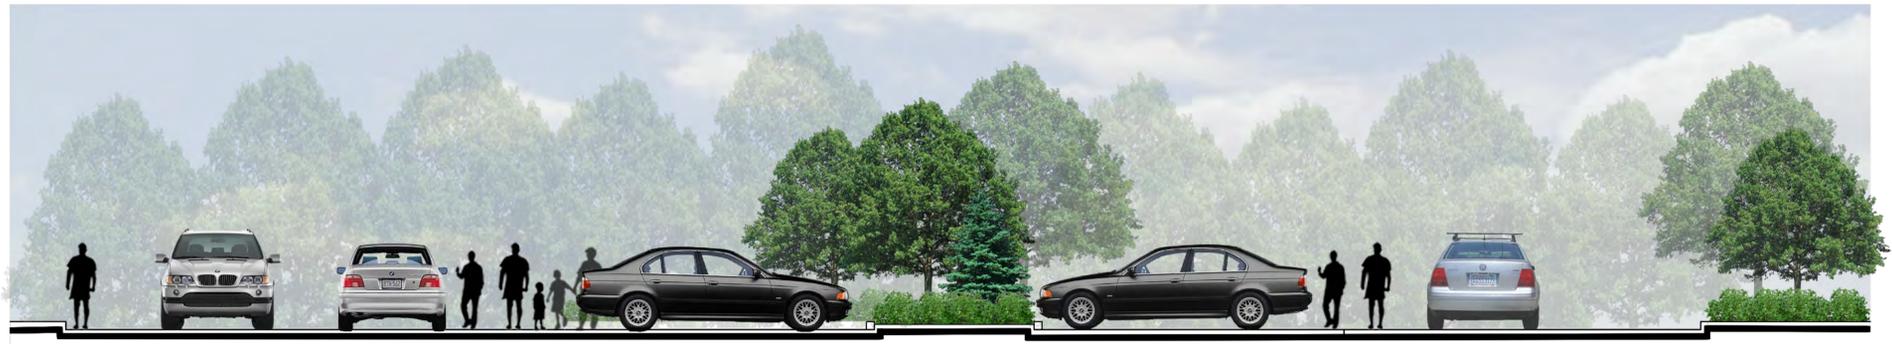
1 SECTION A

Scale: 3/16"=1'-0"

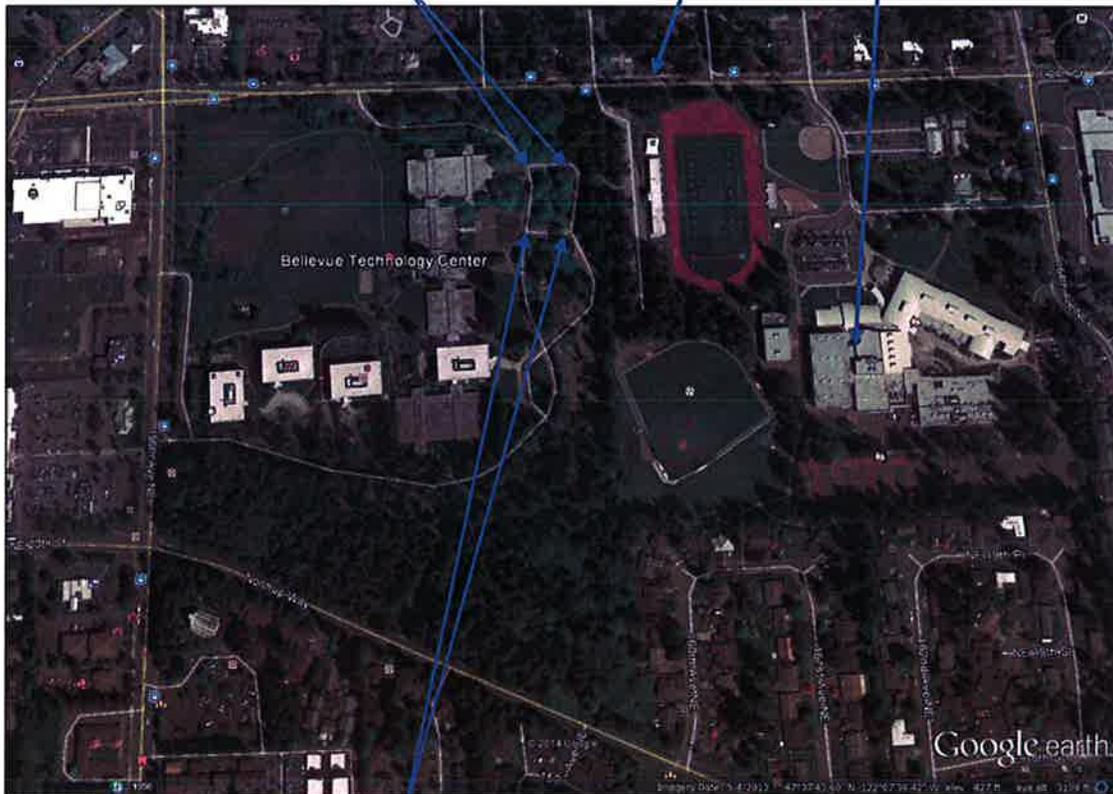
Photo # 1: A 5/4/13 Google Earth image of the Bellevue Technical Center.

The proposed parking expansion is in this area of trees and lawn.

The area has a gentle slope from the southwest corner down to the northeast corner. It is completely covered with lawn and the 16 trees.

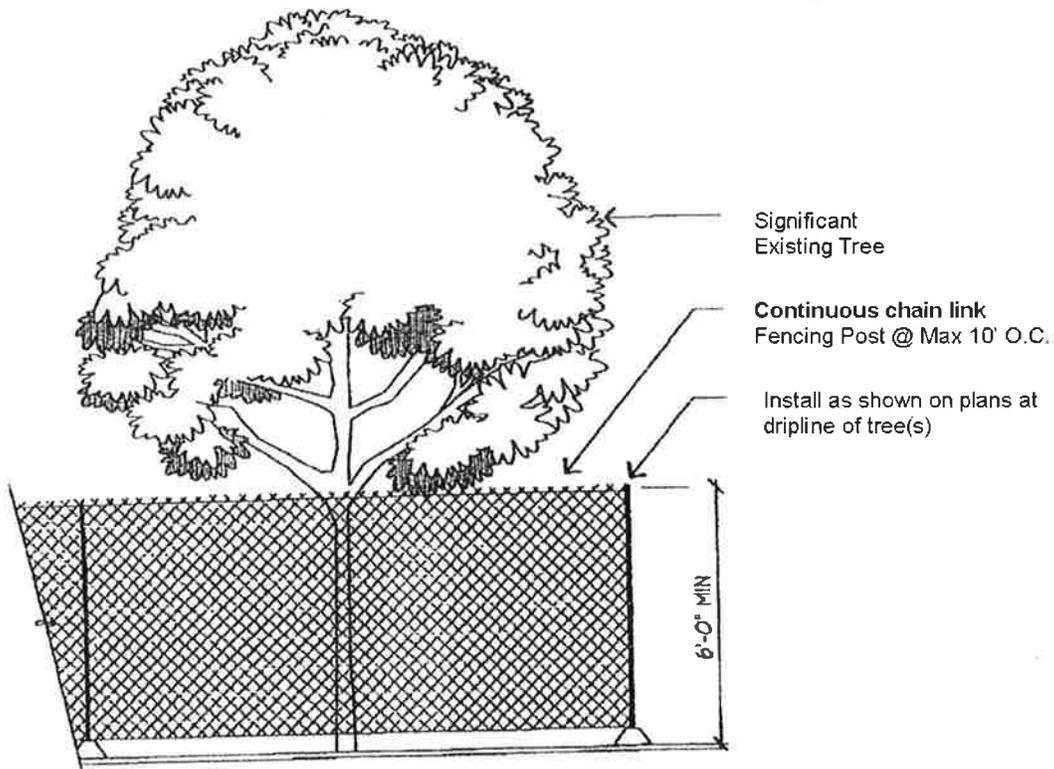
Six-foot high temporary chain link fence shall be placed as shown on plans. Fence shall completely encircle tree(s). Install fence posts using pier blocks only. Avoid driving posts or stakes into major roots.

Make a clean straight cut to remove damaged portion of root for all roots over 1" in diameter damaged during construction. **All** exposed roots shall be temporarily covered with damp burlap and covered with soils the same day, if possible, to prevent drying. If not possible, burlap must be kept moist at all times.
