**City of Bellevue  
Development Services Department  
Land Use Staff Report**

Proposal Name: Bellevue Technology Center - PUD Amendment

File Number: **15-103369-LI**

KBS CAPITAL ADVISORS  
 BUILDING 'A' SITE IMPROVEMENTS FOR PARKING  
 2333 - 158th CT. NE, BELLEVUE, WA 98007  
**SITE PLAN**  
**BELLEVUE TECHNOLOGY CENTER**  
 APPLICATION #XX-XXXXXX XX  
 GRID L-5, SEC. 26, TWP. 25N, RGE. 5E, W.M.

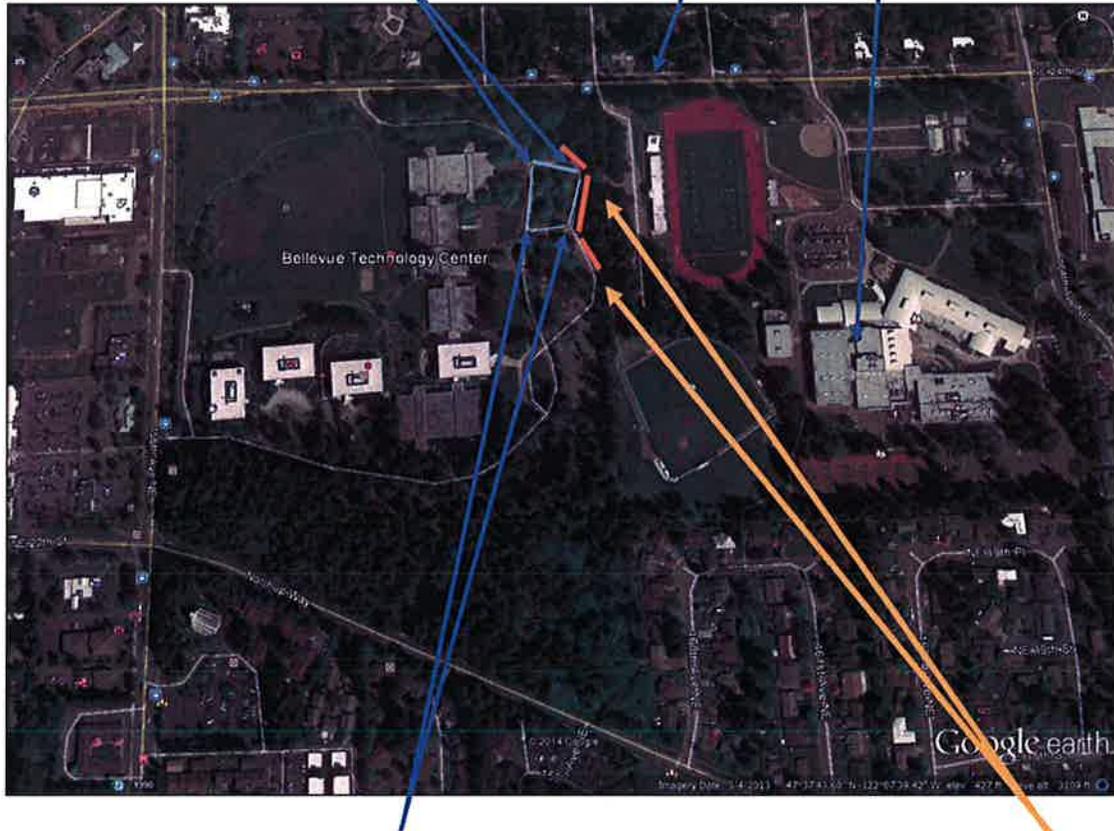
Photo # 1: A 5/4/13 Google Earth image of the Bellevue Technology Center.

The proposed parking expansion is in this area of trees and lawn.

Restoration installation area  
for 11 replacement trees

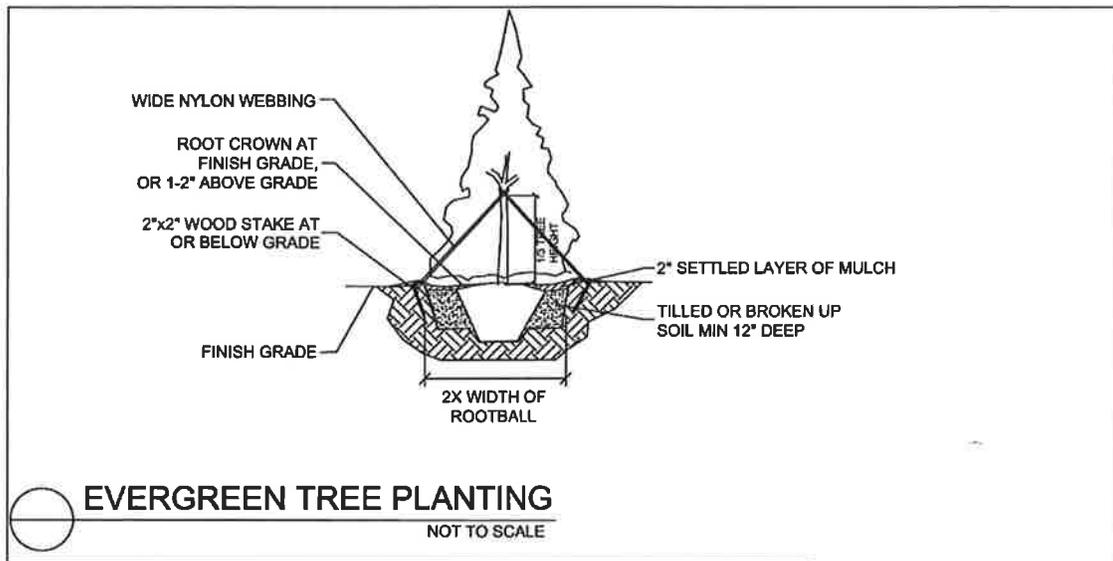
*Planting Detail*

- 14. Trunk Wraps:
  - If the tree arrives from the nursery/grower with trunk wrap, it shall be removed prior to staking.
  - No wraps shall be placed on the trunk.
