# Spot Improvement Annual Report

Year 2013

By King County Metro's  
Transit Systems & Traffic Engineering group (TRANSYTE)

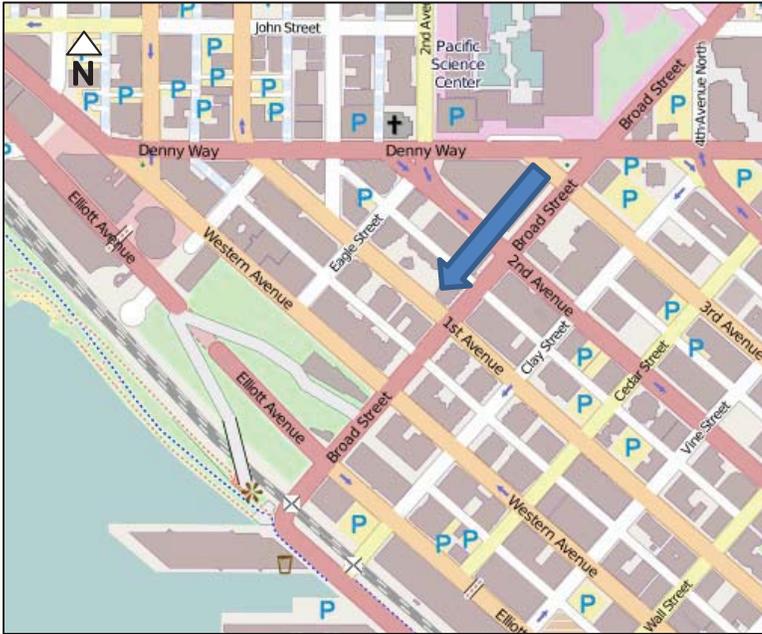
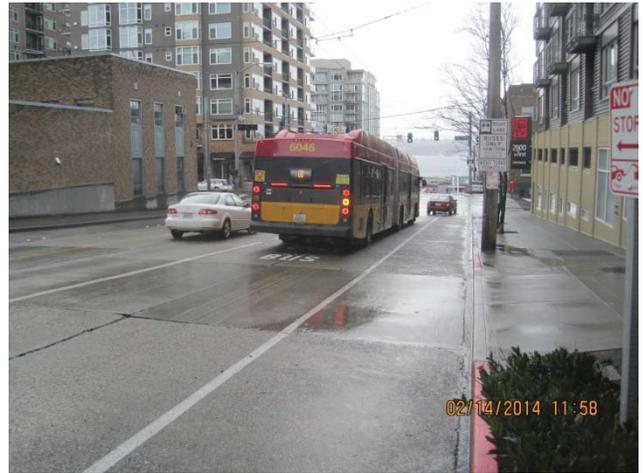
RapidRide D-Line in the westbound bus lane

Rapid Ride D-Line coaches often experienced delay through the Belltown area due to traffic congestion and the awkward jog that outbound coaches must do on Broad Street between 3<sup>rd</sup> and 1<sup>st</sup> Ave.

King County Metro has been requesting a new traffic signal installed at the 3<sup>rd</sup> Ave & Denny Way intersection, which would allow outbound coaches to avoid the jog on Broad Street altogether. However, due to the amount of traffic on Denny and the proximity of the intersection to Denny Way & Broad St intersection, SDOT would not approve a new signal at that intersection. As an alternative, SDOT offered to look at installing a Bus/BAT line on Broad Street. On-street parking utilization was low and overall roadway width was adequate to accommodate the new lane.

Parking was removed on the north side of Broad Street between 3<sup>rd</sup> Ave and 1<sup>st</sup> Ave and a Bus lane was installed. The other lanes were shifted to accommodate the new lane.

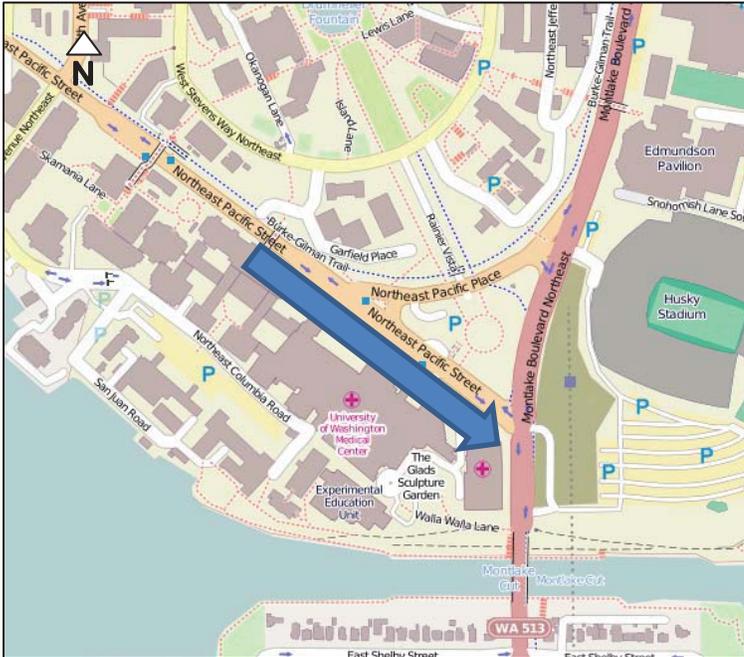
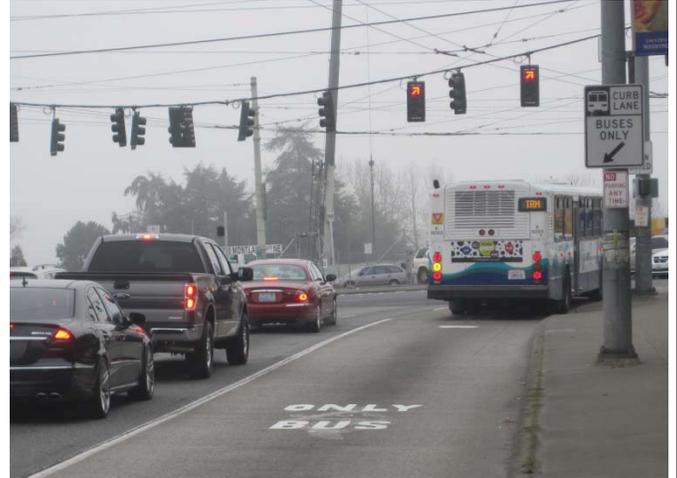
Sound Transit bus operated by King County gets a queue jump via the new bus-only lane.

A 3+HOV lane was provided in the eastbound direction of Pacific Street approaching Montlake Blvd. The HOV lane was intended to provide a bypass of heavy congestion that occurs in the area. However, the usefulness of the lane was limited by the high amount of HOV lane violators. A violation count performed by King County Metro showed that about 50% of the vehicles using the lane were violators.

The 3+HOV lane is an unusual operation on a city street; there are no other HOV lanes on City of Seattle streets. King County Metro proposed to SDOT to convert the HOV lane to Bus-Only operation. This change in operation would reduce the amount of vehicles in the lane, and bus-only restrictions would be easier to enforce than HOV restrictions.

The University of Washington was consulted about the proposal, and agreement was reached with the proposed solution. The 3+HOV signs and markings were removed from the lane and new bus-only signs were installed. BUS ONLY lane markings were installed later.

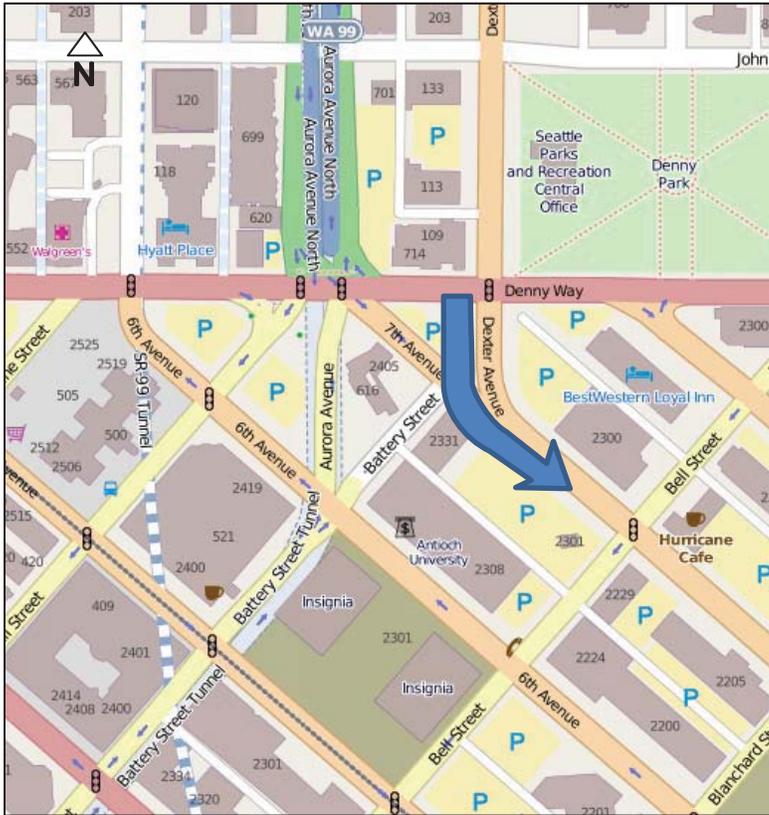
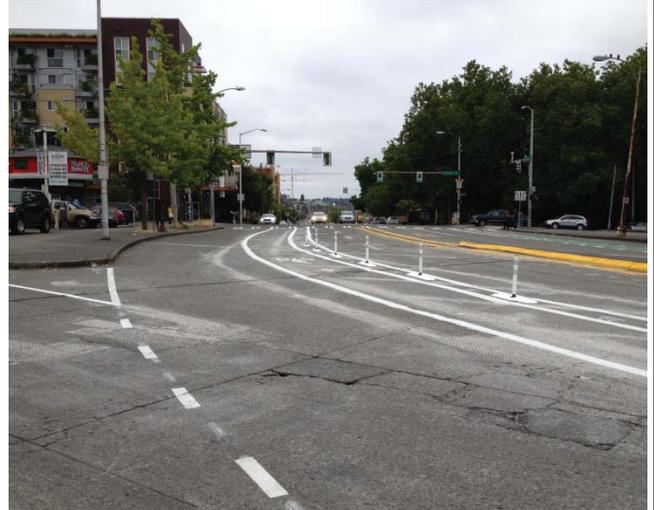
New bike lane and bus-only lane markings near the southbound bus stop

After a new bike lane treatment was installed in 2010 at the intersection of Dexter Ave, Denny Way, and 7th Ave, bus drivers and transit safety officers complained about an awkward weave that occurred between bikes in the bike lane and buses accessing the southbound bus zone. Under this configuration, buses were not allowed to continue in the curb lane between the bus stop and a right turn at Bell Street; this required buses to cross the bike lane up to three times within this area.

King County Metro and SDOT collaborated on a design to fix the weaving problem. An initial design was developed that would install a bus stop island, similar to the others on Dexter. Although this would have been an elegant solution, it proved to be too expensive to complete as a stand-alone project. Also, Service Planning staff had indicated that Routes 26 & 28 may move to Battery/Wall Streets after the Highway 99 North Portal project is complete, which would mean that the island could be abandoned after only a few years of operation.

An alternative lower-cost plan was developed to solve the weaving problem using only paint line adjustments and some parking removal. The lane configuration of Dexter Avenue and 7th Avenue was modified so that buses only have to cross the bike lane once, and then can continue in the curb lane all the way to Bell Street. Also, the southbound right turn lane on Dexter Avenue approaching Denny Way was extended, which allows buses to bypass right turn queues that tend to build up during the PM peak.

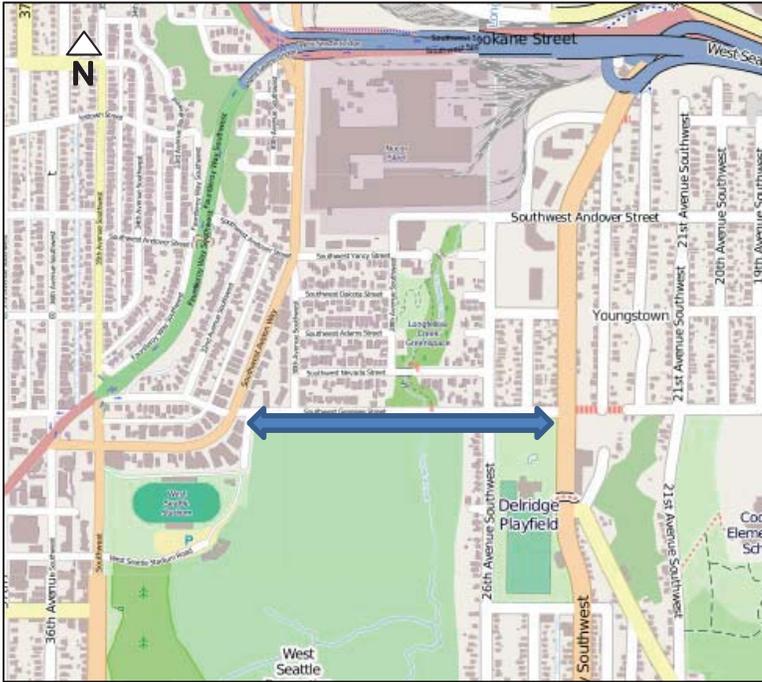
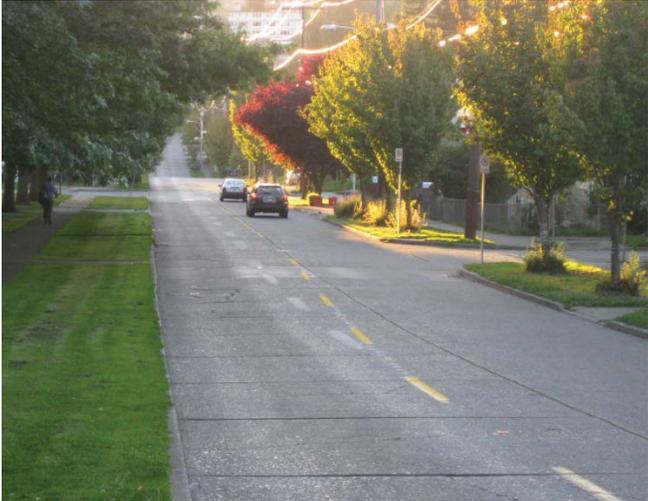
SW Genesee St with removed parking and shifted centerline

With the Fall 2012 service change, the new Route 50 began operating on SW Genesee St between Delridge Way & Avalon Way. This portion of Genesee had narrow travel lanes and there was not adequate width for oncoming buses or other large vehicles to pass.

Parking was allowed on the south side of Genesee St for almost the entire length between Delridge Way and Avalon Way. Prior to the September 2012 service change, King County Metro requested SDOT to restrict parking in selected locations, and consider additional improvements along the remainder of Genesee St. SDOT investigated the parking utilization and conducted outreach to the adjacent residents. It was determined that the on-street parking was not well utilized and most residents had alternative on-site parking or parking available on other streets.

The selected parking restrictions were installed before the September 2012 service change, while SDOT considered changes along Genesee. Based on the sub-standard lane width and low parking usage, SDOT implemented parking resections along the entire length of Genesee between Delridge and Avalon Way. In 2013, the center line was shifted to redistribute the lane width between the two lanes.

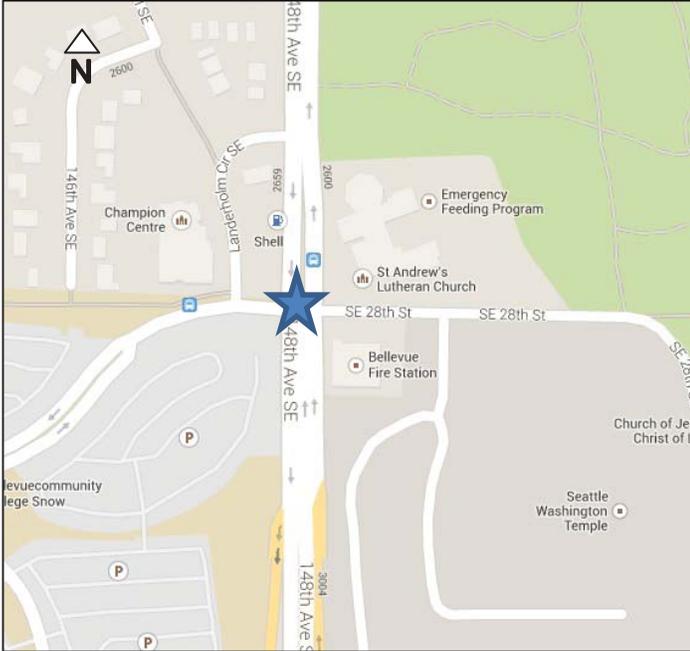
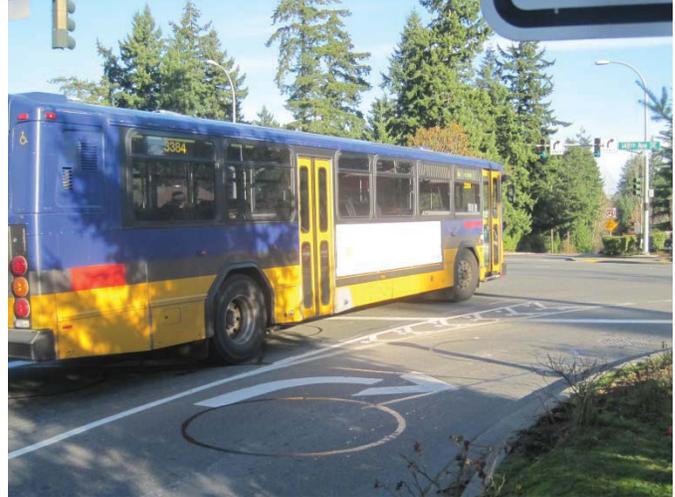
A bus in the outside turn lane making a wide turn to stay in-lane through the whole maneuver.

The eastbound right turn on SE 28<sup>th</sup> Street to 148<sup>th</sup> Ave SE is a double turn lane. There have been a higher than normal number of collisions between buses and cars in this intersection. Buses using the outside turn lane and cars using the inside turn lane have collided due to the geometry of the intersection.

King County Metro and City of Bellevue assessed the current conditions and found that many of the buses were crossing the white line with their rear tire while going through the intersection. Also, cars were changing lanes from the inside lane to the outside lane within the intersection. The combination of these maneuvers has caused a number of collisions between the buses and general purpose vehicles.

After meeting with the City of Bellevue and discussing options, it was decided that there needed to be more separation between the two turning lanes to discourage lane changing in the intersection. King County Road Services installed a painted island with raised pavement markers between the turn lanes to encourage vehicles in the outer turn lane to make wider turns and to encourage vehicles in the curb lane to stay in the curb lane.

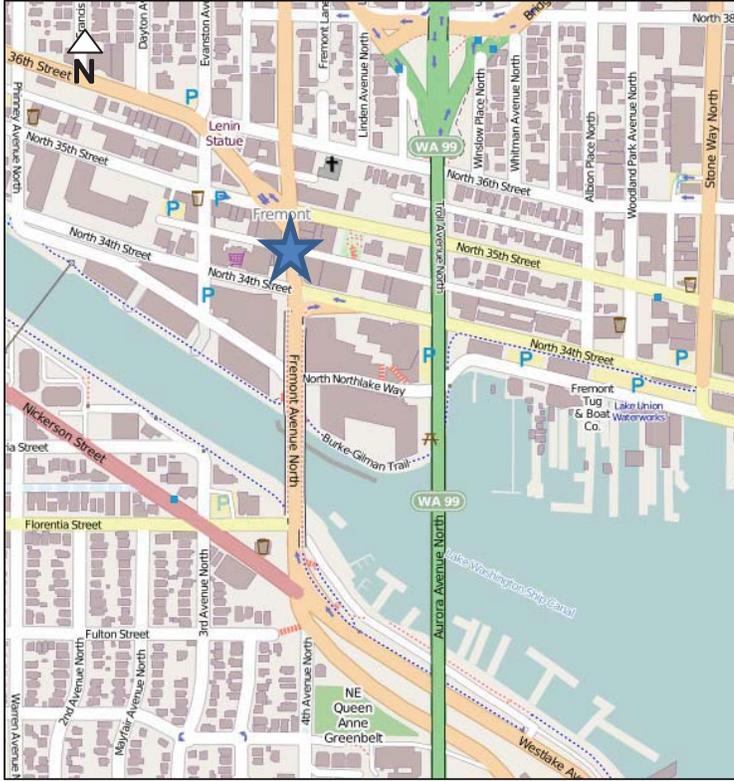
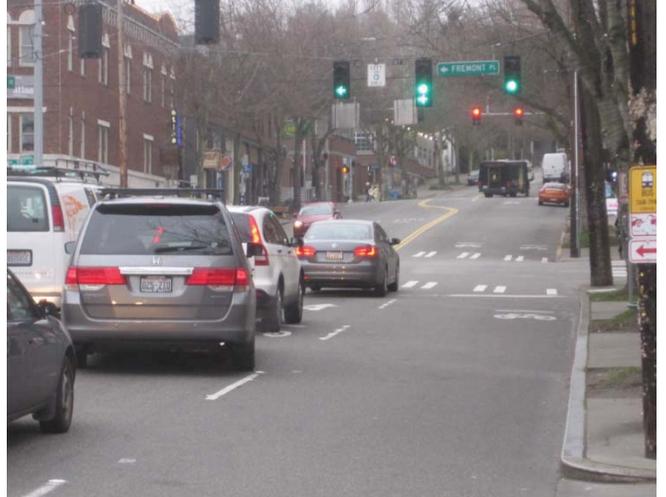
On-street parking removed on the northbound side of Fremont Ave approaching N 35<sup>th</sup> Street.

In the northbound and southbound direction of Fremont Avenue N between 35th and 34th Street, a handful of on-street parking spaces were making it difficult for coaches to maneuver in and out of the busy bus stops near the center of Fremont. The effective length of the southbound bus zone was limited due to the on-street parking. After the Fall 2012 service change, the volume of buses travelling on Fremont Ave was significantly increased.

The proposed parking restrictions were put into place in Fall of 2013. In addition, parking signage and curb paint in the area was updated to make it more visible and easier to understand. The 30-minute load zone was relocated to N 35<sup>th</sup> Street.

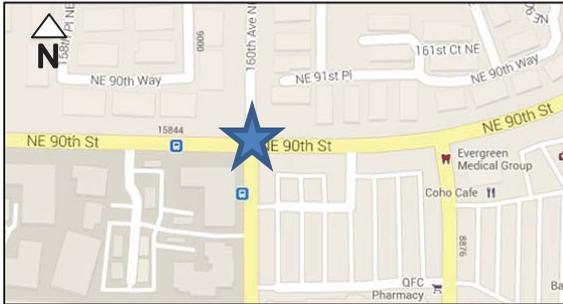
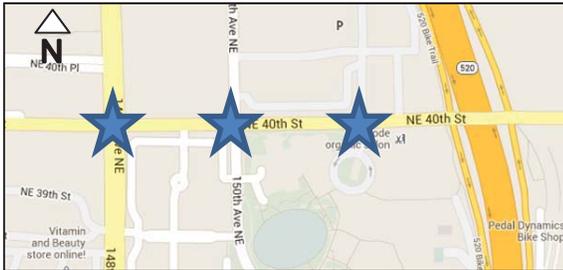
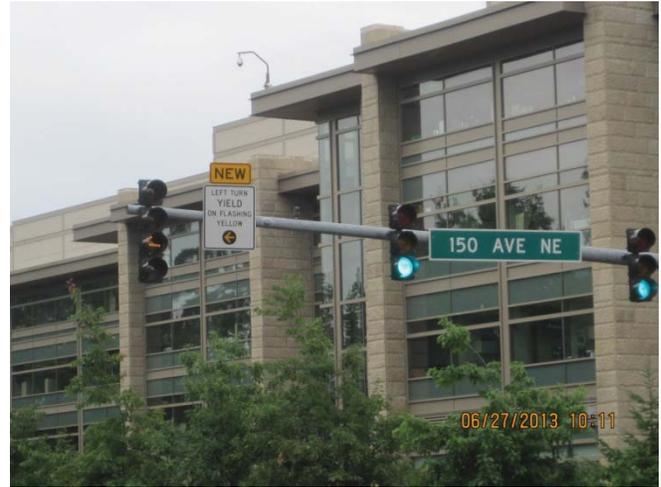
Flashing yellow arrow signal light installed at all the subject intersections, plus relevant signage.

Along the main roadway, the intersections of NE 40<sup>th</sup> St and 148<sup>th</sup> Ave NE, NE 40<sup>th</sup> St and 150<sup>th</sup> Ave NE, NE 40<sup>th</sup> St and 152<sup>nd</sup> Ave NE, and NE 90<sup>th</sup> St and 160<sup>th</sup> Ave NE all had protected-only left turn movements. Since Transit Signal Priority has been implemented, the wait time for turning vehicles had increased due to the shortened light cycles.

King County Metro staff contacted the City of Redmond with concerns about these intersections. After performing analysis of the intersections, the City of Redmond concluded that protected-permissive left turn phasing could be installed while meeting safety requirements. Protected-permissive phasing would also allow faster bus movement through the intersections, as well as reduced delay for general traffic.

The City of Redmond installed the new signal phasing and optimized the signal timing. New protected-permissive phasing was implemented using flashing yellow arrow displays. New signage was placed at each intersection to inform drivers of the change.

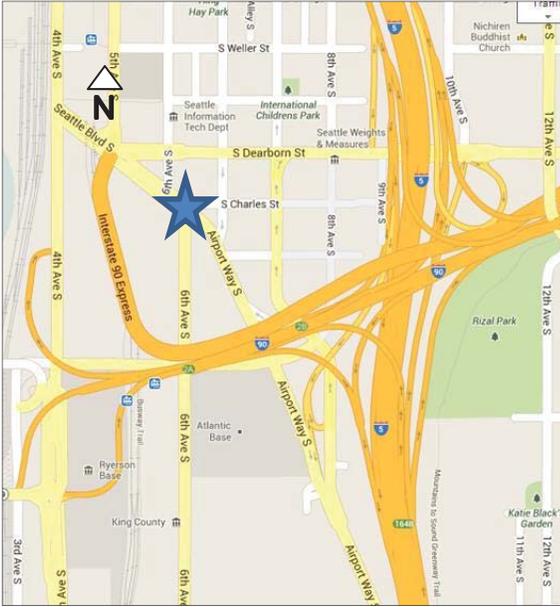
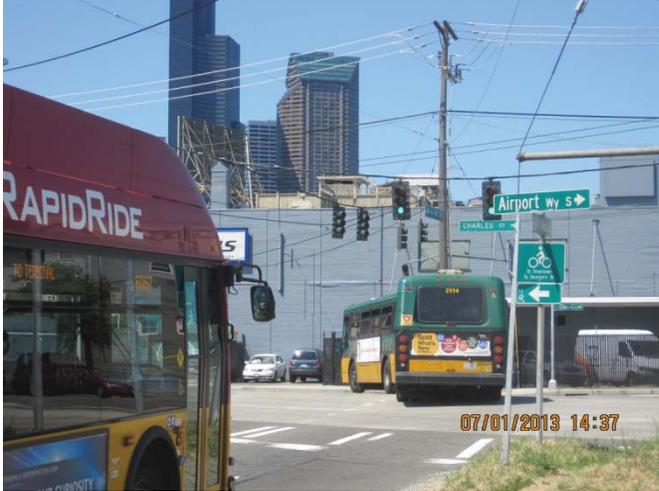
Buses leaving the base successfully pass through the intersection on the first cycle.

Buses leaving the Atlantic and Central Bases were often delayed when trying to turn left onto Seattle Boulevard from 6<sup>th</sup> Avenue South, due to the signal operation at this intersection. It would typically take multiple signal cycles for the buses to get through the intersection and continue on to their routes.

Recurring delays were occurring due to the short green time available for vehicles approaching northbound on 6<sup>th</sup> Avenue S. A broken loop detector was not able to accurately gauge how long the vehicle queue was, and would not allow a green light to be extended to allow all the waiting vehicles to get through. The signal's coordination with the other signals along Seattle Boulevard and Airport Way S was also causing long waits for the vehicles on 6<sup>th</sup> Avenue S because the signal would have to wait for a defined point in the signal coordination cycle. Replacing the loop in the roadway would be costly and it would not likely last long due to the poor pavement condition.

Video detection was proposed at this intersection for all directions, so that queue lengths could be determined properly. The coordination of this signal with other signals along Seattle Boulevard and Airport Way S was also reworked to allow for a shorter wait time for traffic in the side streets. There was minimal disruption to traffic during installation. The improvements were implemented in Spring 2013.

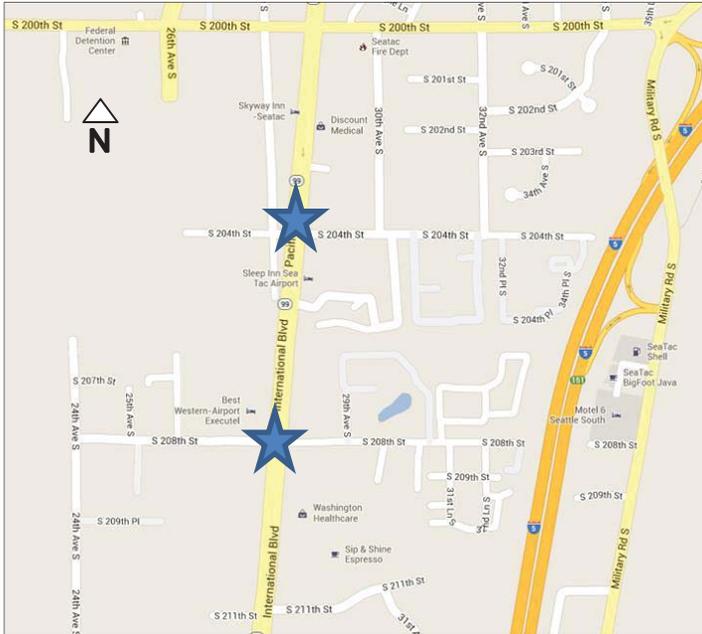
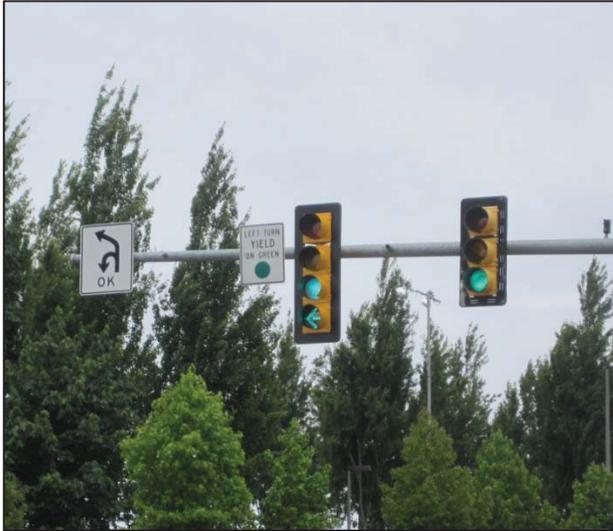
New signal display at the subject intersections

At both these intersections, the northbound and southbound left turn movements were previously a protected-only movement. Vehicles turning left had to wait significantly long times for the protected left turn phase, and enough green time had to be provided to the protected left turn phase to clear out all of the queued vehicles. Rapid Ride A-Line coaches on Pacific Highway S were delayed when these signals provided protected-only left turn phases.

The protected-permissive operation was accepted by all involved agencies and new protected-permitted left turn signal phases and additional signage were installed to show the new operation.

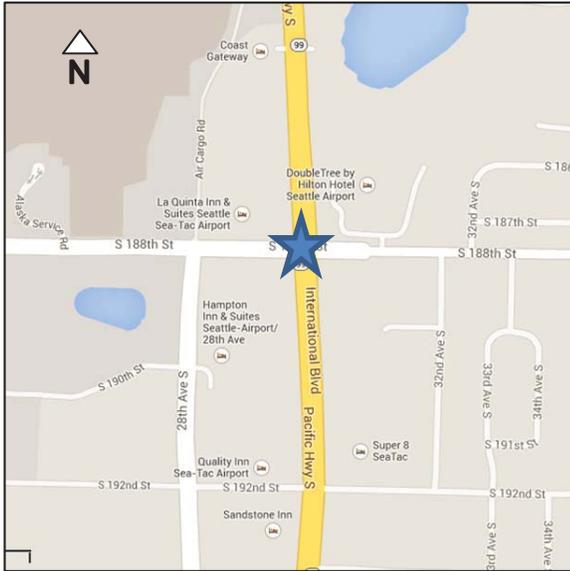
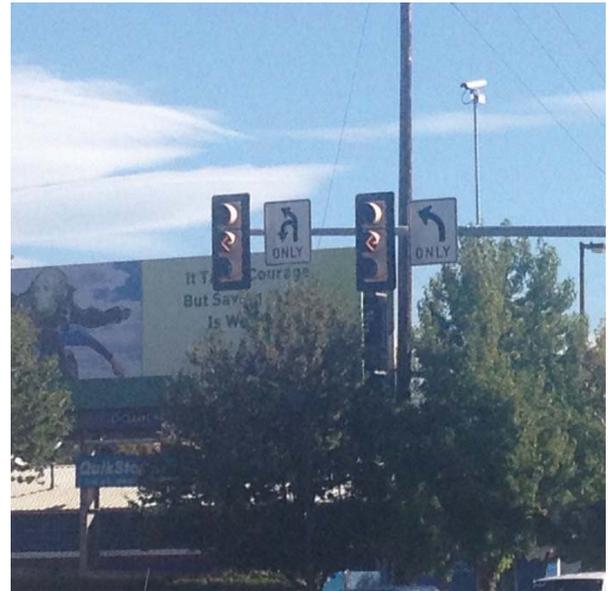
Southbound left turn signals changing to yellow after allowing all vehicles through the light

The heavy traffic going southbound on Pacific Highway S turning eastbound onto S 188<sup>th</sup> Street creates a long queue at that traffic signal. Metro buses as well as general purpose traffic were getting stuck at the intersection because of a short left turn phase. Many vehicles had to wait for multiple cycles to get through the intersection.

It was determined that the detection at this intersection was damaged, and the detection system needed to be replaced. When deciding between different options, video detection was chosen due to its lower cost and minimal disruption it creates when installing.

King County Road Services installed video detection cameras for the southbound left turn lanes. This camera is able to detect the amount of cars waiting to turn left, and can adjust the amount of green time provided.

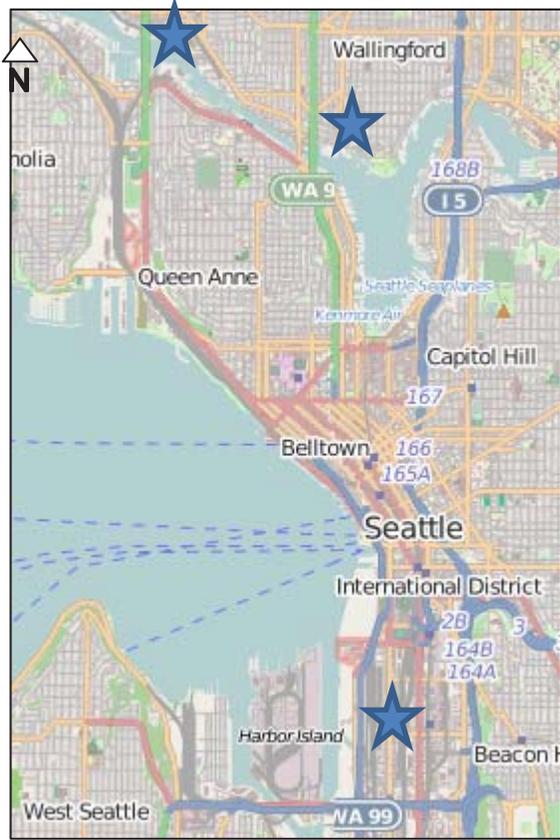
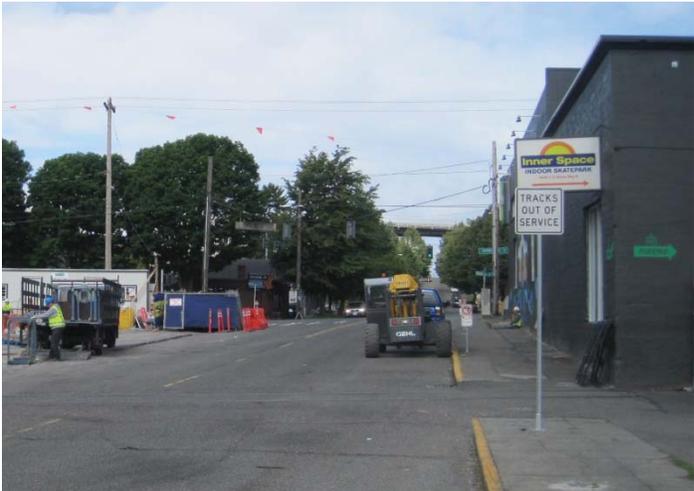
TRACKS OUT OF SERVICE sign exempts buses from needing to stop at this abandoned railroad crossing.

Federal safety rules currently require all bus drivers to stop at all railroad crossings to stop, look, and listen for approaching trains. At several locations, frequent bus routes crossed railroad crossings that were abandoned and had zero chance of a train approaching (at some crossings the tracks were physically disconnected or partially paved over). However, the stop, look, listen rule still applied at the abandoned crossings, causing needless stops and delay.

Three locations were identified in the City of Seattle that were no longer owned by any railroad and could have signage installed by SDOT. These locations are: Leary Way & 14th Ave NW, 35th St & Stone Way N, and S Lander St & S Occidental St. TRACKS OUT OF SERVICE signs have been installed at the first two locations, and will soon be installed at the third location.

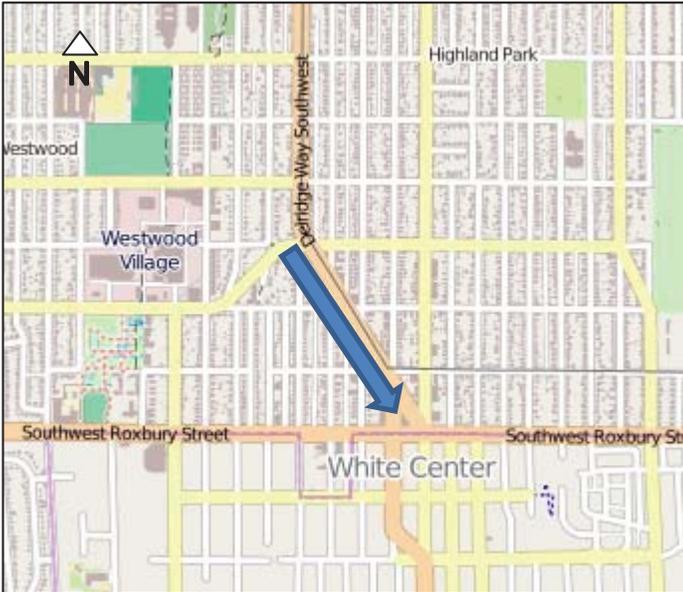
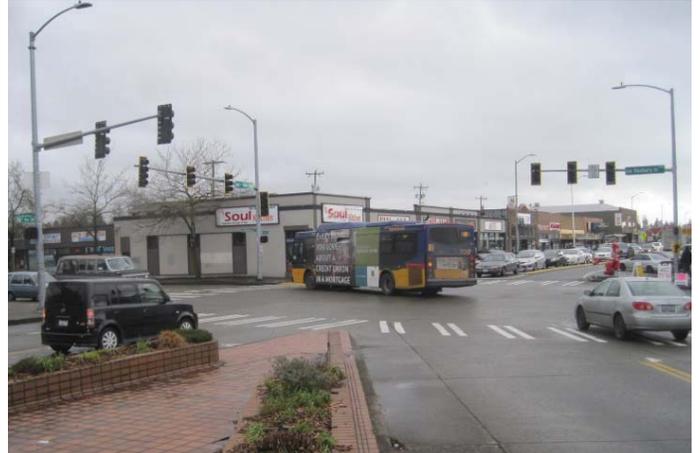
Route 60 turning from the newly paved Delridge Way onto Roxbury with a protected signal

There were reports of safety concerns for operators making a southbound left turn from 16<sup>th</sup> Av SW to SW Roxbury Street.

At a meeting in the field with staff from SDOT and King County Metro, it was determined that due to the geometry of the 5-legged intersection at Delridge, 16<sup>th</sup> SW & Roxbury, it was difficult for drivers to make the southbound left turn and at the same time yield to opposing traffic and pedestrians. Many operators had to wait until the signal turned yellow to make the left turn.

Reroute the buses from coming southbound on 16<sup>th</sup> to come southbound on Delridge. This required reclassification of the section of Delridge between Roxbury and 17<sup>th</sup>. The SDOT Delridge Paving project would also construct new a concrete and asphalt roadway that would be suitable for bus traffic.
