# Petrescu Retaining Wall

Project No. KE130063A

Subject: Slope Restoration and Ecology Block Wall Recommendations  
16710 SE 34<sup>th</sup> Street  
Bellevue, Washington

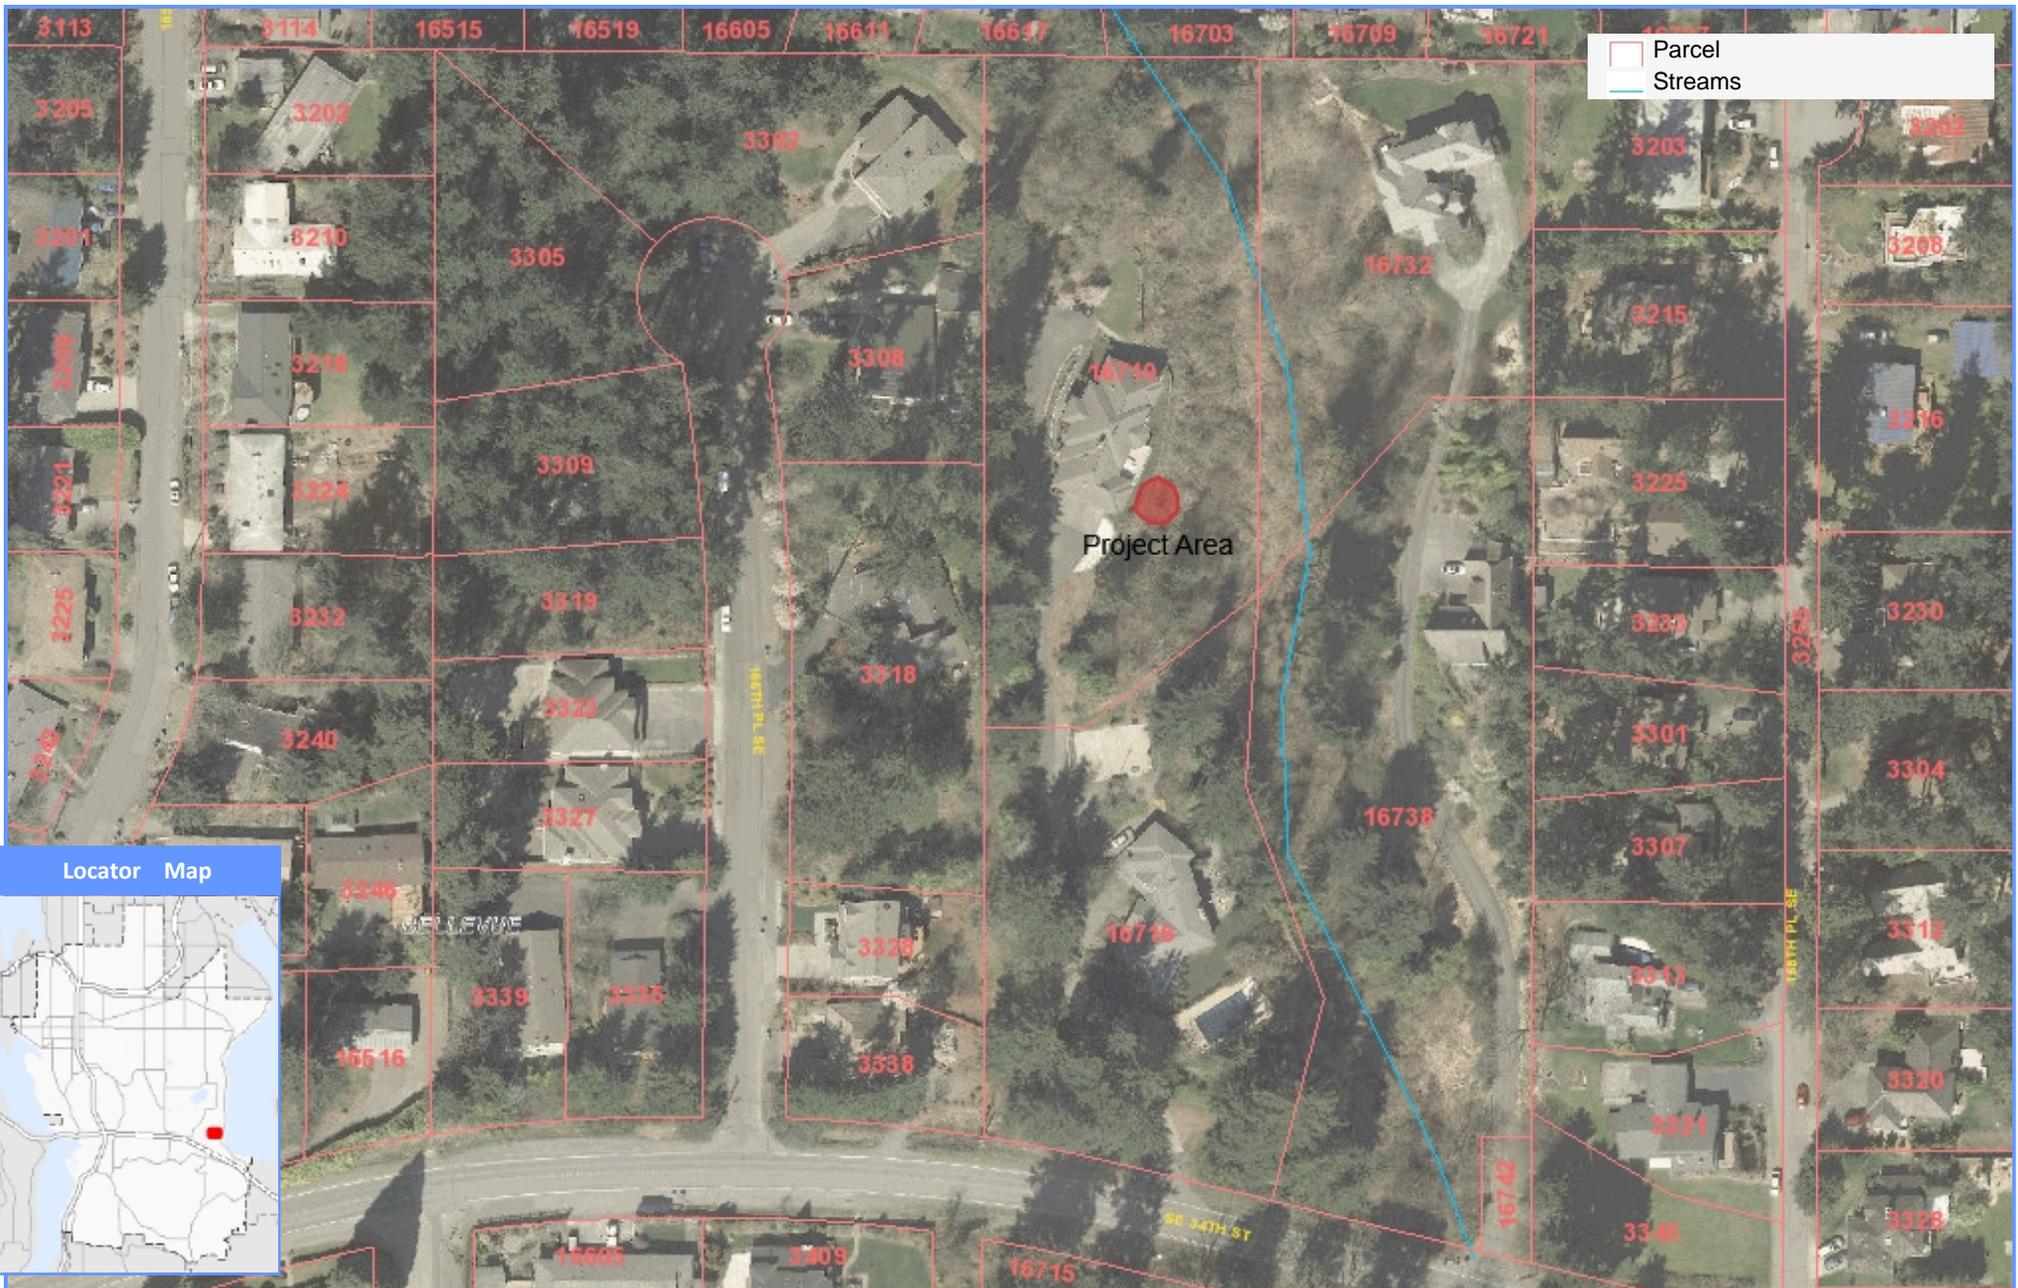
Attachment: Figure 1 - Grading Mitigation and Revegetation Plan

The “affected” area immediately below the ecology block wall includes a roughly 4- to 6-foot-wide level bench leading to an approximate 1.5H:1V (Horizontal:Vertical) slope. The affected area extends roughly 20 feet downslope and consists of exposed, loose soil currently covered with straw. We observed shallow surface cracks along the transition between the level and steep portions of the affected area. Several, discarded random modular blocks were observed along the lower portion of the affected area. The steep slope below the affected area was well vegetated, with both trees and native underbrush.

Based on our observations, we recommend that drainage elements be incorporated into the existing ecology block wall, along with a moderate amount of remedial grading followed by revegetation of the slope with erosion-resistant plantings. Figure 1 shows the existing residence and the area of the recommended mitigation measures. Based on our limited site and document review, we have the following comments:

- Figure 1 includes a recommended detail for the existing ecology block wall. A minimum 1-foot-wide blanket of 2-inch-diameter drain rock should be placed along the back face of the ecology block wall. A 4-inch-diameter, perforated drainpipe should be placed at the base of the drainage zone and routed by gravity to a suitable discharge. If not tied to the existing house drainage system, the wall drainage should be tightlined to the bottom of the existing slope east of the wall.
- We recommend that the affected portion of the slope below the ecology block wall be regraded to a maximum slope of 2H:1V, with the resulting ground surface compacted to a firm condition. Excess soil should be removed from the slope area. The distances shown on Figure 1 from the wall and recommended mitigation area to the residence should be considered approximate.

- Figure 1 includes a planting plan with recommended plant species. Temporary erosion and sediment control (TESC) measures for the recommended mitigation area are also recommended. For most sites with active grading, the TESC measures include a perimeter silt fence. Since the “grading” at this particular site will be limited to regrading the upper portion of the slope and the placement of potted plants, we consider the trenching associated with silt fence installation to create a greater impact than the proposed re-planting activities. Instead, we recommend that the sequence of planting is arranged such that the plants planned for the lowest portions of the mitigation area are planted first. As these plants are placed, we recommend that bark mulch be spread in the low areas to provide a temporary erosion control perimeter for the re-planting area. Subsequent planting and mulching can then continue upslope through the mitigation/ revegetation area.
