**City of Bellevue
Development Services Department
Land Use Staff Report**

Proposal Name: Karpman Short Plat Amendment

Proposal Address: 2836 112th Avenue SE

File Number: 16-132531-LF

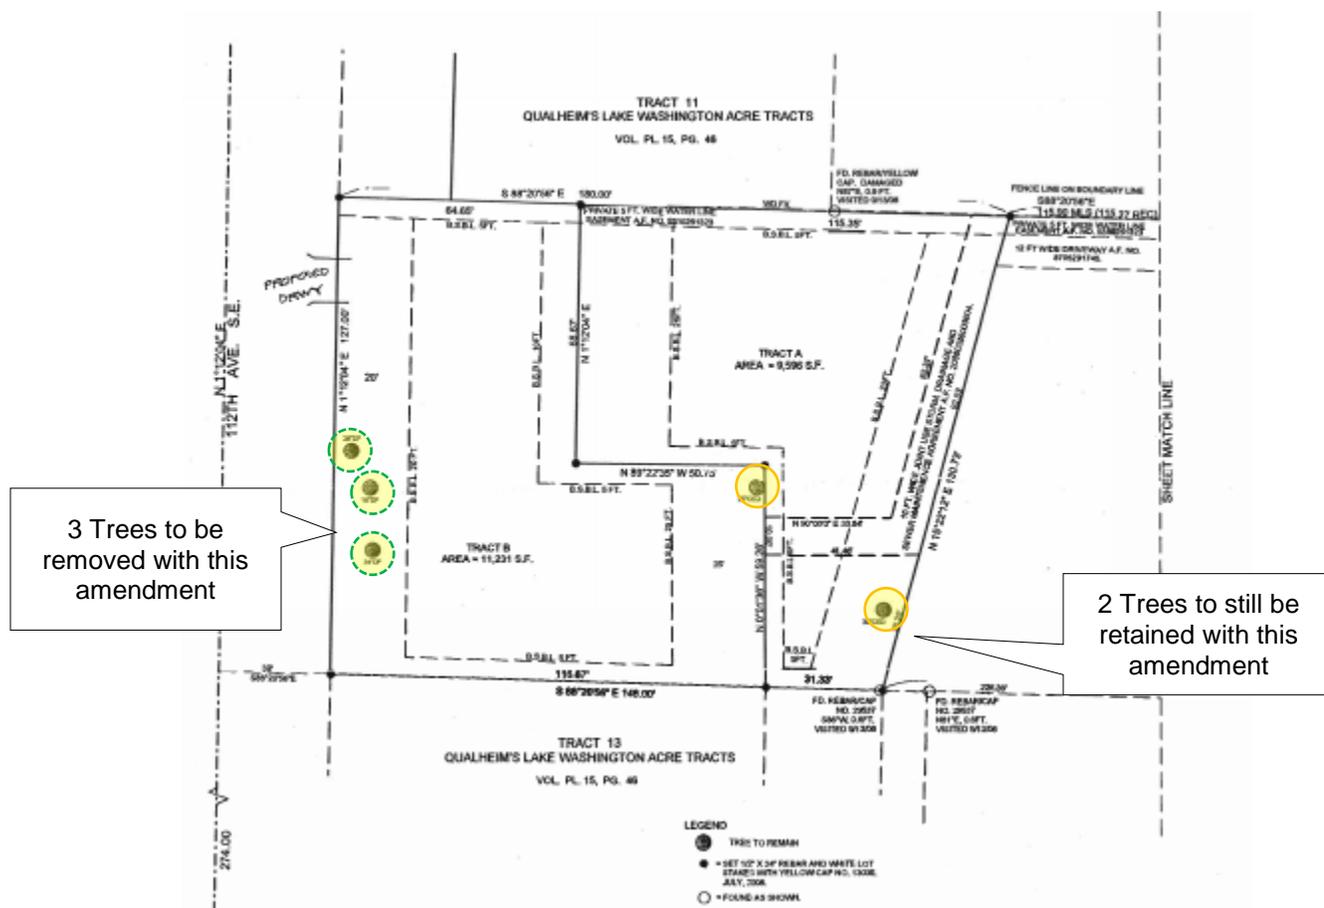
**Figure 1 – Original Short Plat Approval
 5 Trees Retained**

Application for a Final Short Plat Amendment to modify the tree preservation plan shown on the face of the Final Short Plat (King Co. Rec. #20090626900005). The applicant requests the amendment in order to reassign which specific trees are to be retained in order to have more flexibility when designing a single family home on the western Tract B. In the approved Final Short Plat, 15% of the 596 diameter inches of trees on site were required to be retained. Five trees were proposed to be retained for a total of 126 diameter inches or 21%. However, as plans for development of Tract B were explored, three of the trees that were originally proposed to be retained (78 diameter inches total) would be severely impacted by the construction of the foundation of the envisioned home due to their close proximity to both the foundation and the public street. In order to alter the placement of trees to be preserved on the recorded short plat, a short plat amendment application was filed with the City to retain a 44 inch diameter cedar tree along the eastern edge of Tract B in lieu of the three trees along the western edge of the site. With a new total of 94 diameter inches retained, the project would still meet the required 15% tree retention.

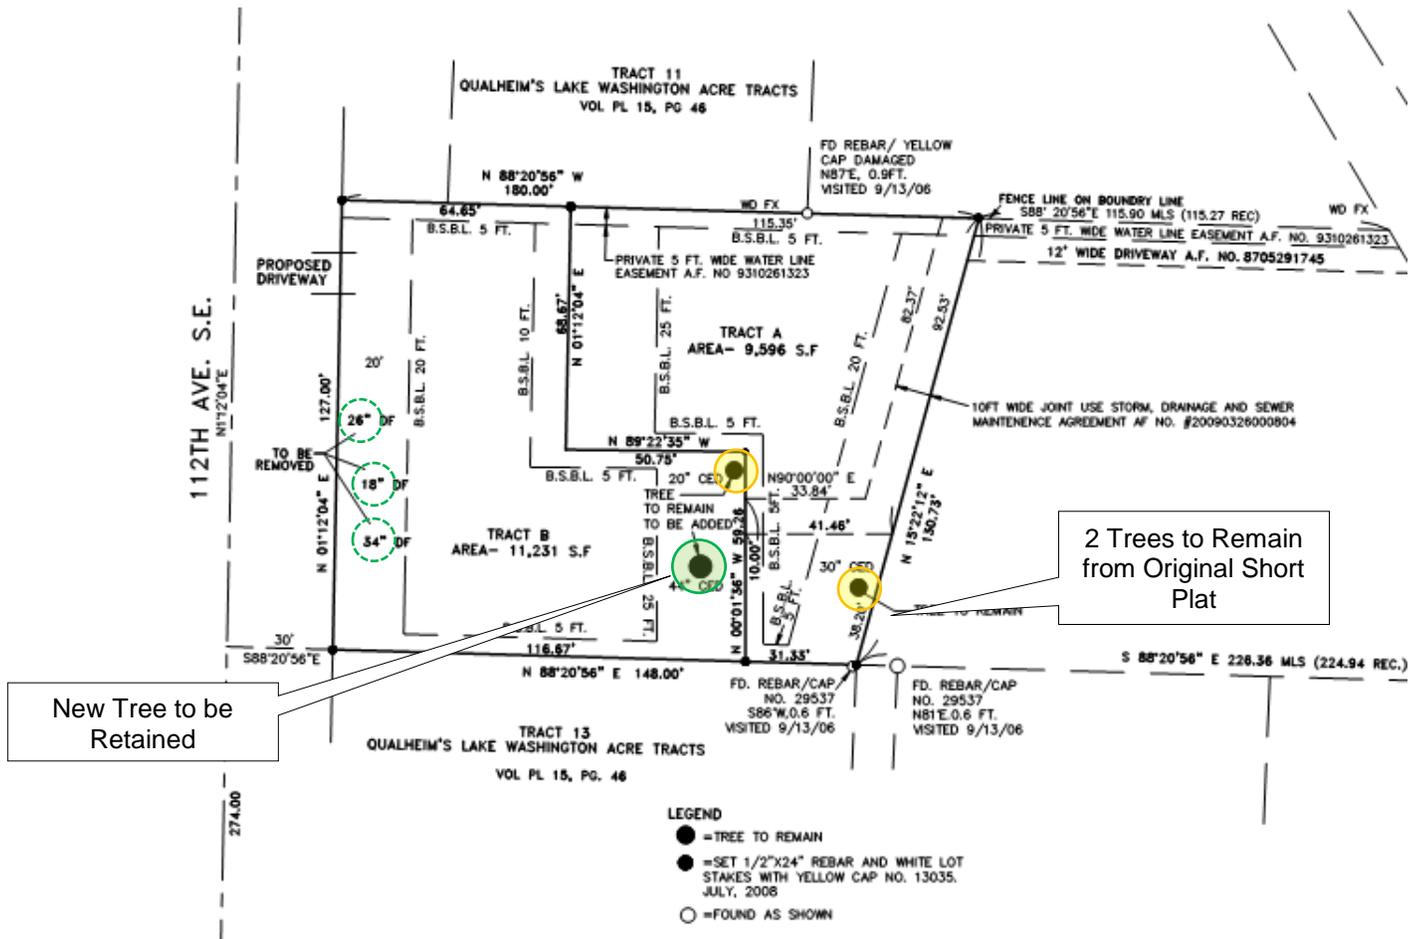
**Figure 2 – Proposed Amended Short Plat
 3 Trees Retained**

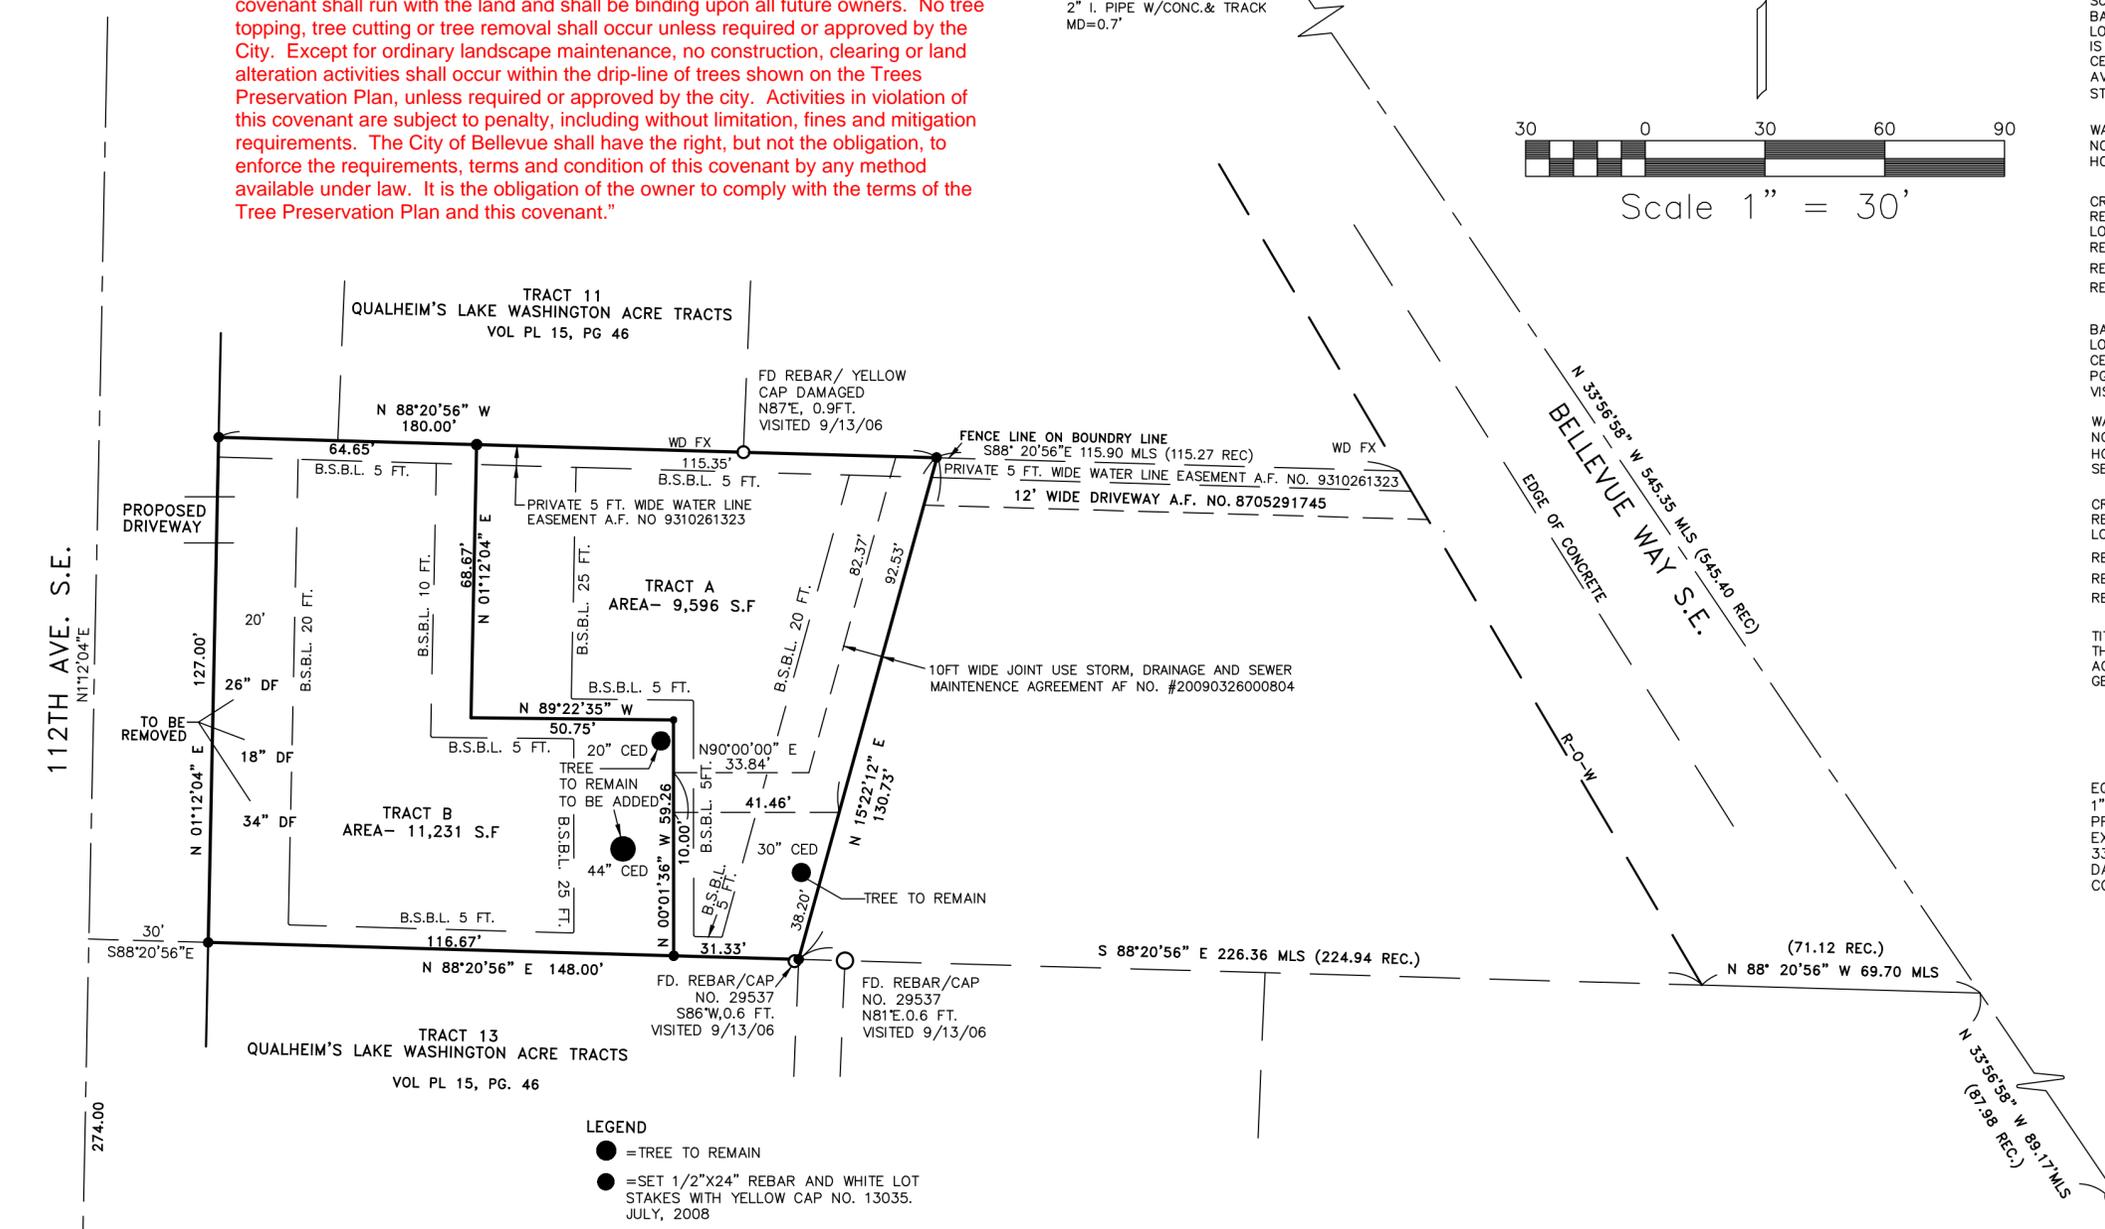
AMENDED SHORT PLAT NO. 16 132531 LF

112TH AVE. S.E. N1°12'04"E
S.E. 30TH ST
S.E. 30TH ST
CITY OF BELLEVUE
HORIZ STATION: 3532
MIC
1/4" BRASS PLUG IN CONC MD=1.50'
VISITED 9/11/06
POINT OF COMMENCE

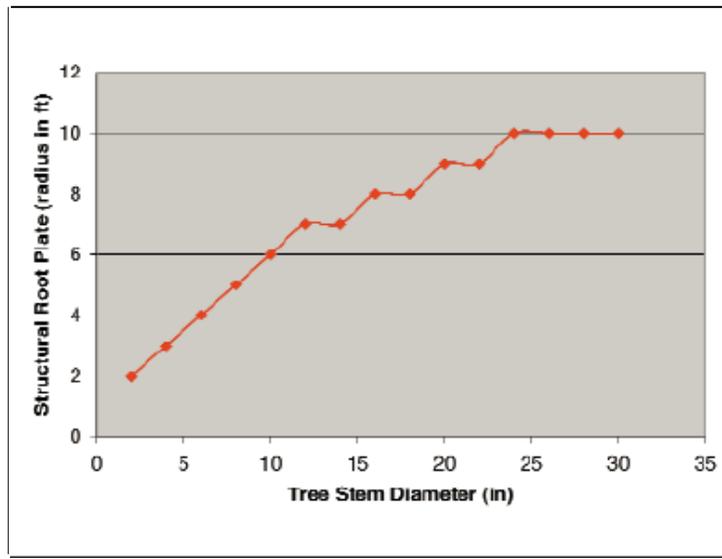
Figure 8. Size of the Structural Root Plate in relation to tree stem diameter. Note that the SRP levels off at 10' for any tree over 24" in diameter.

Typically intrusion within the CRZ is strongly discouraged by the tree care industry. However trenching type incursion, that is excavation that will occur along only one sector of a tree's CRZ, can reach significantly into the root growth area without having a detrimental long term effect. What does have to be absolutely protected is a tree's Structural Root Plate (SRP). This radial area is again related to the diameter inches of the tree in question but not quite in a direct proportion as in the CRZ. Figure 8 below illustrates the relationship.

In the case of the #21 cedar mentioned above, the excavation for the east side foundation could come as near as 11' to the base of the tree. From Figure 8 the Structural Root Plate for a 44" DSH tree is given as 10' so excavating for the foundation would be just outside its SRP. The demolition and excavation for the 2841 house will come no closer than 20' to the #23 cedar well outside its SRP. The #24 fir on the property to the south also stands a little more than 20' from the excavation work for the upper house.

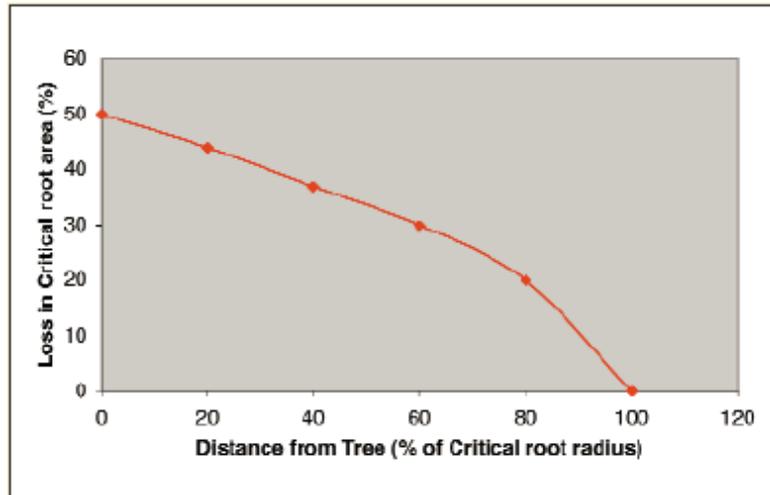
Figure 7. Chart giving the loss in critical root area as a function of the radial distance to the CRZ disturbance.

The chart shown in Figure 7 below is used to determine what percentage of a tree's Critical Root Zone will be affected by trenching type incursion. In general trees can sustain losses of up to 30% of the overall area within their CRZ without having long term detrimental results.

Using the #21 cedar again as the example, with the foundation excavation being 11' from the tree's base and it having a 44" DSH, there will be impact at a linear distance equal to 25% of the maples CRZ (11'/44'). The chart shows that this roughly equates to a 40% loss in the cedar's Critical Root Area (CRA) putting it significantly beyond the maximum recommended impact. The intrusion would have to be extended out to a distance of more than 27' before the loss in CRA would fall within the accepted limits. This is not counting the impact from the excavation for the lower house. The #24 fir will be lightly impacted at worst, losing no more than 20% of its Critical Root Area.

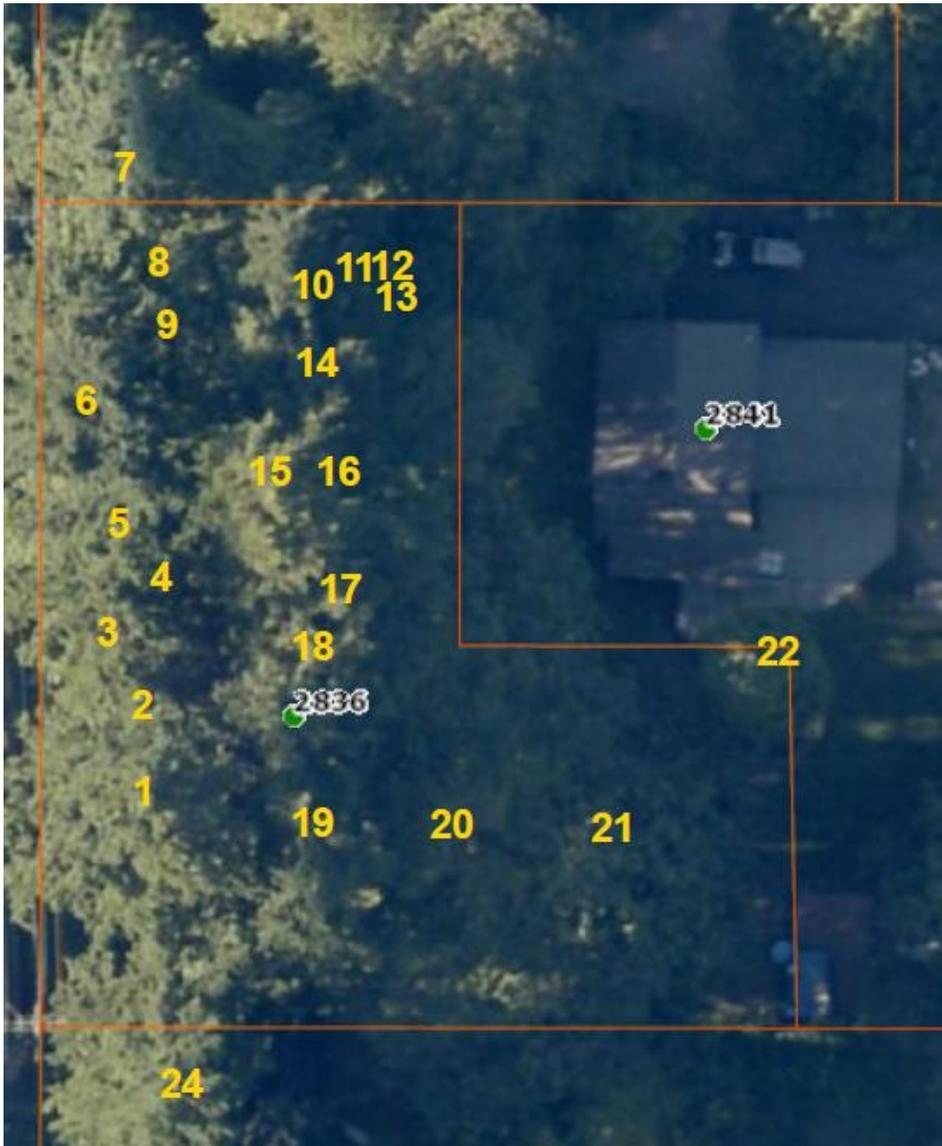
Figure 1. Aerial view of the Karpman lots. The yellow numerals correspond to the trees listed in the description section and show their approximate placements. The #23 cedar is just out of the image at the bottom right corner.

The following itemized list begins at the SW corner of the property. Each tree was tagged and their numerical designations are reflected in Figure 1. Diameters were measured at the standard height of 54" above grade (DSH) during the February 2016 site visits. Heights were estimated. Core test were completed on the majority of the trees to aid in determining their conditions.

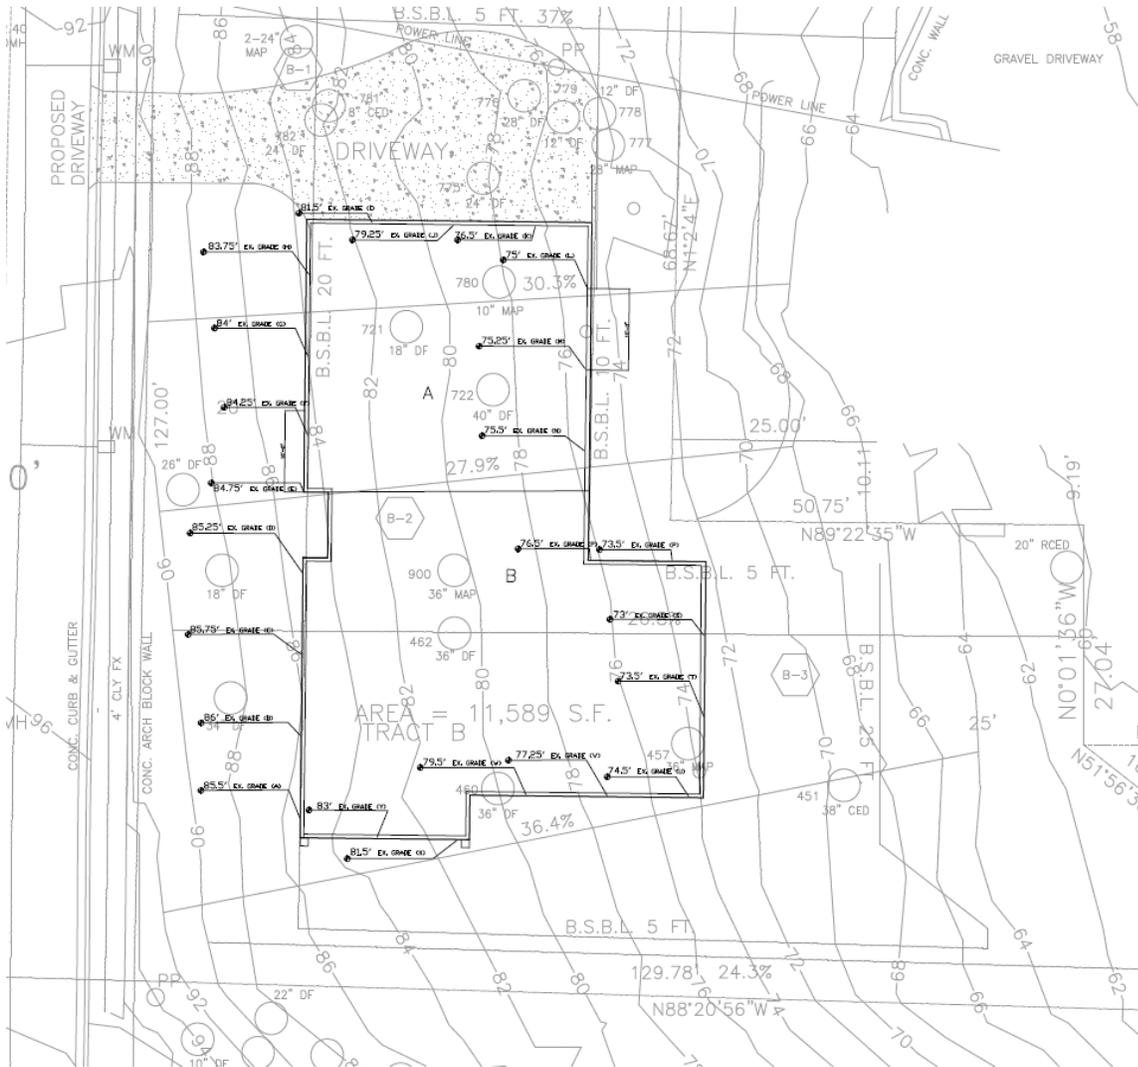
Figure 2. Proposed foundation and driveway plan for the Karpman home on the upper lot.

The Karpman family has proposed to build a home designed by Huber Architects which will fill a good portion of the property as shown in Figure 2. A short plat showing the numbers and placements of the trees on the lot was done in 2007 and submitted in January 2008. Five trees from that survey were proposed for permanent retention namely Numbers 406, 407, 410, 526, and 531. Superior NW Enterprise was contacted by Huber to re-assess all the trees present as to their health, stability, and overall suitability for retention.

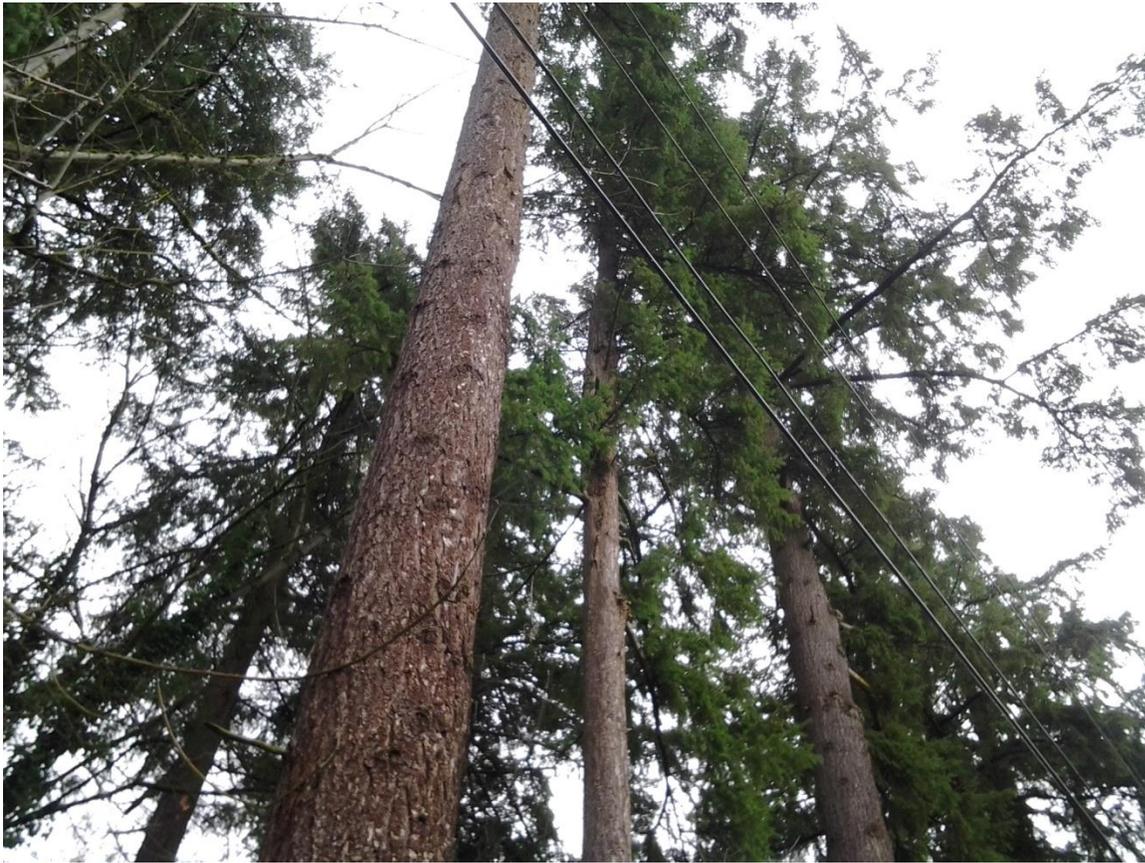
Figure 3. Photo showing the damaged area with advanced decay at the midpoint of the #2 fir.

- 2) Douglas Fir 17.5" DSH, 75' tall standing 12' north and nearly in line with the #1 tree. It was listed as Number 407 on the 2007 short plat. It is in poor condition with a presumed site of advanced decay near its midpoint (Figure 3). The exterior damage traces cover an area from near the 40' mark to at least the 55' level on the north face. A 5" caliper woodpecker hole can be seen from the ground near the center of the wound site as shown in Figure 4. The fir exhibits average new growth and color.

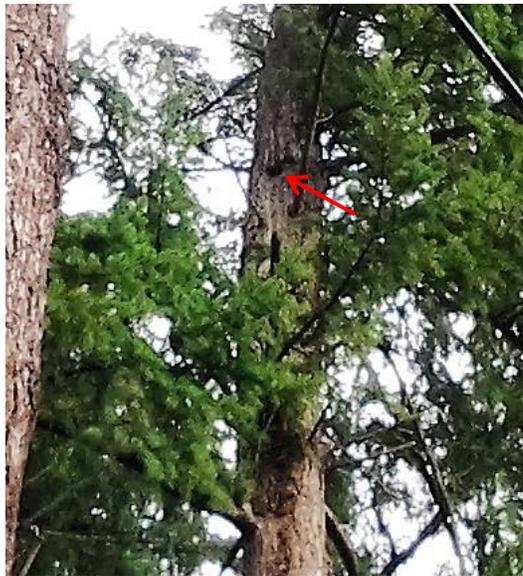
Figure 4. Close up of photo above showing the 5" woodpecker hole (red arrow).

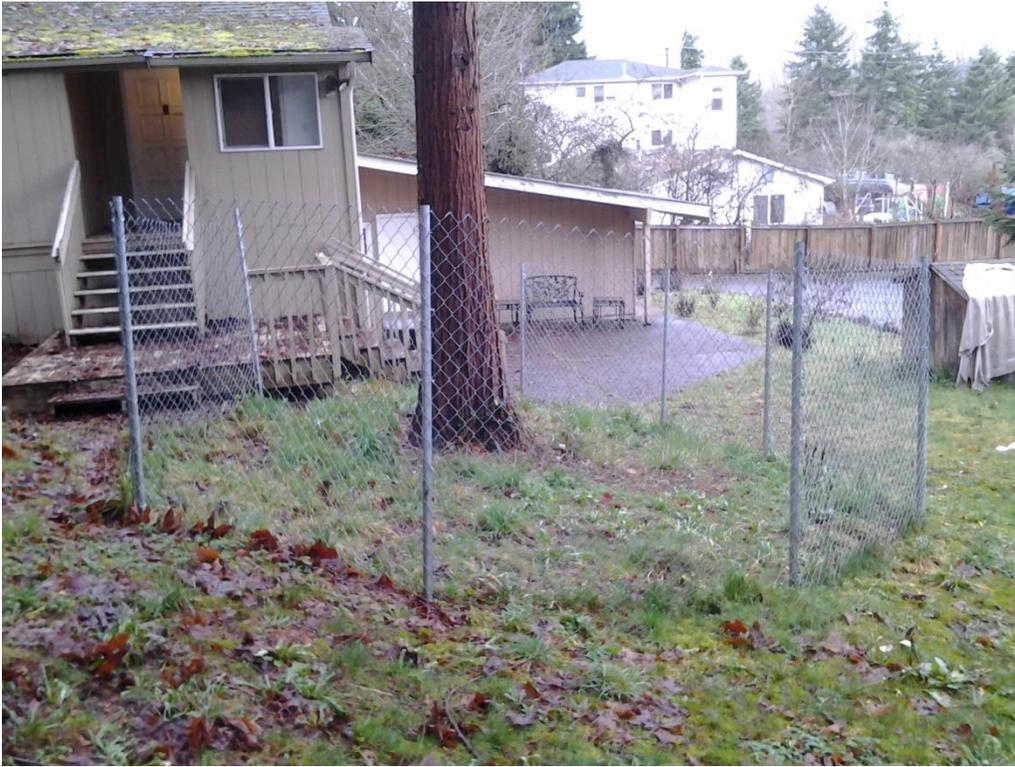
Figure 5. Photo of #22 Port Orford Cedar looking to the north. The house in the background will be razed and replaced.

- 22) Port Orford Cedar (*Chamaecyparis lawsoniana*) 23" DSH, 60' tall standing on the south side of the 2841 Bellevue Way house which is below the subject property (Figure 5). This tree was not tagged or core tested. It is in average condition with normal color and decent new growth. It has a good height to diameter ratio. It was Number 526 on the previous short plat.

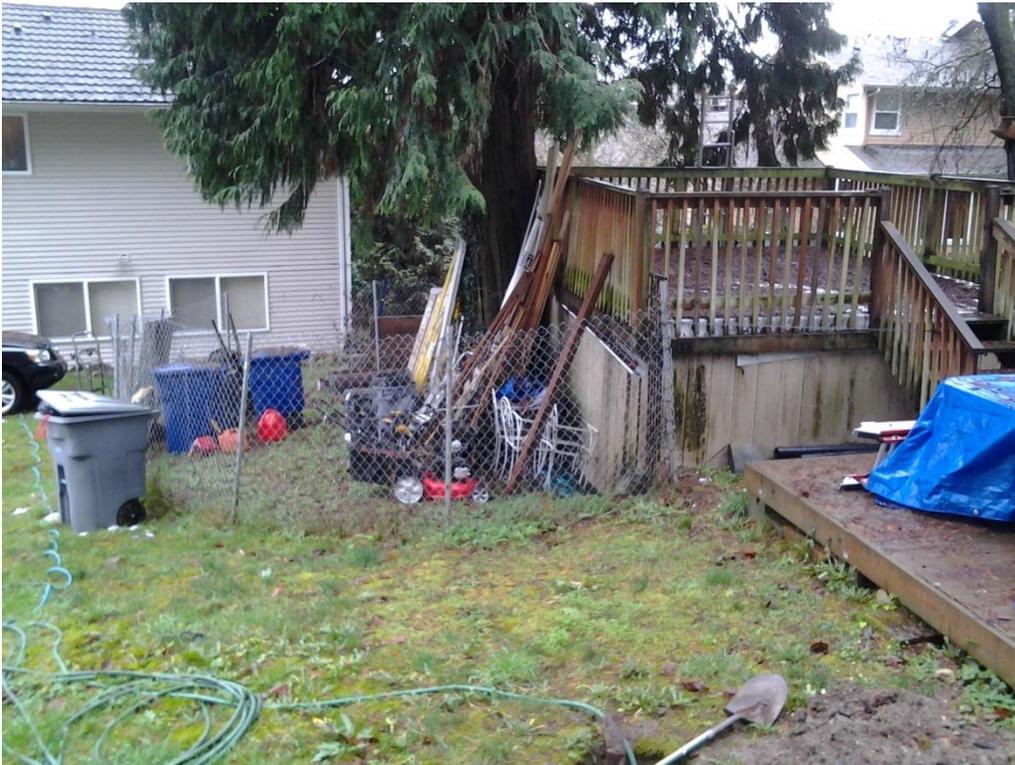
Figure 6. Photo of #23 Western Red cedar looking to the east from mid-yard. The structure to the right of the tree will be removed by hand during the demolition.

- 23) Western Red Cedar 32" DSH, 65' tall standing against the north wall of the out building on the south side of 2841 property (Figure 6). This tree was not tagged or core tested. It is in average condition with normal growth and color. The structure's impact on the cedar's roots is unknown. Tree was Number 531 on the previous short plat.
- 24) Douglas Fir 26" DSH, 85' tall standing 5' north and 13' east of the SW corner marker. Tree was not tagged or core tested. Appears to be in average condition with normal new growth and color. Not noted on 2007 short plat.

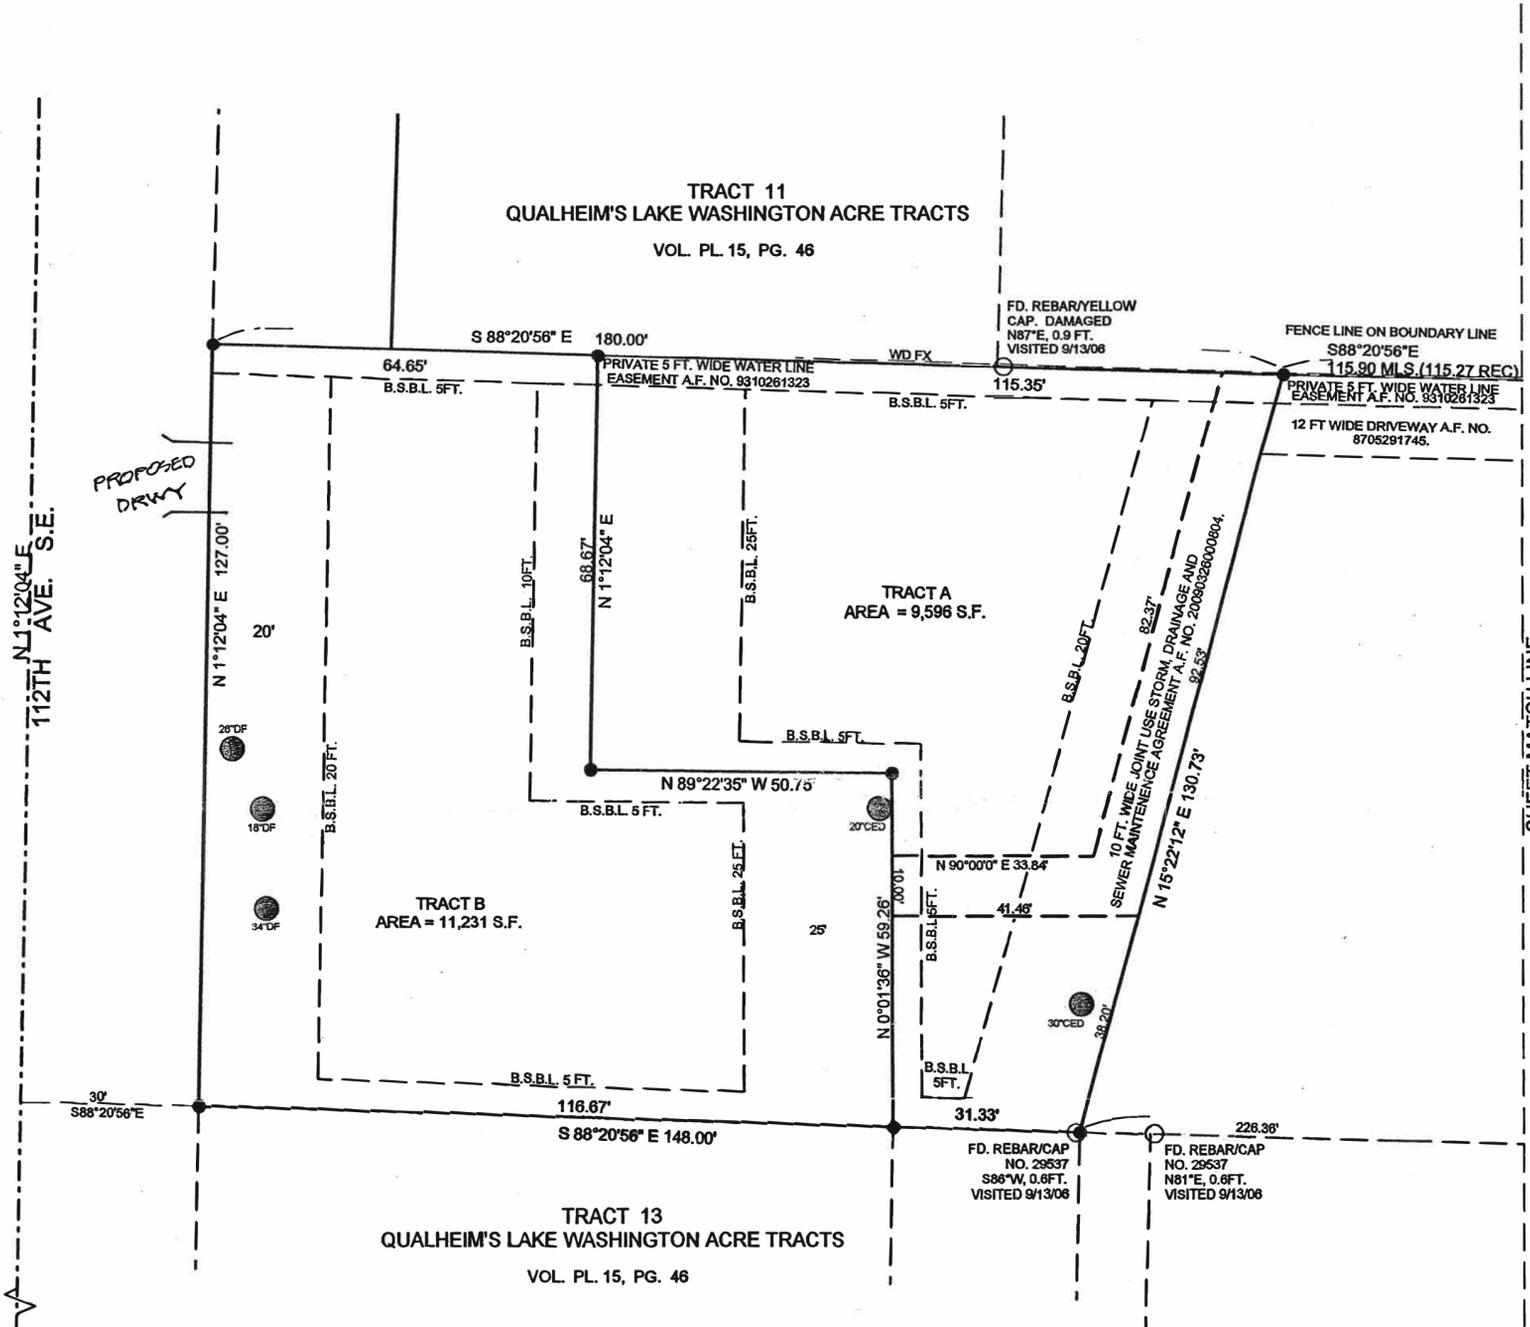
City of Bellevue
FINAL SHORT PLAT 08-143209-LF
PRELIM. SHORT PLAT NO. 07-104693-LN

SURVEYOR'S NOTES:
 BASIS OF BEARINGS:
 LOT LINE ADJUSTMENT NO. 84-28, A.F. NO. 8409279001
 CENTERLINE 112TH N01°12'04"E IN SURVEY IN VOL. 17, PG. 100,
 VISITED 9/11/06.
