# Coal Creek Park Newcastle Trailhead

## File Number: 10-125203-LO

City of Bellevue  
**Coal Creek  
 Newcastle Trailhead**

EXISTING CONDITIONS  
**2**  
 SHEET 2 of 9

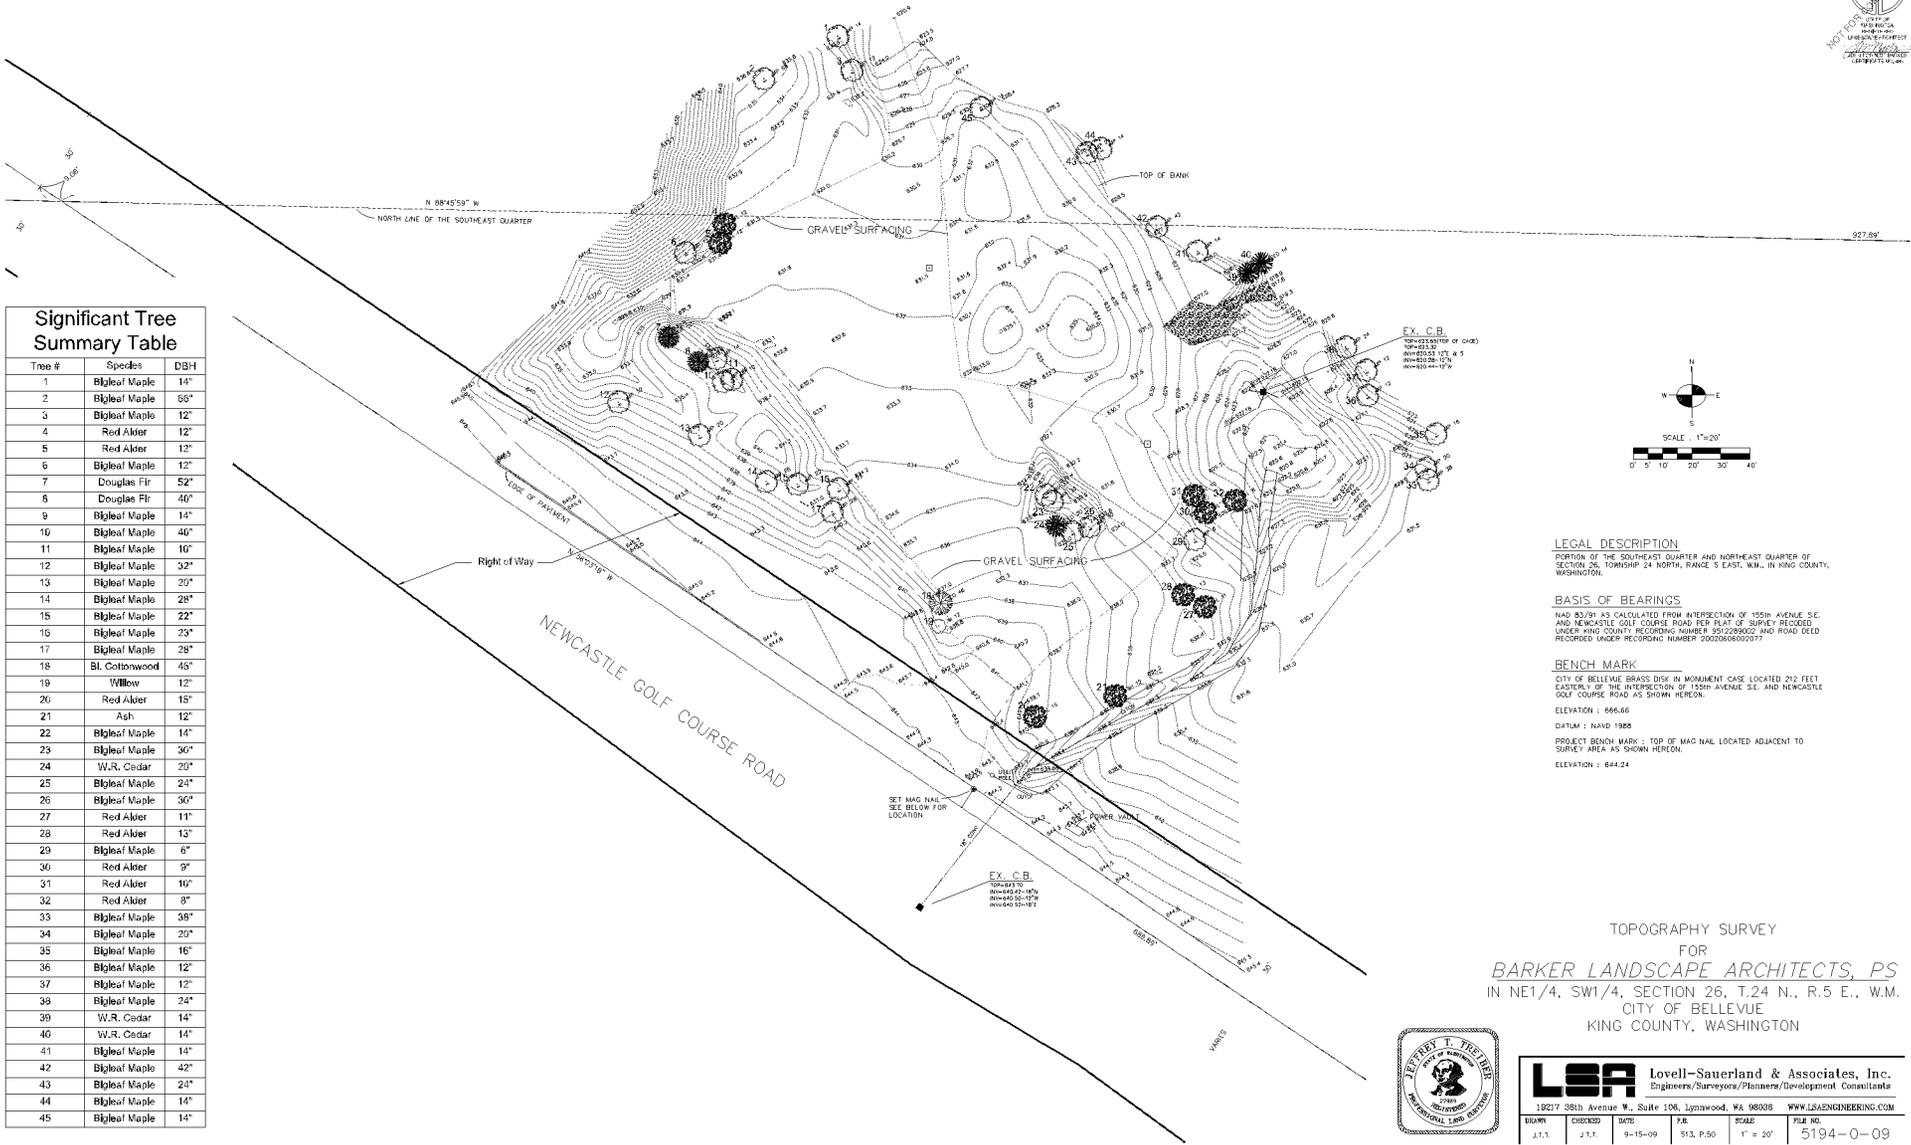
**Significant Tree Summary Table**

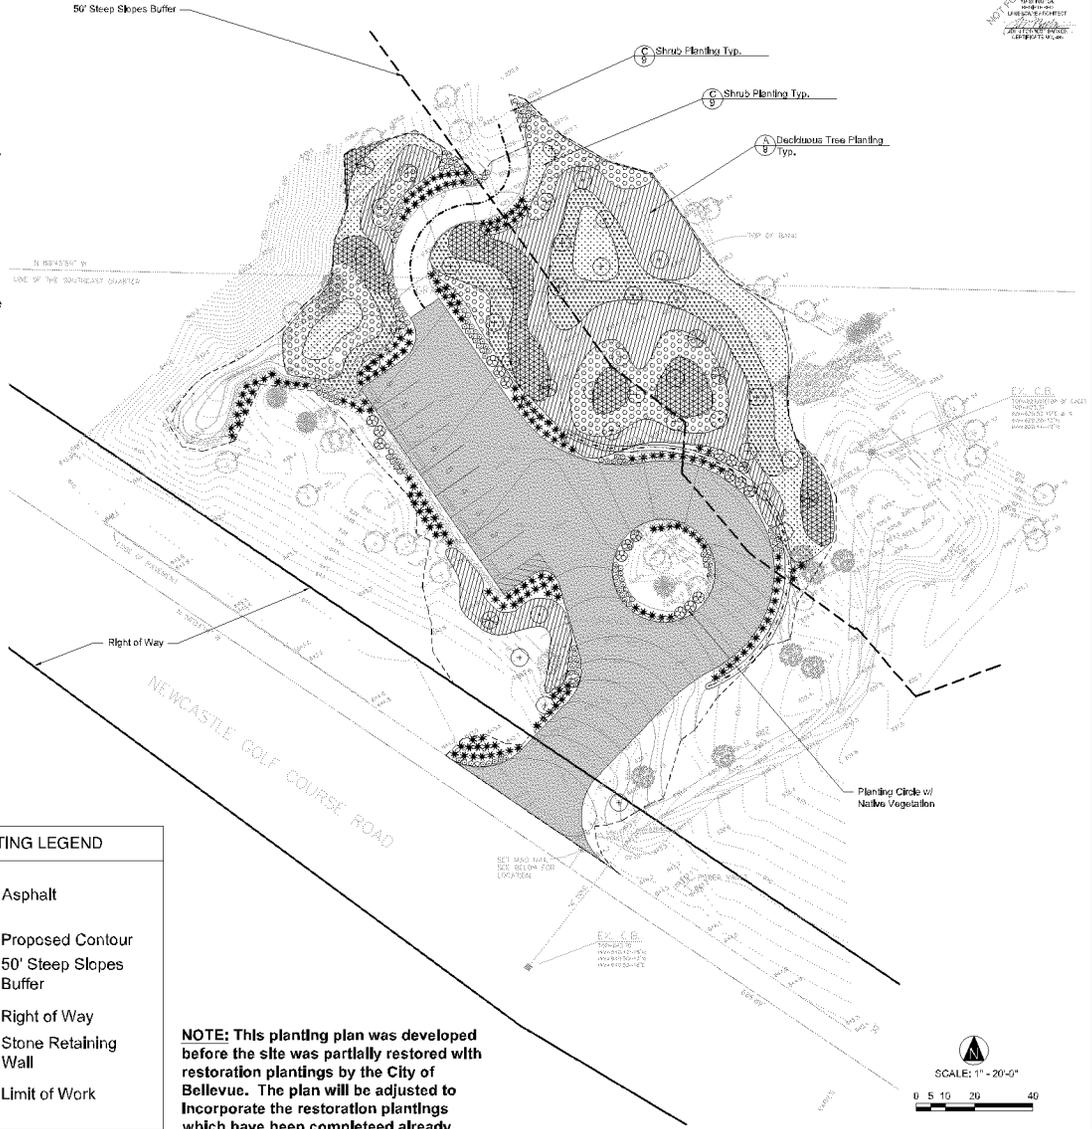
PLANTING PLAN  
**6**  
SHEET 6 of 9

**NOTE:** This planting plan was developed before the site was partially restored with restoration plantings by the City of Bellevue. The plan will be adjusted to incorporate the restoration plantings which have been completed already.

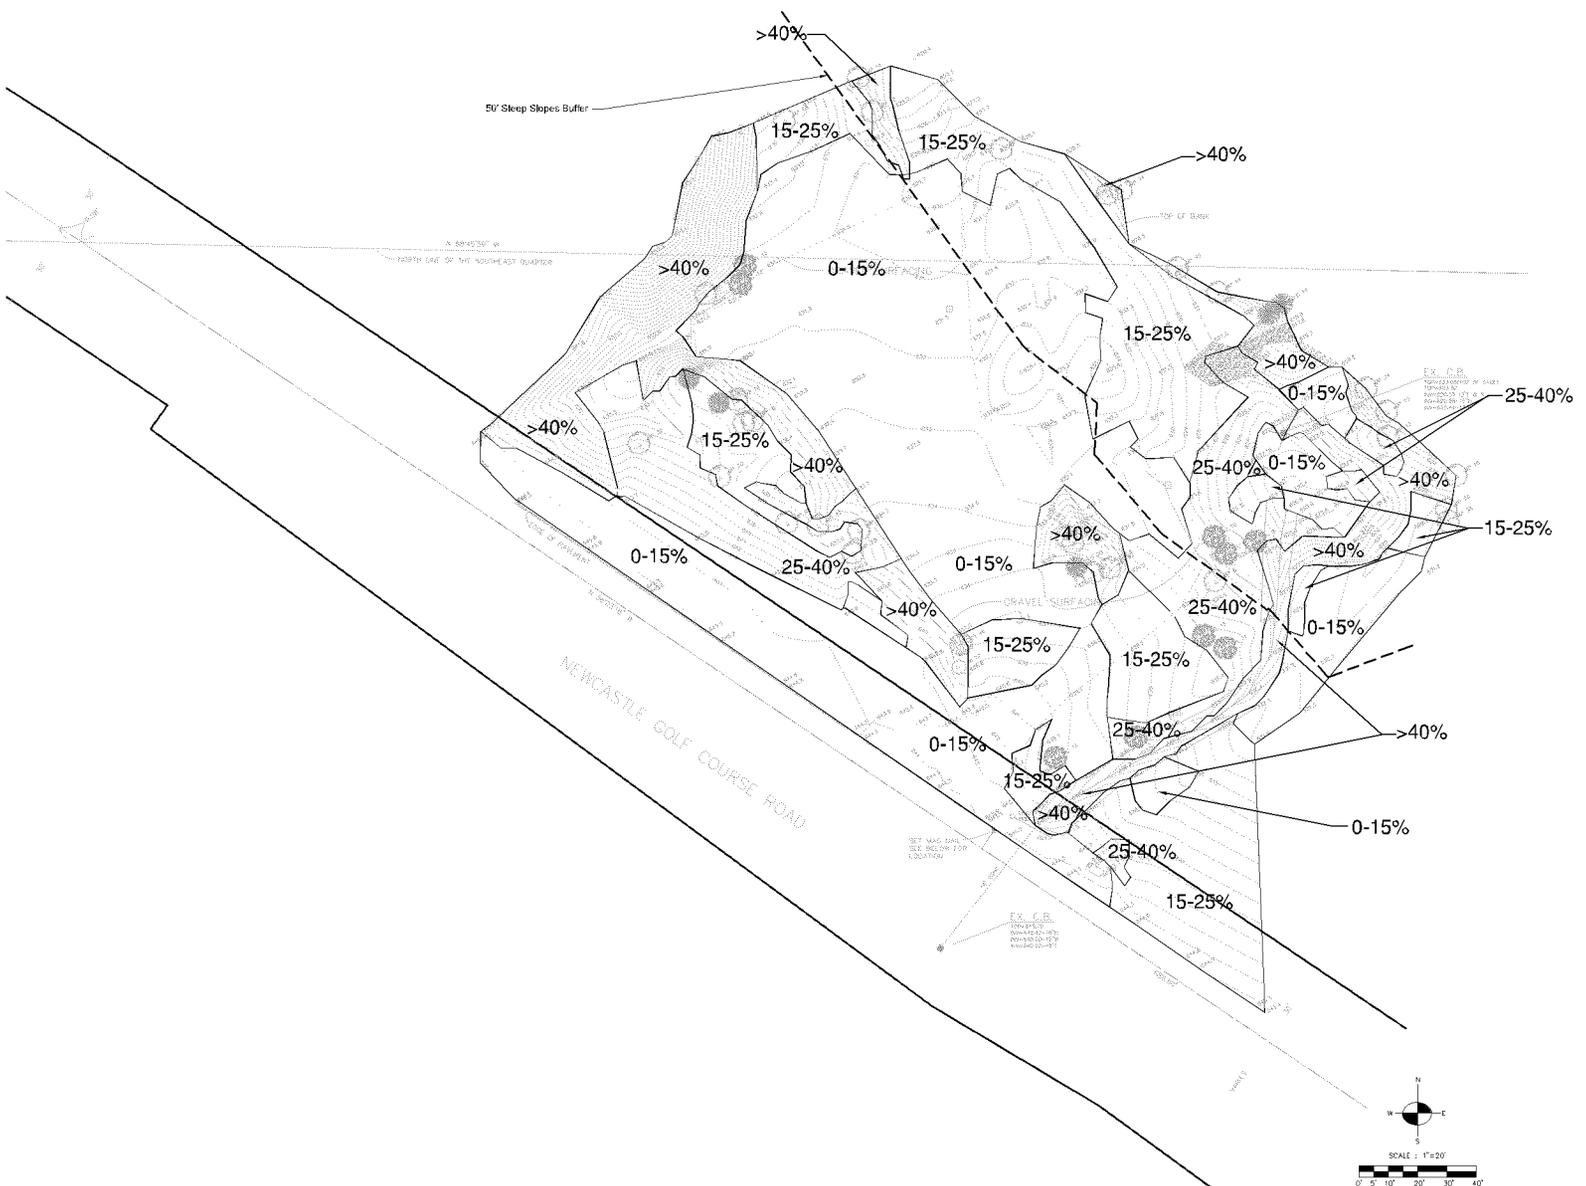
SLOPE CATEGORIES  
**7**  
 SHEET 7 of 9

**SLOPE CATEGORIES LEGEND**

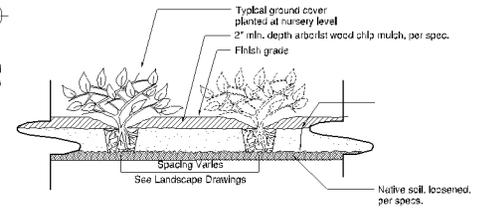
**E GROUNDCOVER PLANTING**  
 NTS

- (1) All groundcover shall be planted at equal triangular spacing or on center spacing as specified on planting plan
- (2) Locate groundcover one half of specified spacing distance from any curb, sidewalk, or other hard surface, unless otherwise specified

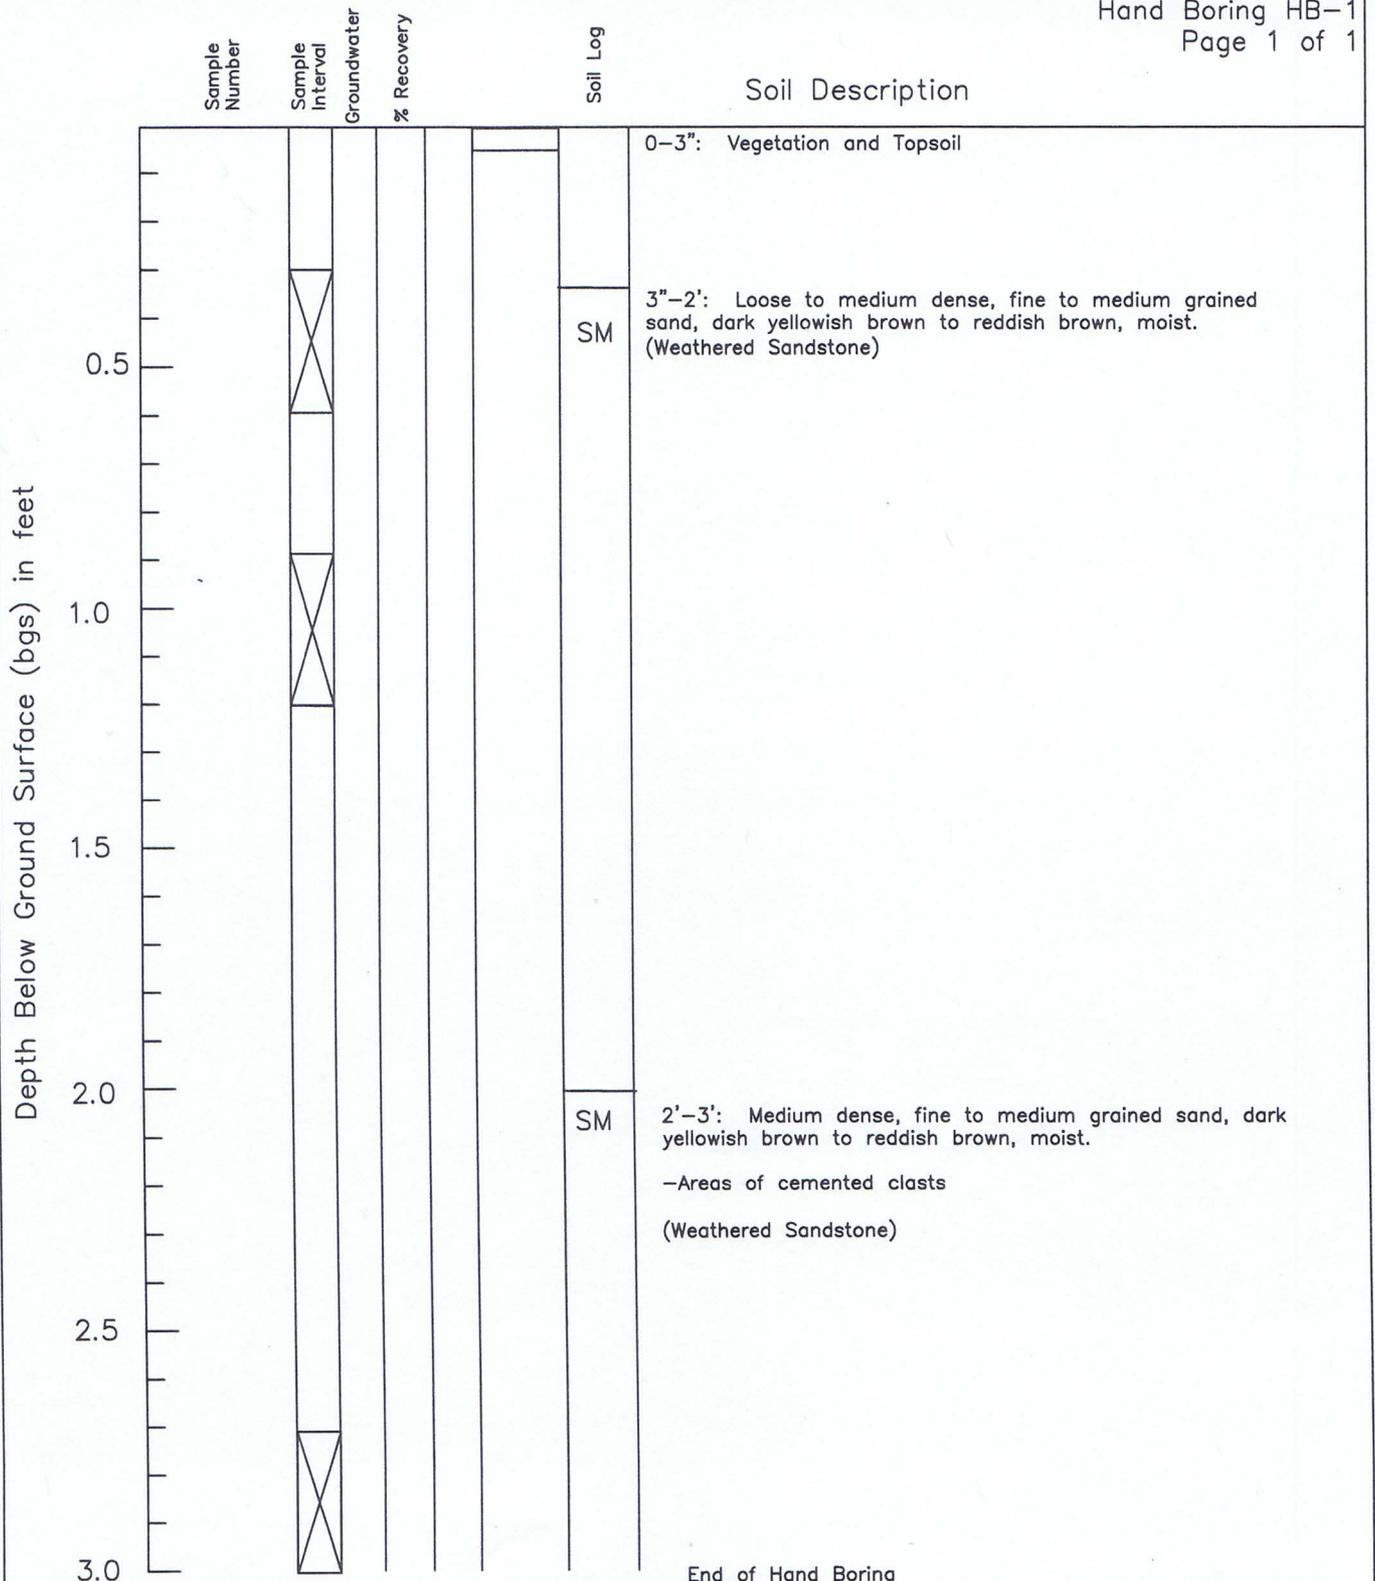
Hand Boring Log

Logged by: Phil Haberman Driller: Phil Haberman Drilling Method: Hand Auger Sampling Method: Grab Casing Type: N/A Annular Pack: N/A Slot Size: N/A	Hammer Size: NA Date Drilled: 9/25/09 Hole Diameter: 4 inches Hole Depth: 3 feet Well Diameter: N/A Well Depth: N/A Screened Interval: N/A	Depth to Water (First Encountered): None Depth to Water (Static): None
-----------------------------------------------------------------------------------------------------------------------------------------------------------------------	--------------------------------------------------------------------------------------------------------------------------------------------------------------	---------------------------------------------------------------------------

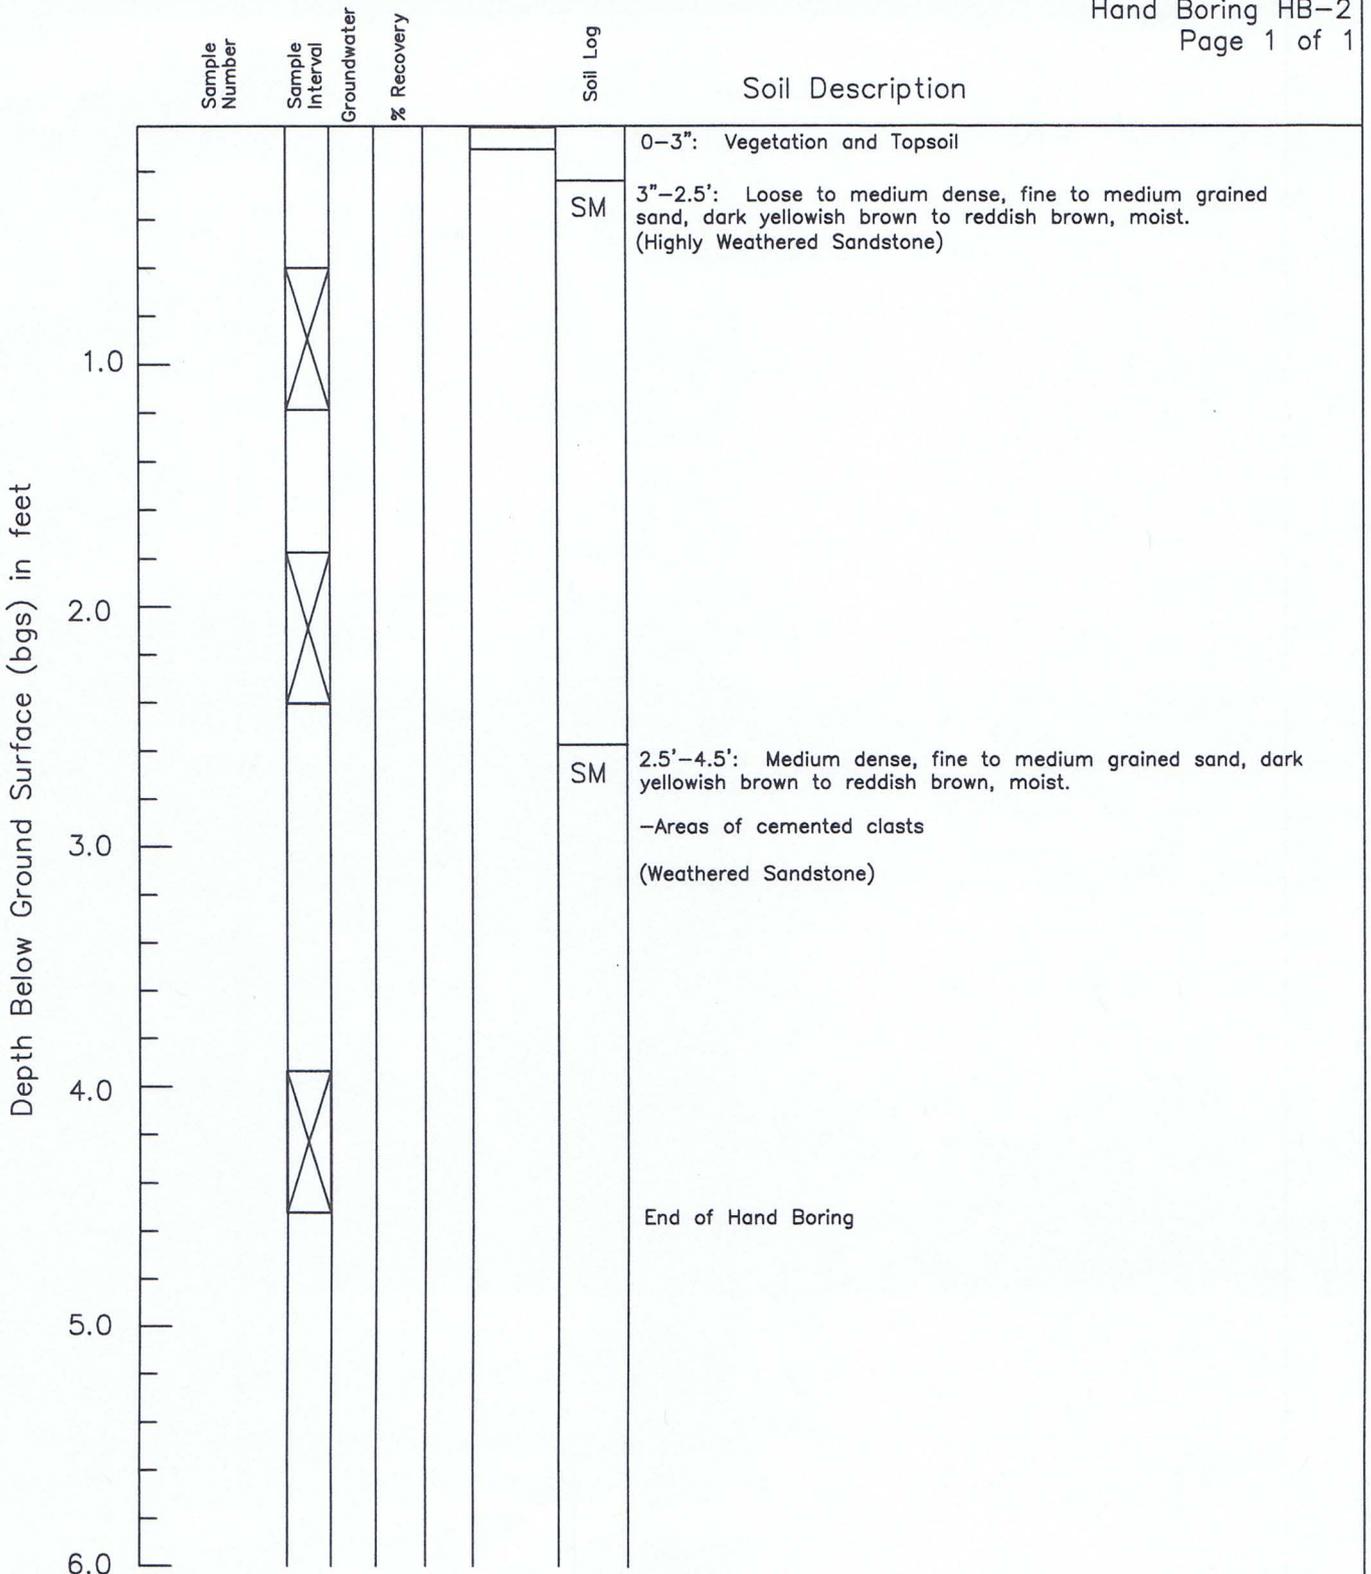
Hand Boring Log

Logged by: Phil Haberman Driller: Phil Haberman Drilling Method: Hand Auger Sampling Method: Grab Casing Type: N/A Annular Pack: N/A Slot Size: N/A	Hammer Size: NA Date Drilled: 9/25/09 Hole Diameter: 4 inches Hole Depth: 4.5 feet Well Diameter: N/A Well Depth: N/A Screened Interval: N/A	Depth to Water (First Encountered): None Depth to Water (Static): None
-----------------------------------------------------------------------------------------------------------------------------------------------------------------------	----------------------------------------------------------------------------------------------------------------------------------------------------------------	---------------------------------------------------------------------------

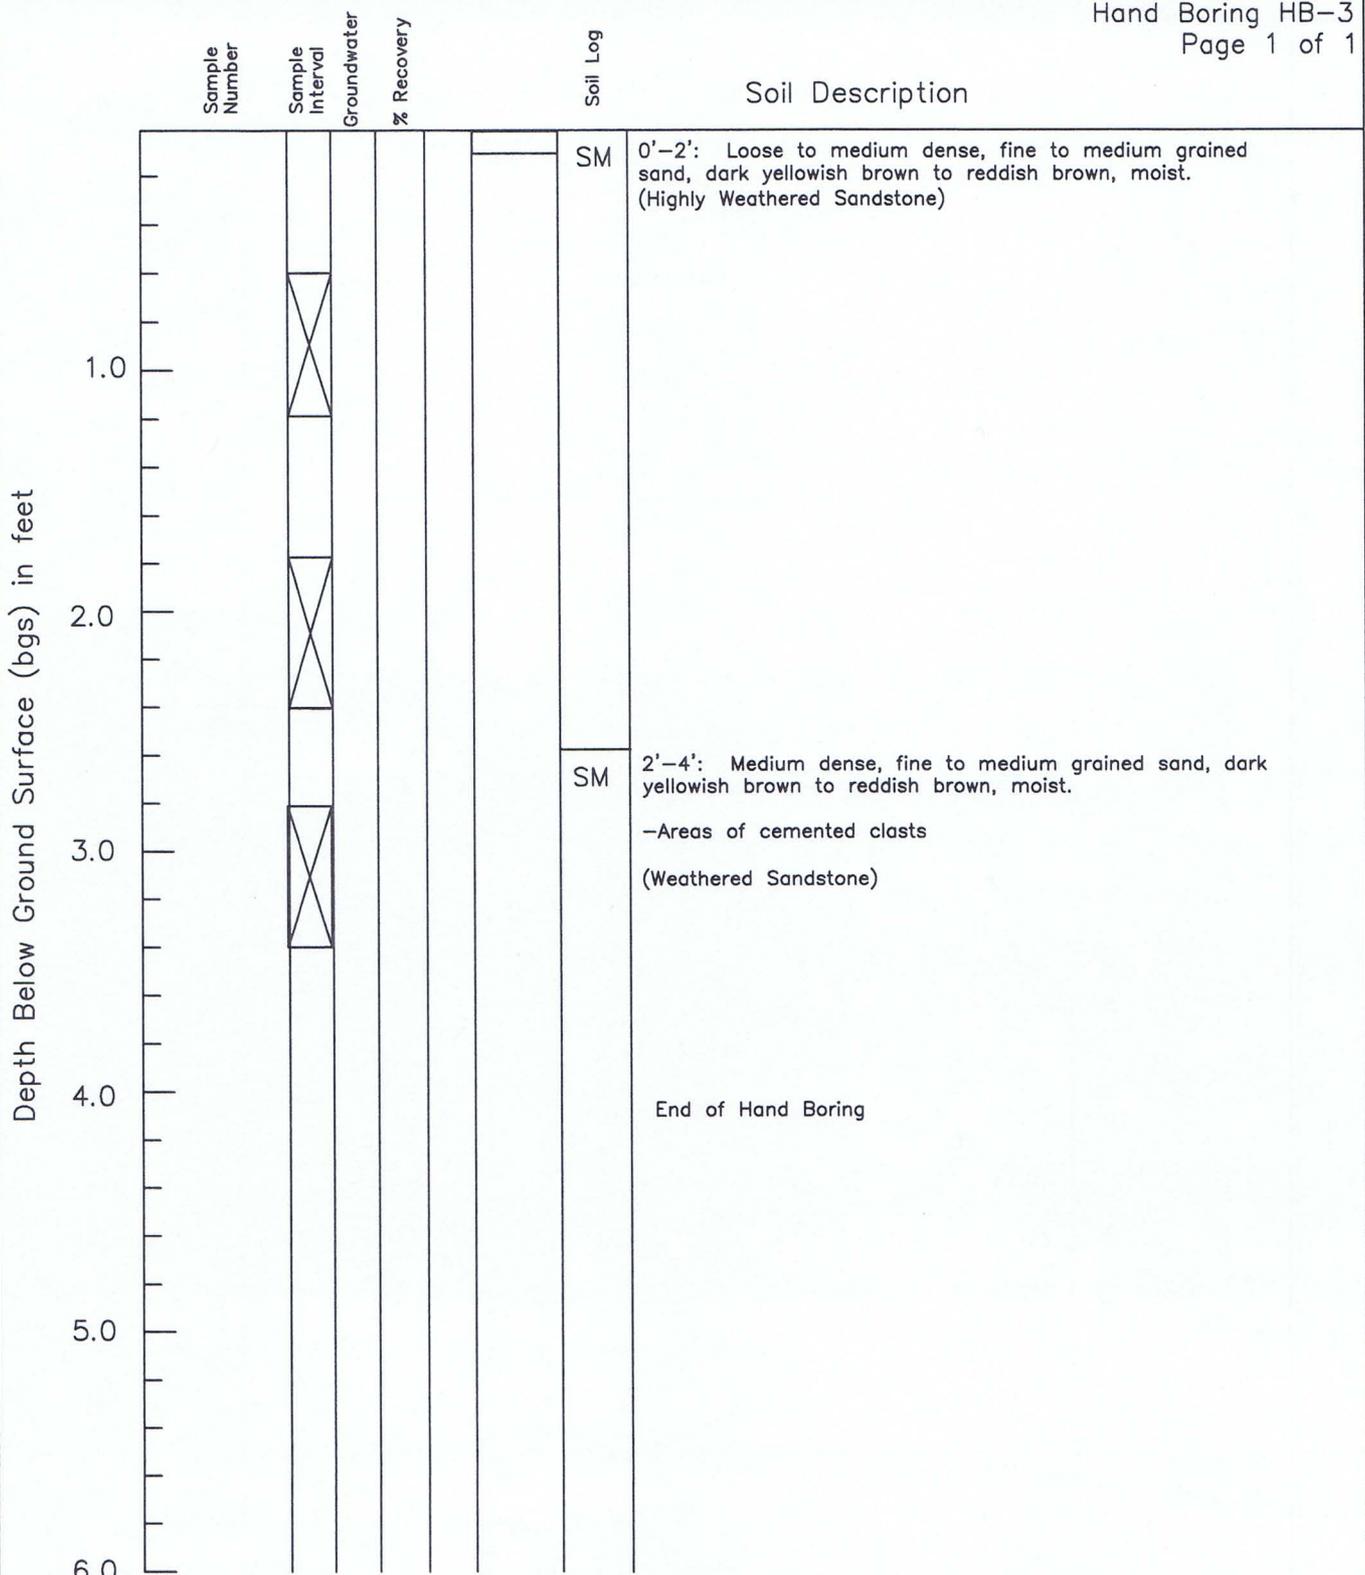
Hand Boring Log

Logged by: Phil Haberman Driller: Phil Haberman Drilling Method: Hand Auger Sampling Method: Grab Casing Type: N/A Annular Pack: N/A Slot Size: N/A	Hammer Size: NA Date Drilled: 9/25/09 Hole Diameter: 4 inches Hole Depth: 4 feet Well Diameter: N/A Well Depth: N/A Screened Interval: N/A	Depth to Water (First Encountered): None Depth to Water (Static): None
-----------------------------------------------------------------------------------------------------------------------------------------------------------------------	--------------------------------------------------------------------------------------------------------------------------------------------------------------	---------------------------------------------------------------------------

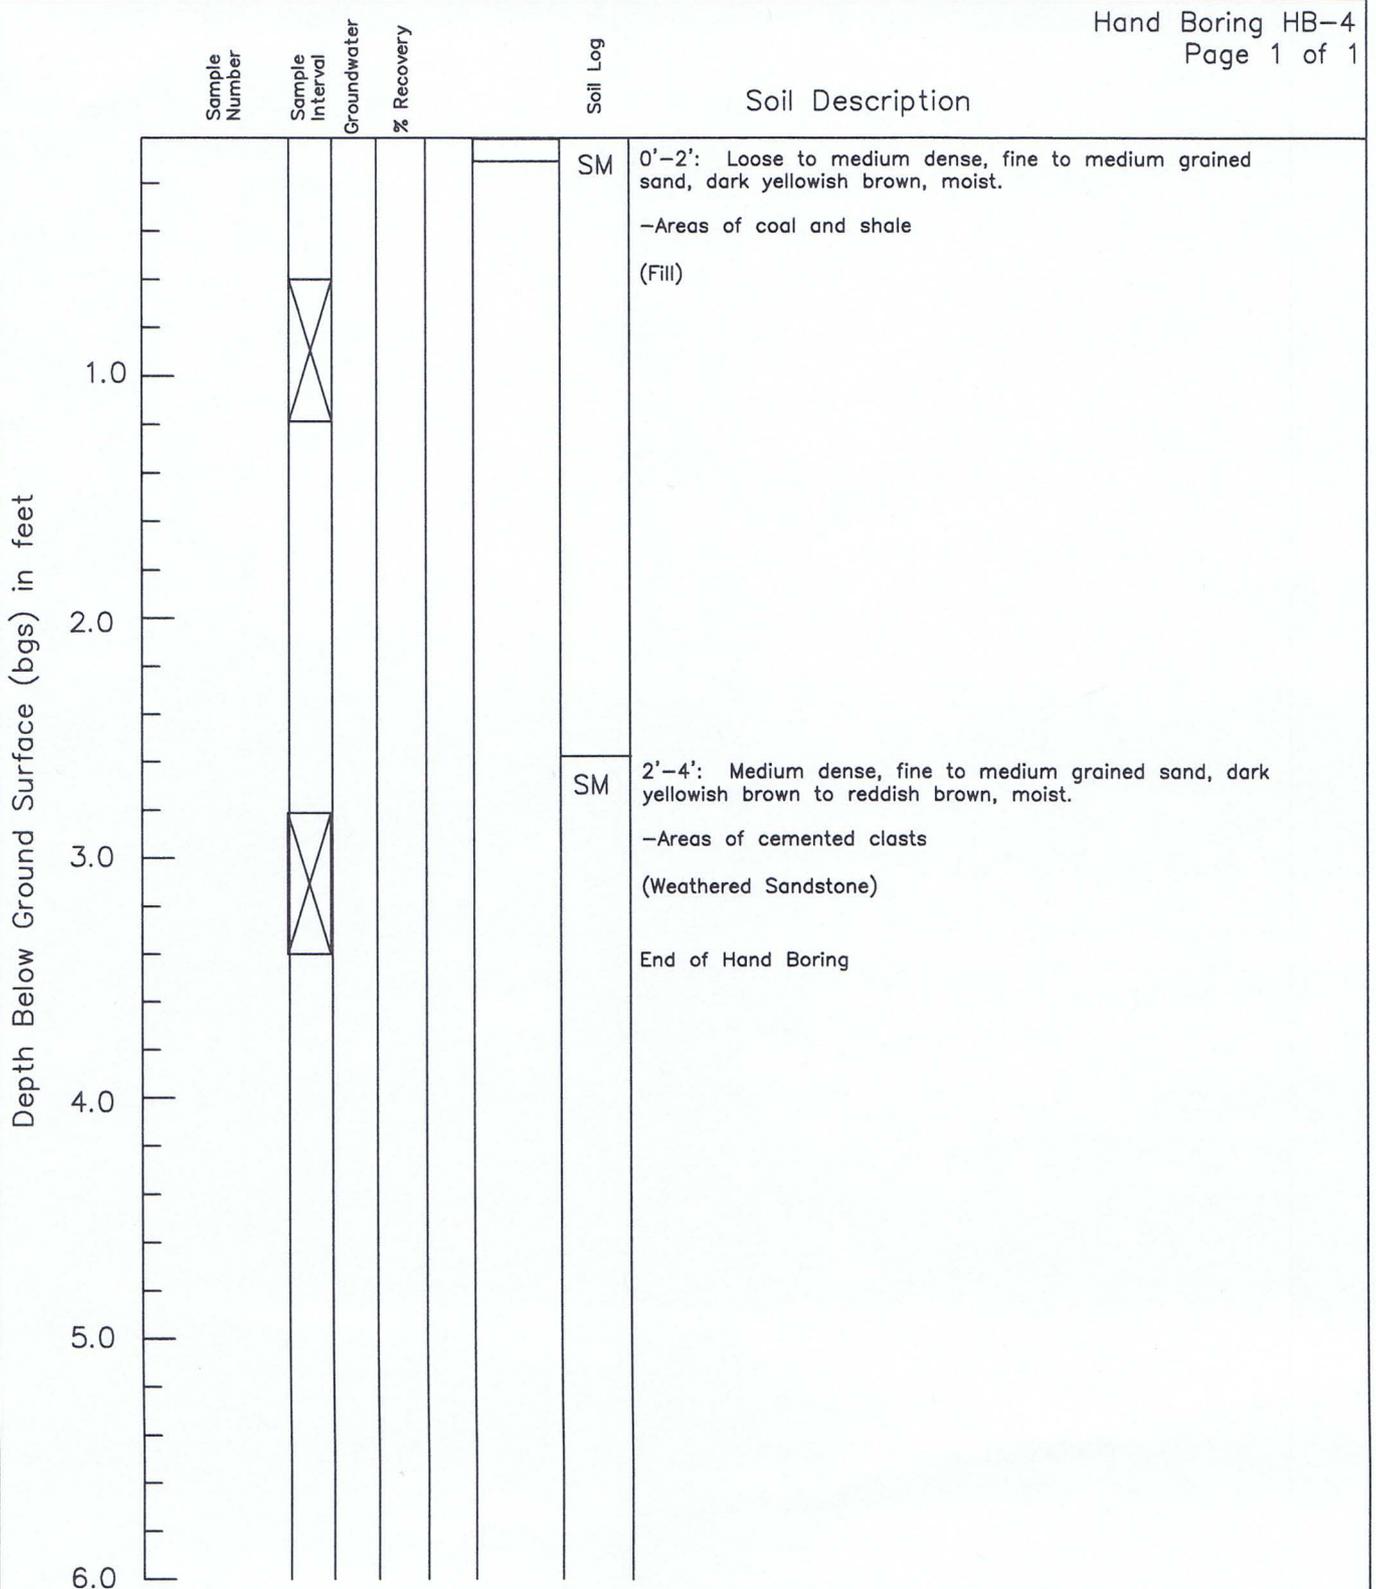
Logged by: Phil Haberman Driller: Phil Haberman Drilling Method: Hand Auger Sampling Method: Grab Casing Type: N/A Annular Pack: N/A Slot Size: N/A	Hammer Size: NA Date Drilled: 9/25/09 Hole Diameter: 4 inches Hole Depth: 3.5 feet Well Diameter: N/A Well Depth: N/A Screened Interval: N/A	Depth to Water (First Encountered): None Depth to Water (Static): None
-----------------------------------------------------------------------------------------------------------------------------------------------------------------------	----------------------------------------------------------------------------------------------------------------------------------------------------------------	---------------------------------------------------------------------------

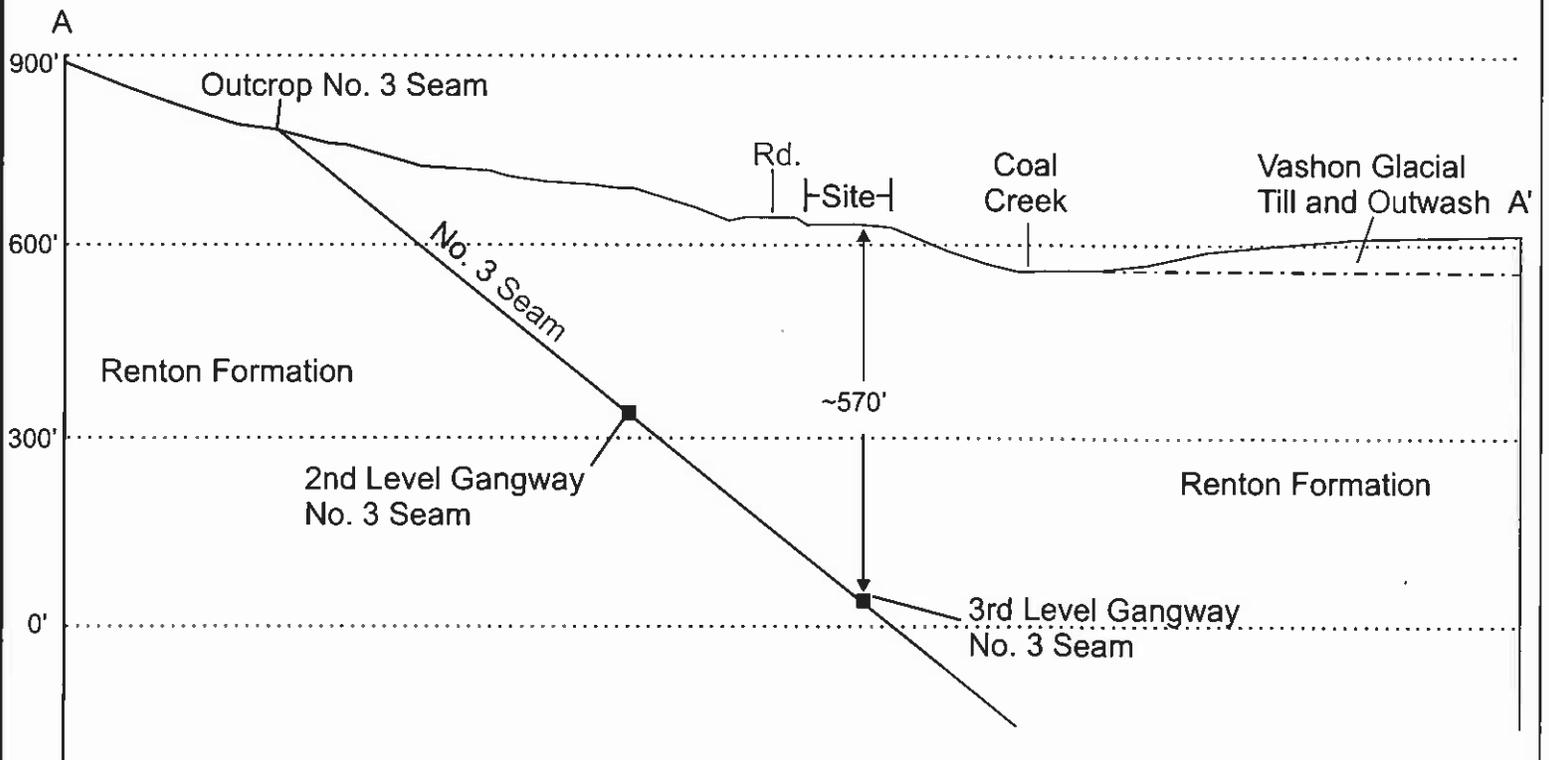
Note: The No. 3 Seam was Projected Using a Dip of 38 Degrees Per Historic Mine Data and Publication Information

----- Geologic Contact (Approximate)

evaluation of potential for sinkhole development, and suggests recommendations for mitigation to comply with **20.25H.130**. The report indicates that the site sits above a third level gangway of the No. 3 Seam located 570 feet below the surface. The report also found that the site contains no observed opening, sinkholes, shafts, or other mine-related features, and that it is likely that the third level gangway is fully collapsed. Furthermore, Kane determined that it is unlikely that other undocumented mine workings are underlying the site, and that the site seems suitable for development as a trailhead without additional mitigation measures.
