**City of Bellevue
Development Services Department
Land Use Staff Report**

Proposal Name: Ellison Slope Reconstruction and Enhancement

Proposal Address: 853 97th Avenue SE

File Number: 09-122918-LO

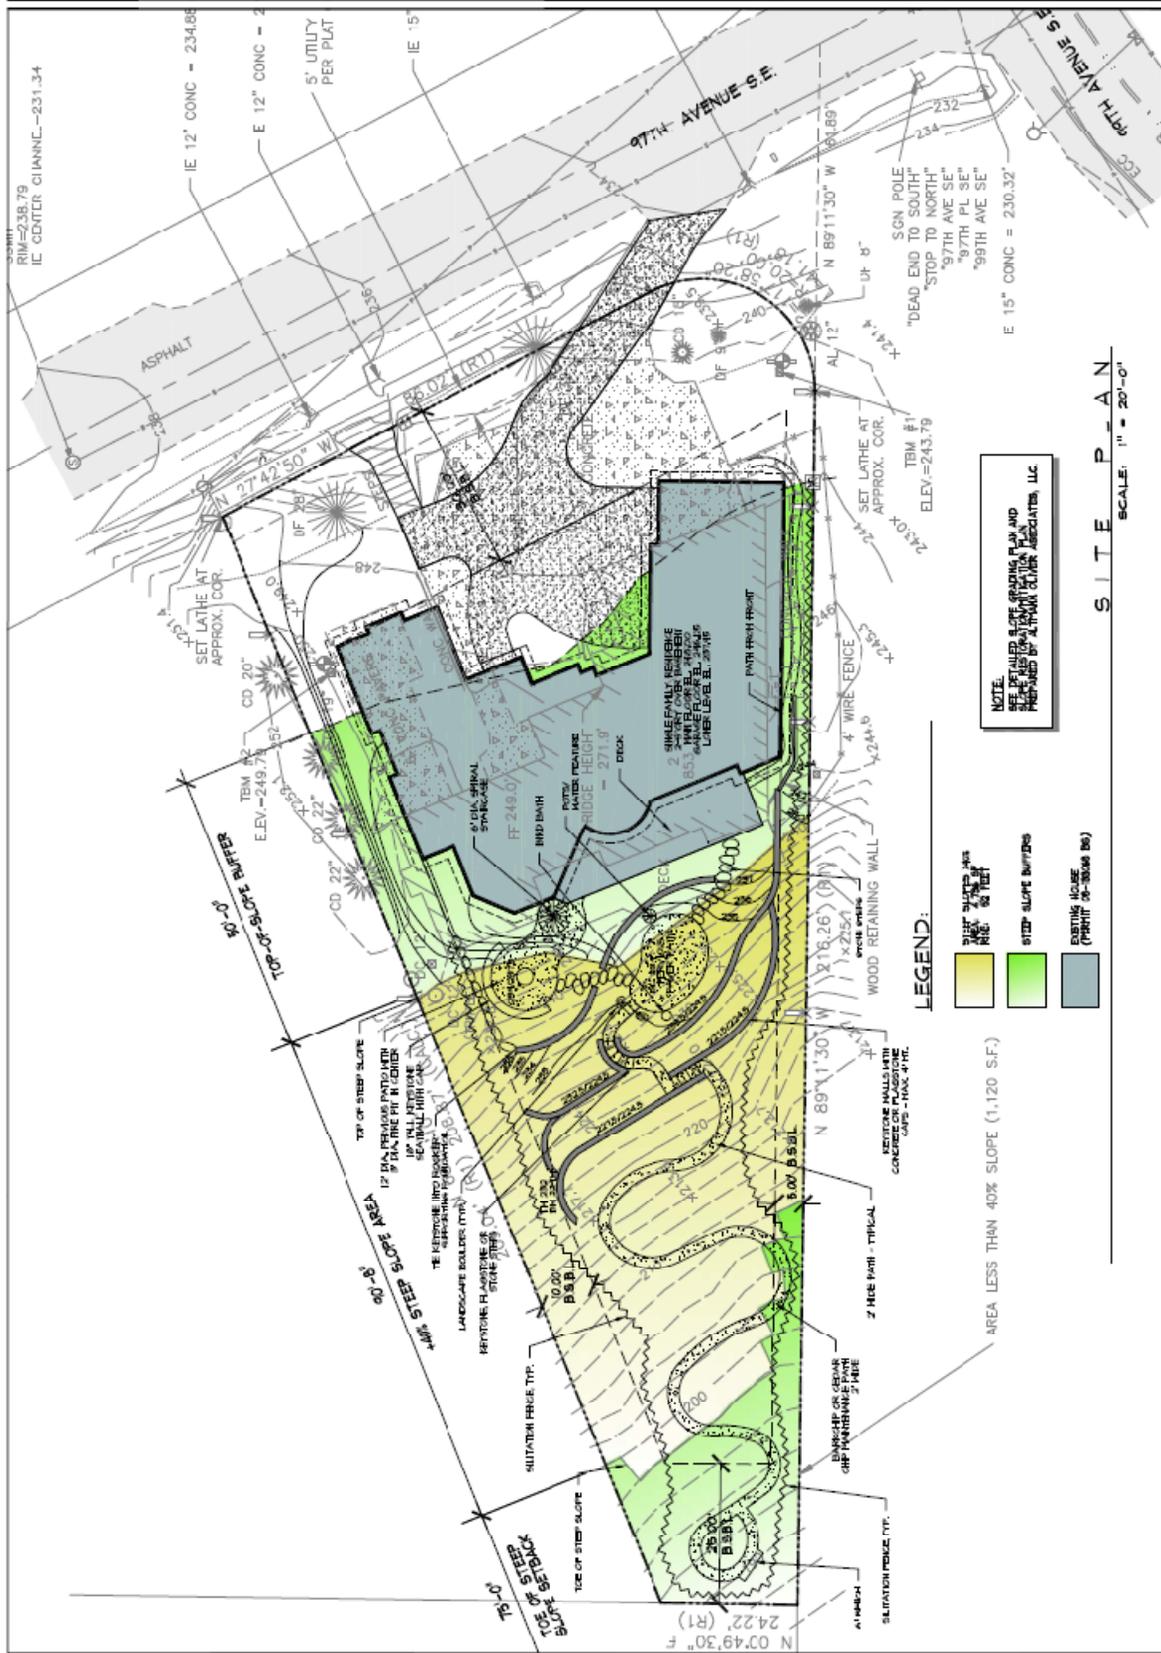
Figure 1: Site Plan

The property is located at 853 97th Avenue SE in Bellevue. The property is roughly triangular in shape. The western third of the property is relatively level and is currently being redeveloped with a single-family residence. The eastern two-thirds of the property slope steeply down to the east. The property is bounded on the north by another single-family residential property and to the south by an undeveloped portion of open space owned and managed by the Bellevue Parks & Community Services Department. The site plan show in Figure 1 below illustrates the property dimensions, the location of the primary structure under construction and the proposed slope stabilization measures.

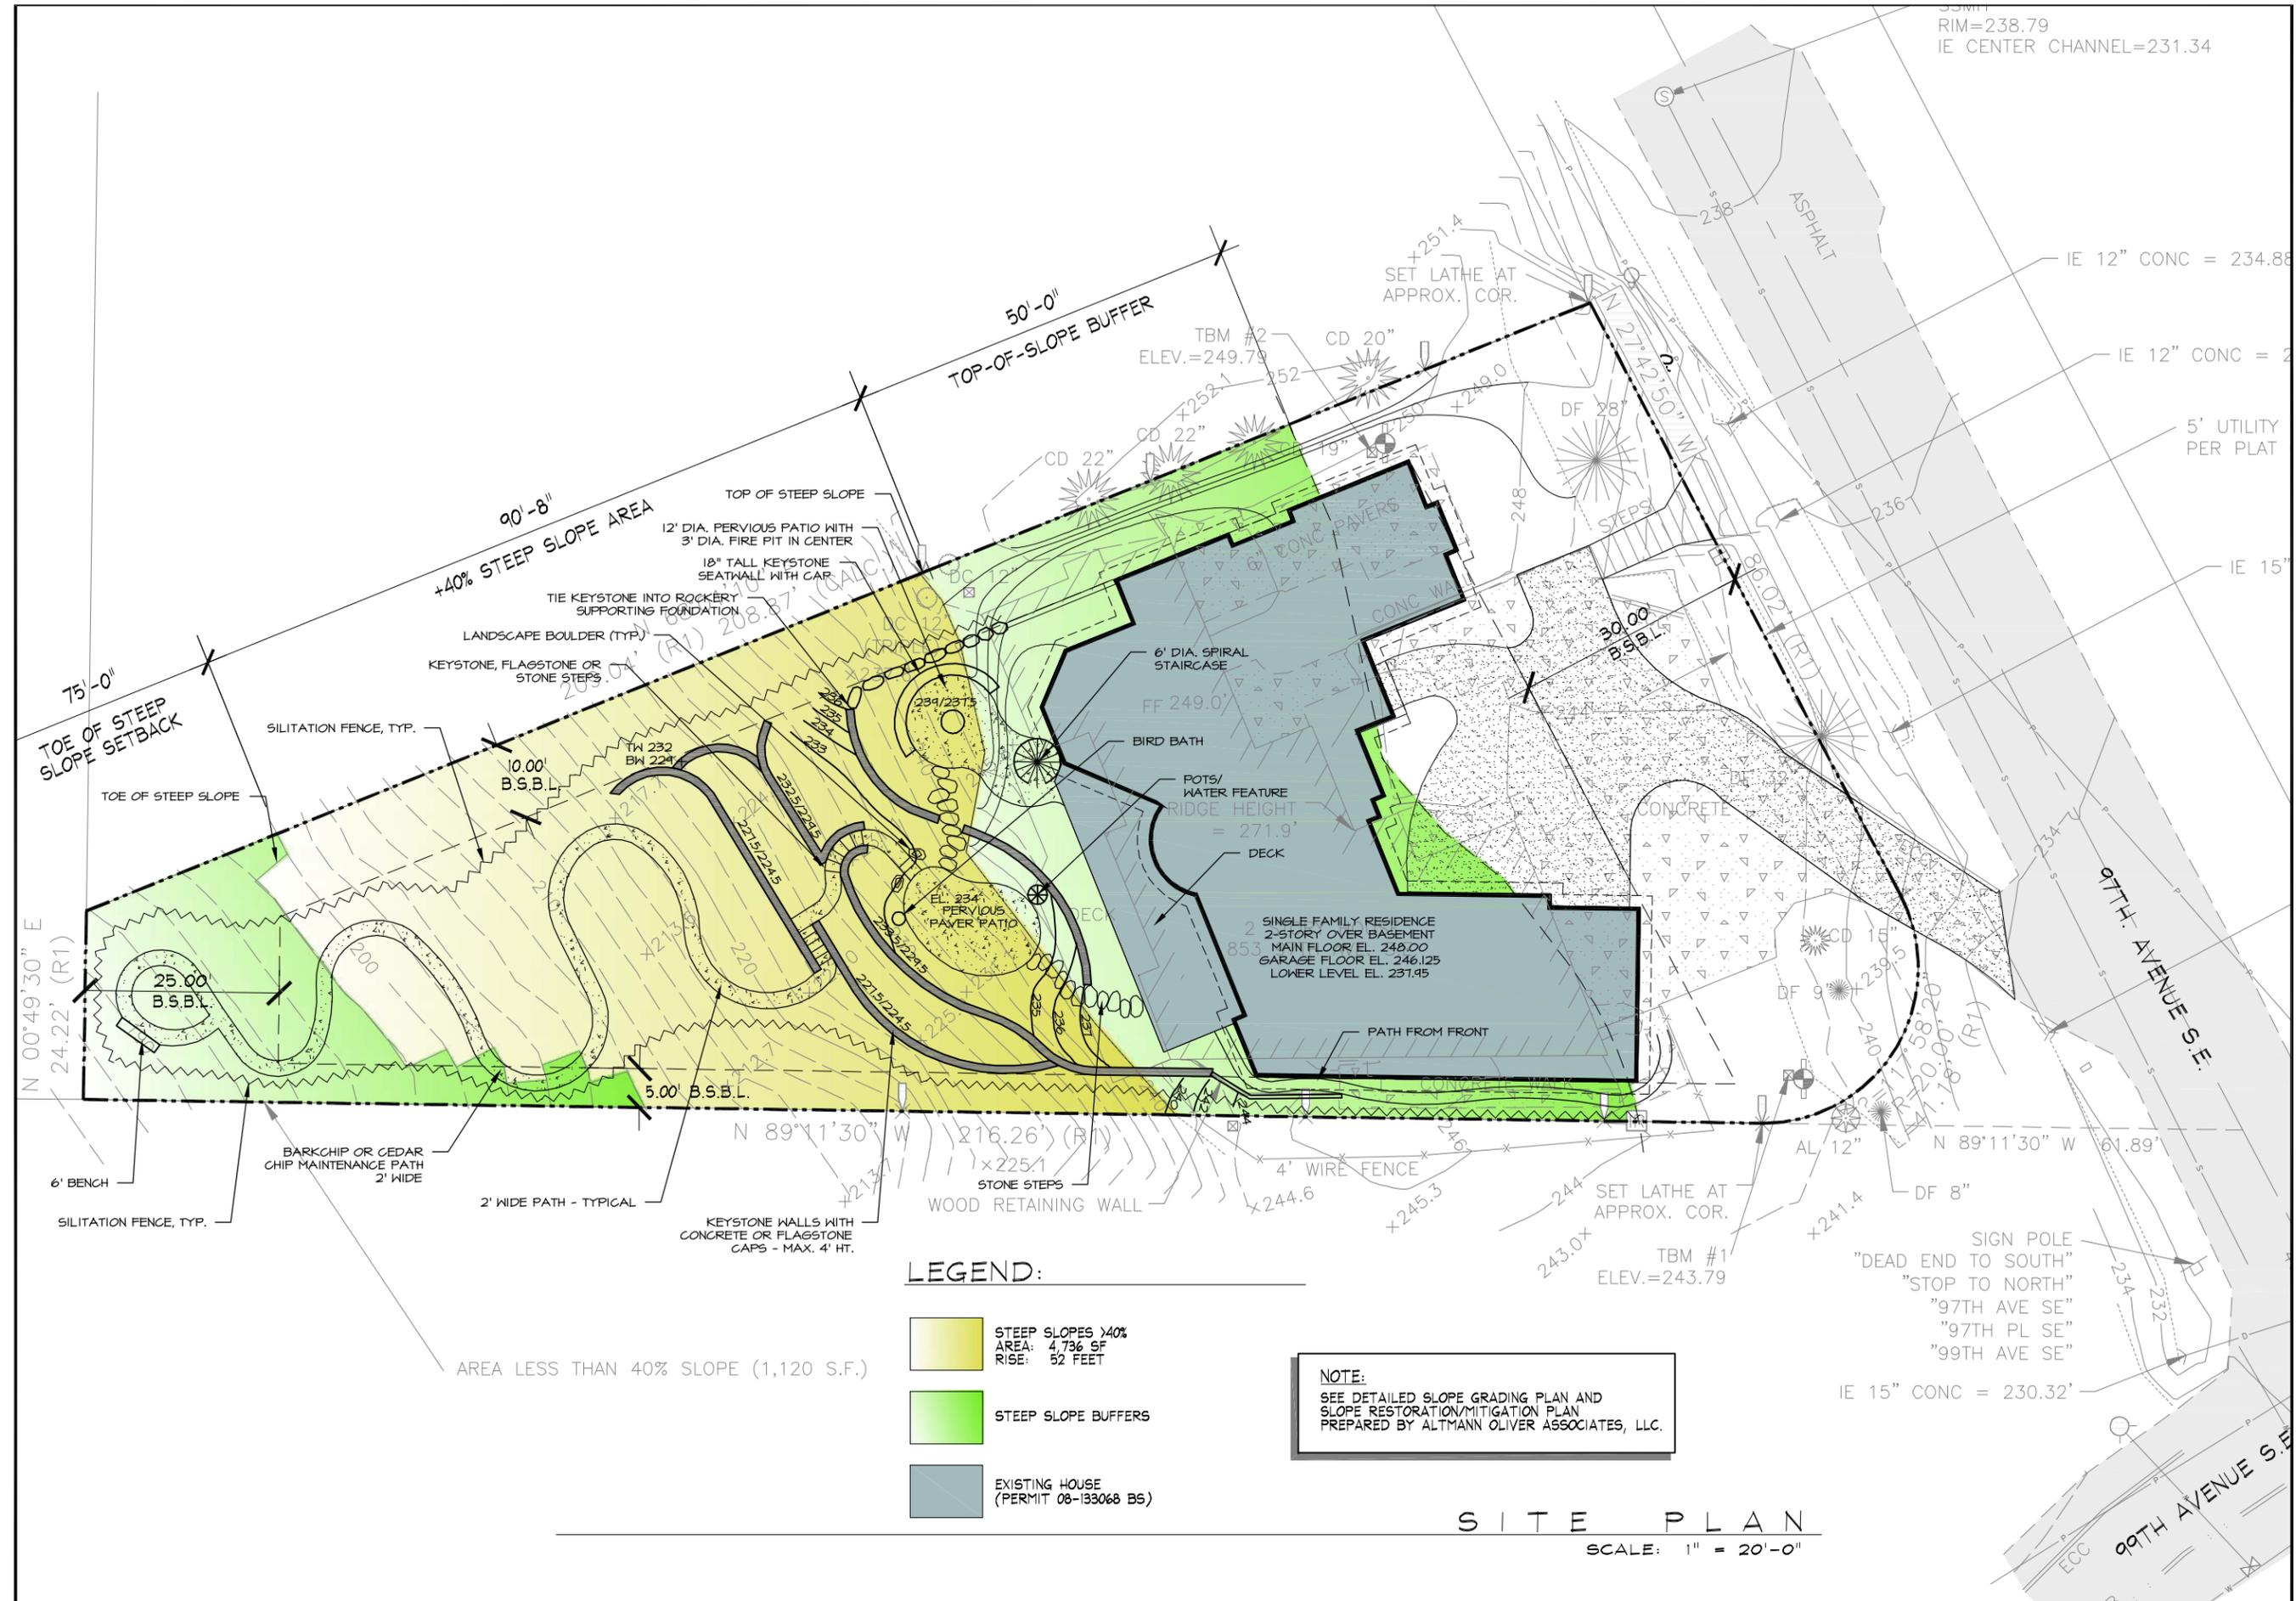
- STEEP SLOPES >40%
AREA: 4,736 SF
RISE: 52 FEET
- STEEP SLOPE BUFFERS
- EXISTING HOUSE
(PERMIT 08-193068 BS)

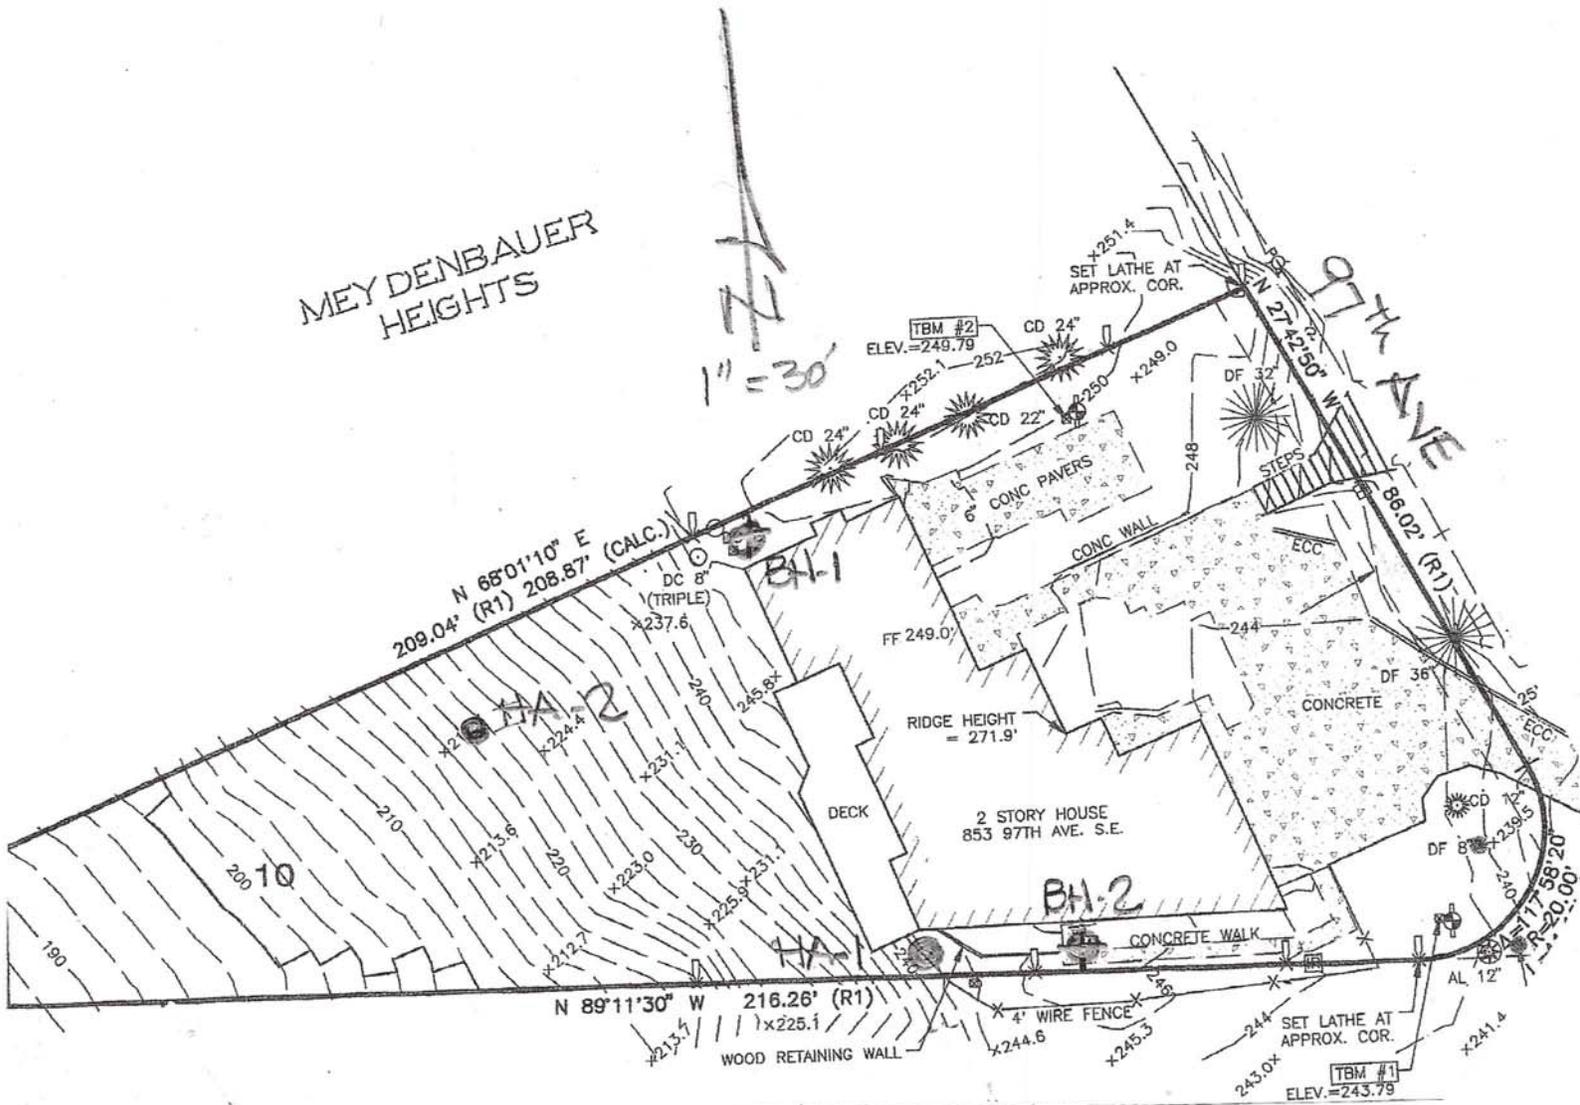
SITE PLAN

Site Plan and Topographic Survey prepared by MacPherson Design

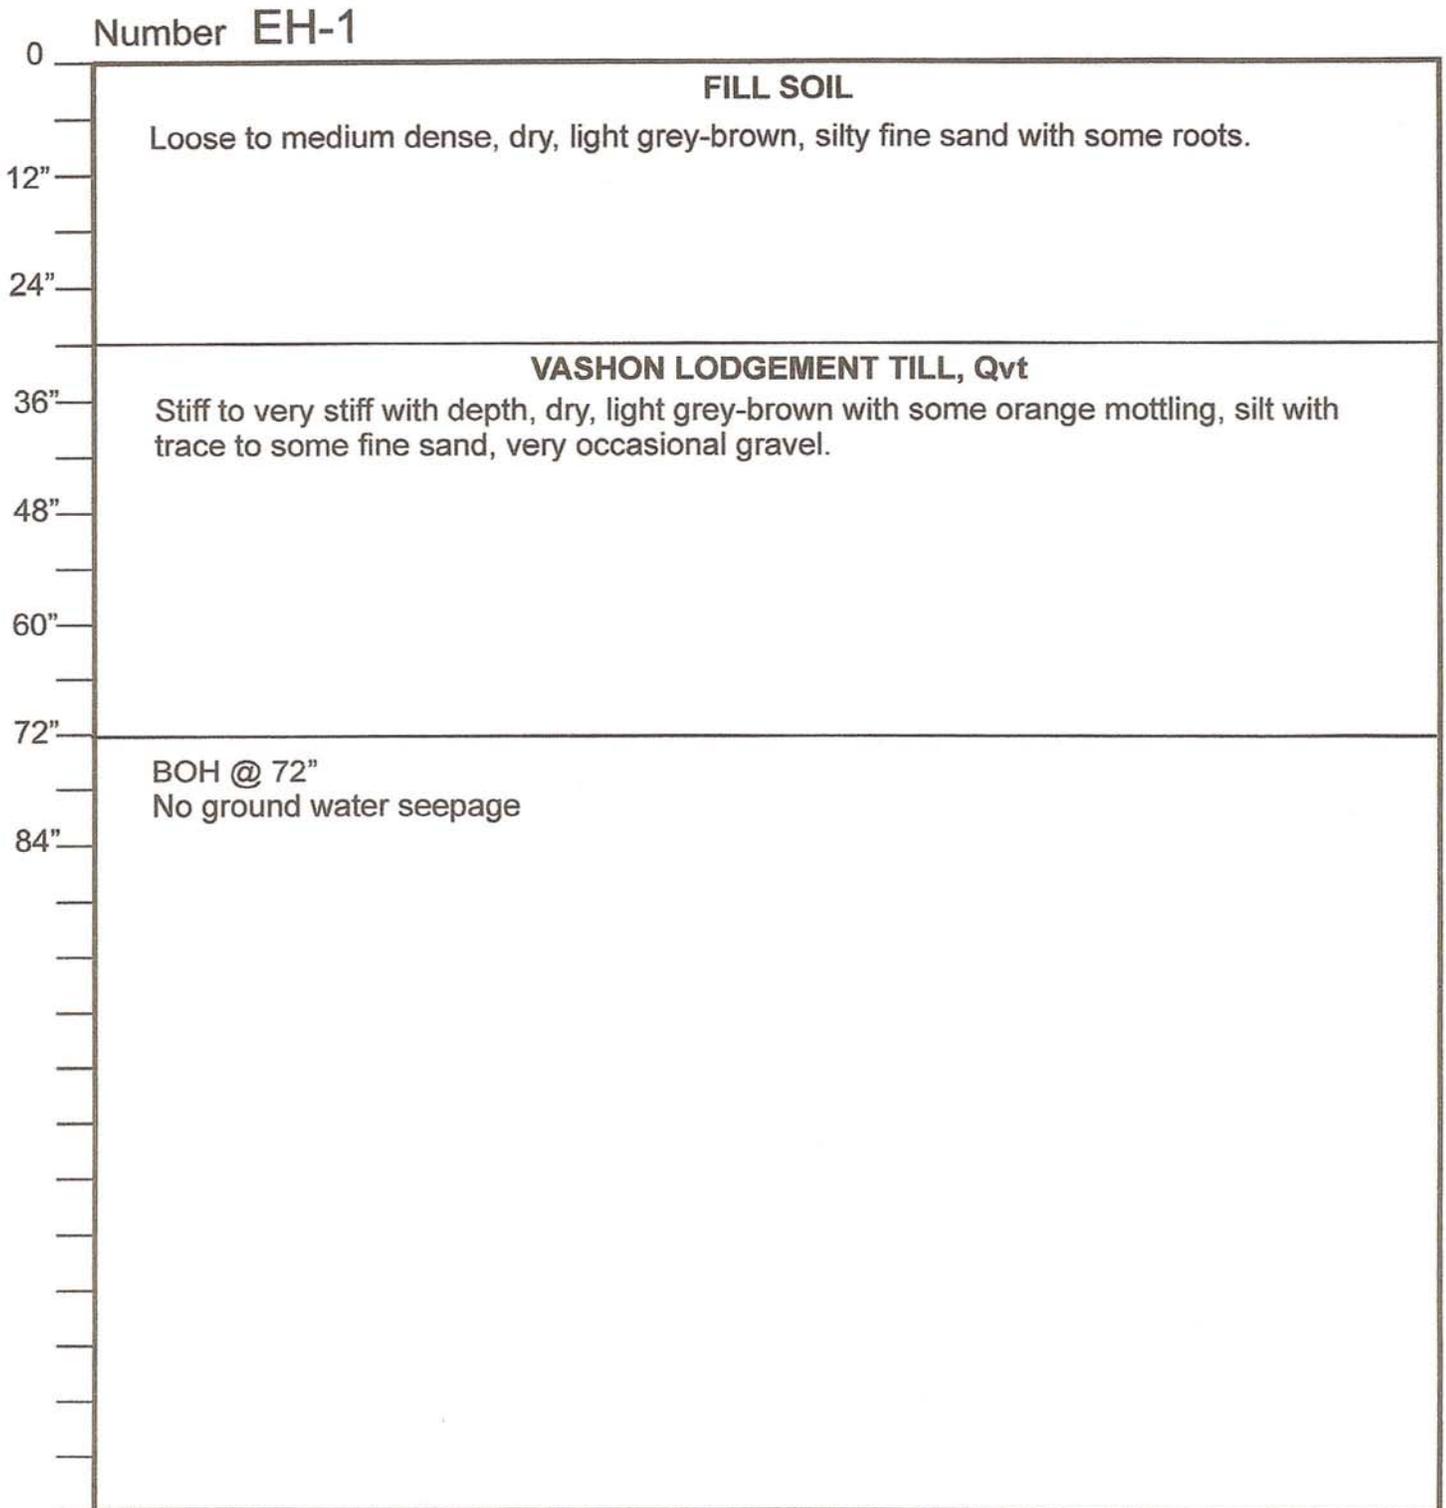
HAND HOLE LOG

Subsurface conditions depicted represent our observation at the time and location of this exploratory hole, modified by geologic interpretation, engineering analysis, and judgment. They are not necessarily representative of other times and location. We will not accept responsibility for the use or interpretation by others of information presented on this log.

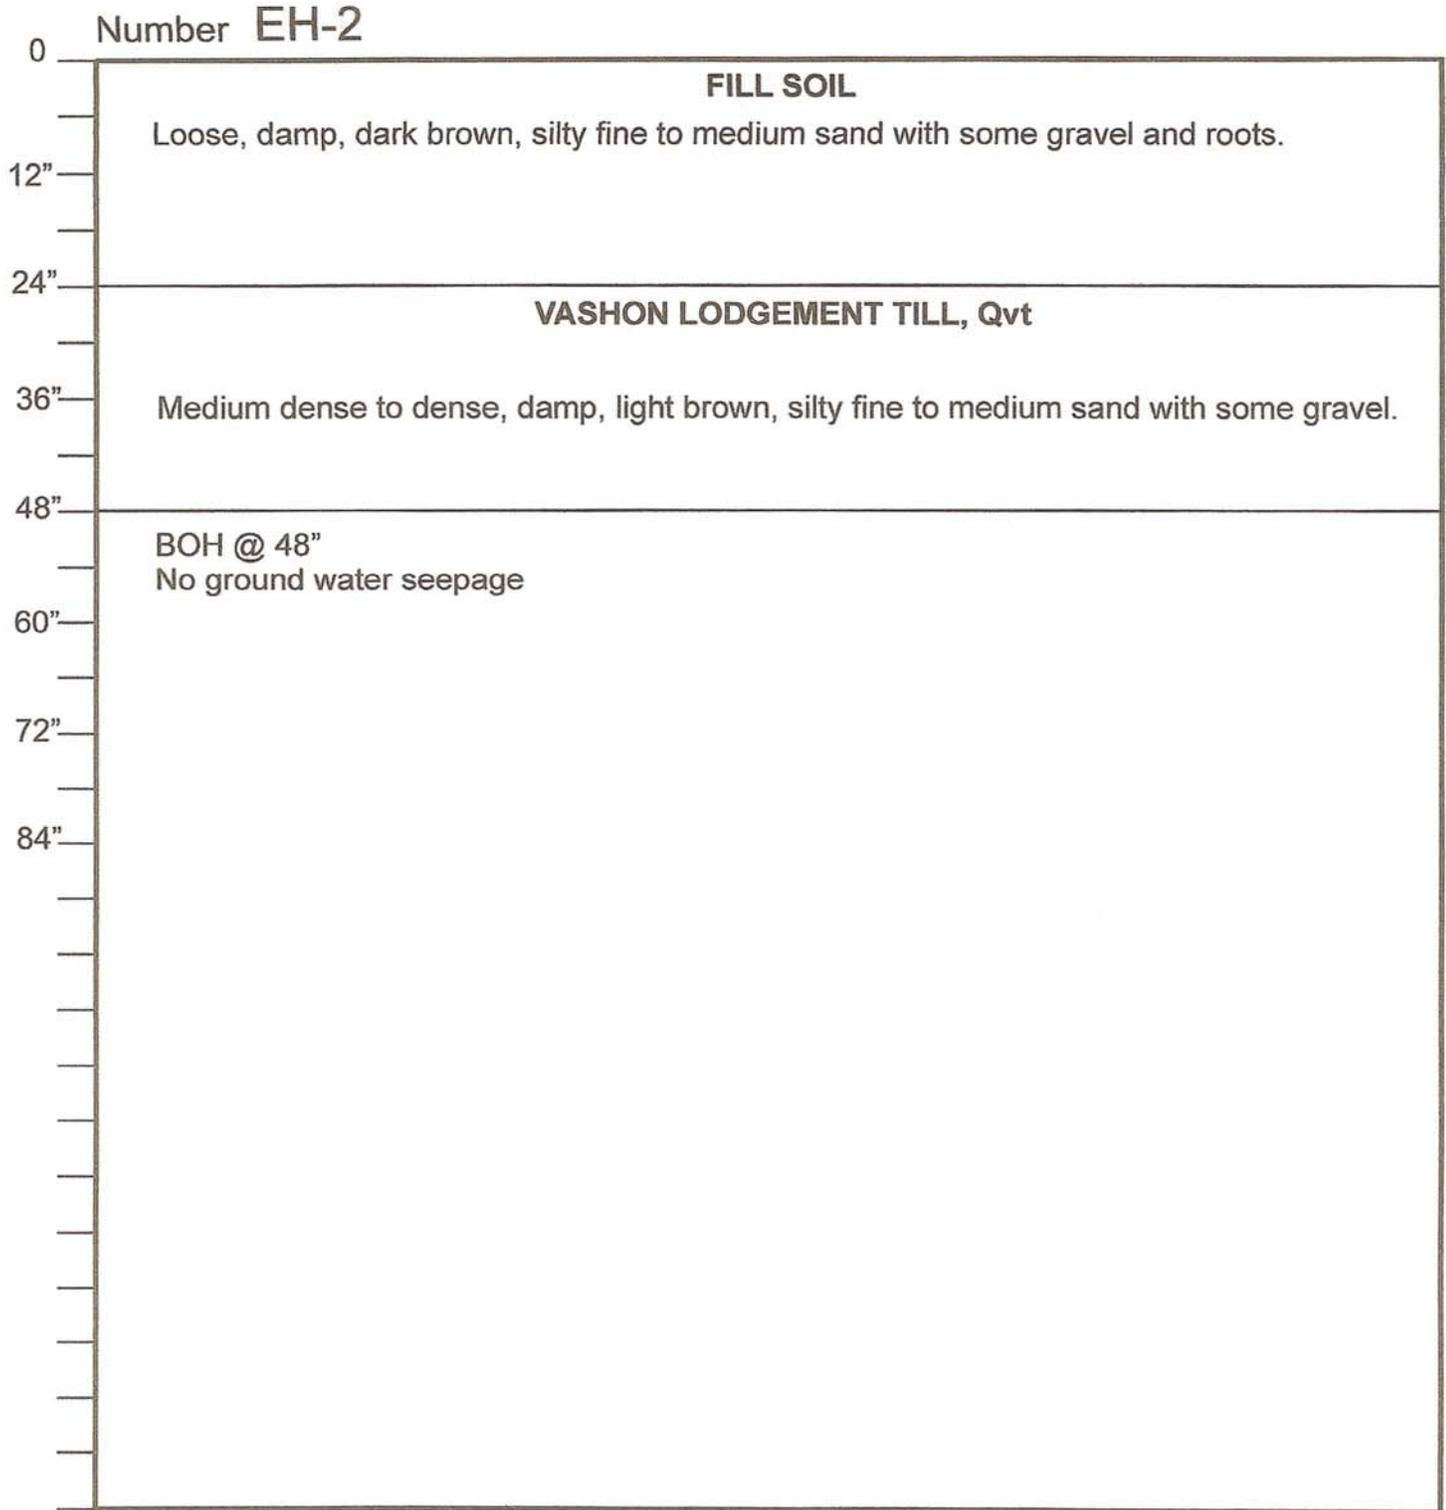
HAND HOLE LOG

Subsurface conditions depicted represent our observation at the time and location of this exploratory hole, modified by geologic interpretation, engineering analysis, and judgment. They are not necessarily representative of other times and location. We will not accept responsibility for the use or interpretation by others of information presented on this log.

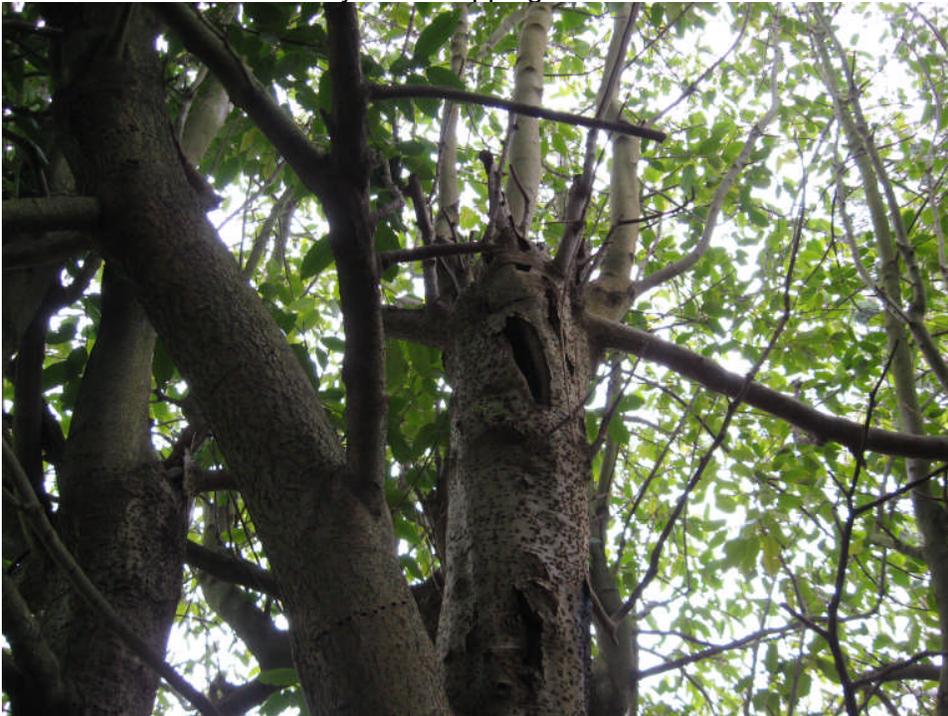
Tree #113 Extensive decay below topping cut
